Council of the Isles of Scilly

Tractor Shed Roof Replacement and Repairs

Pre-Construction Information

4101565\_Tractor Shed

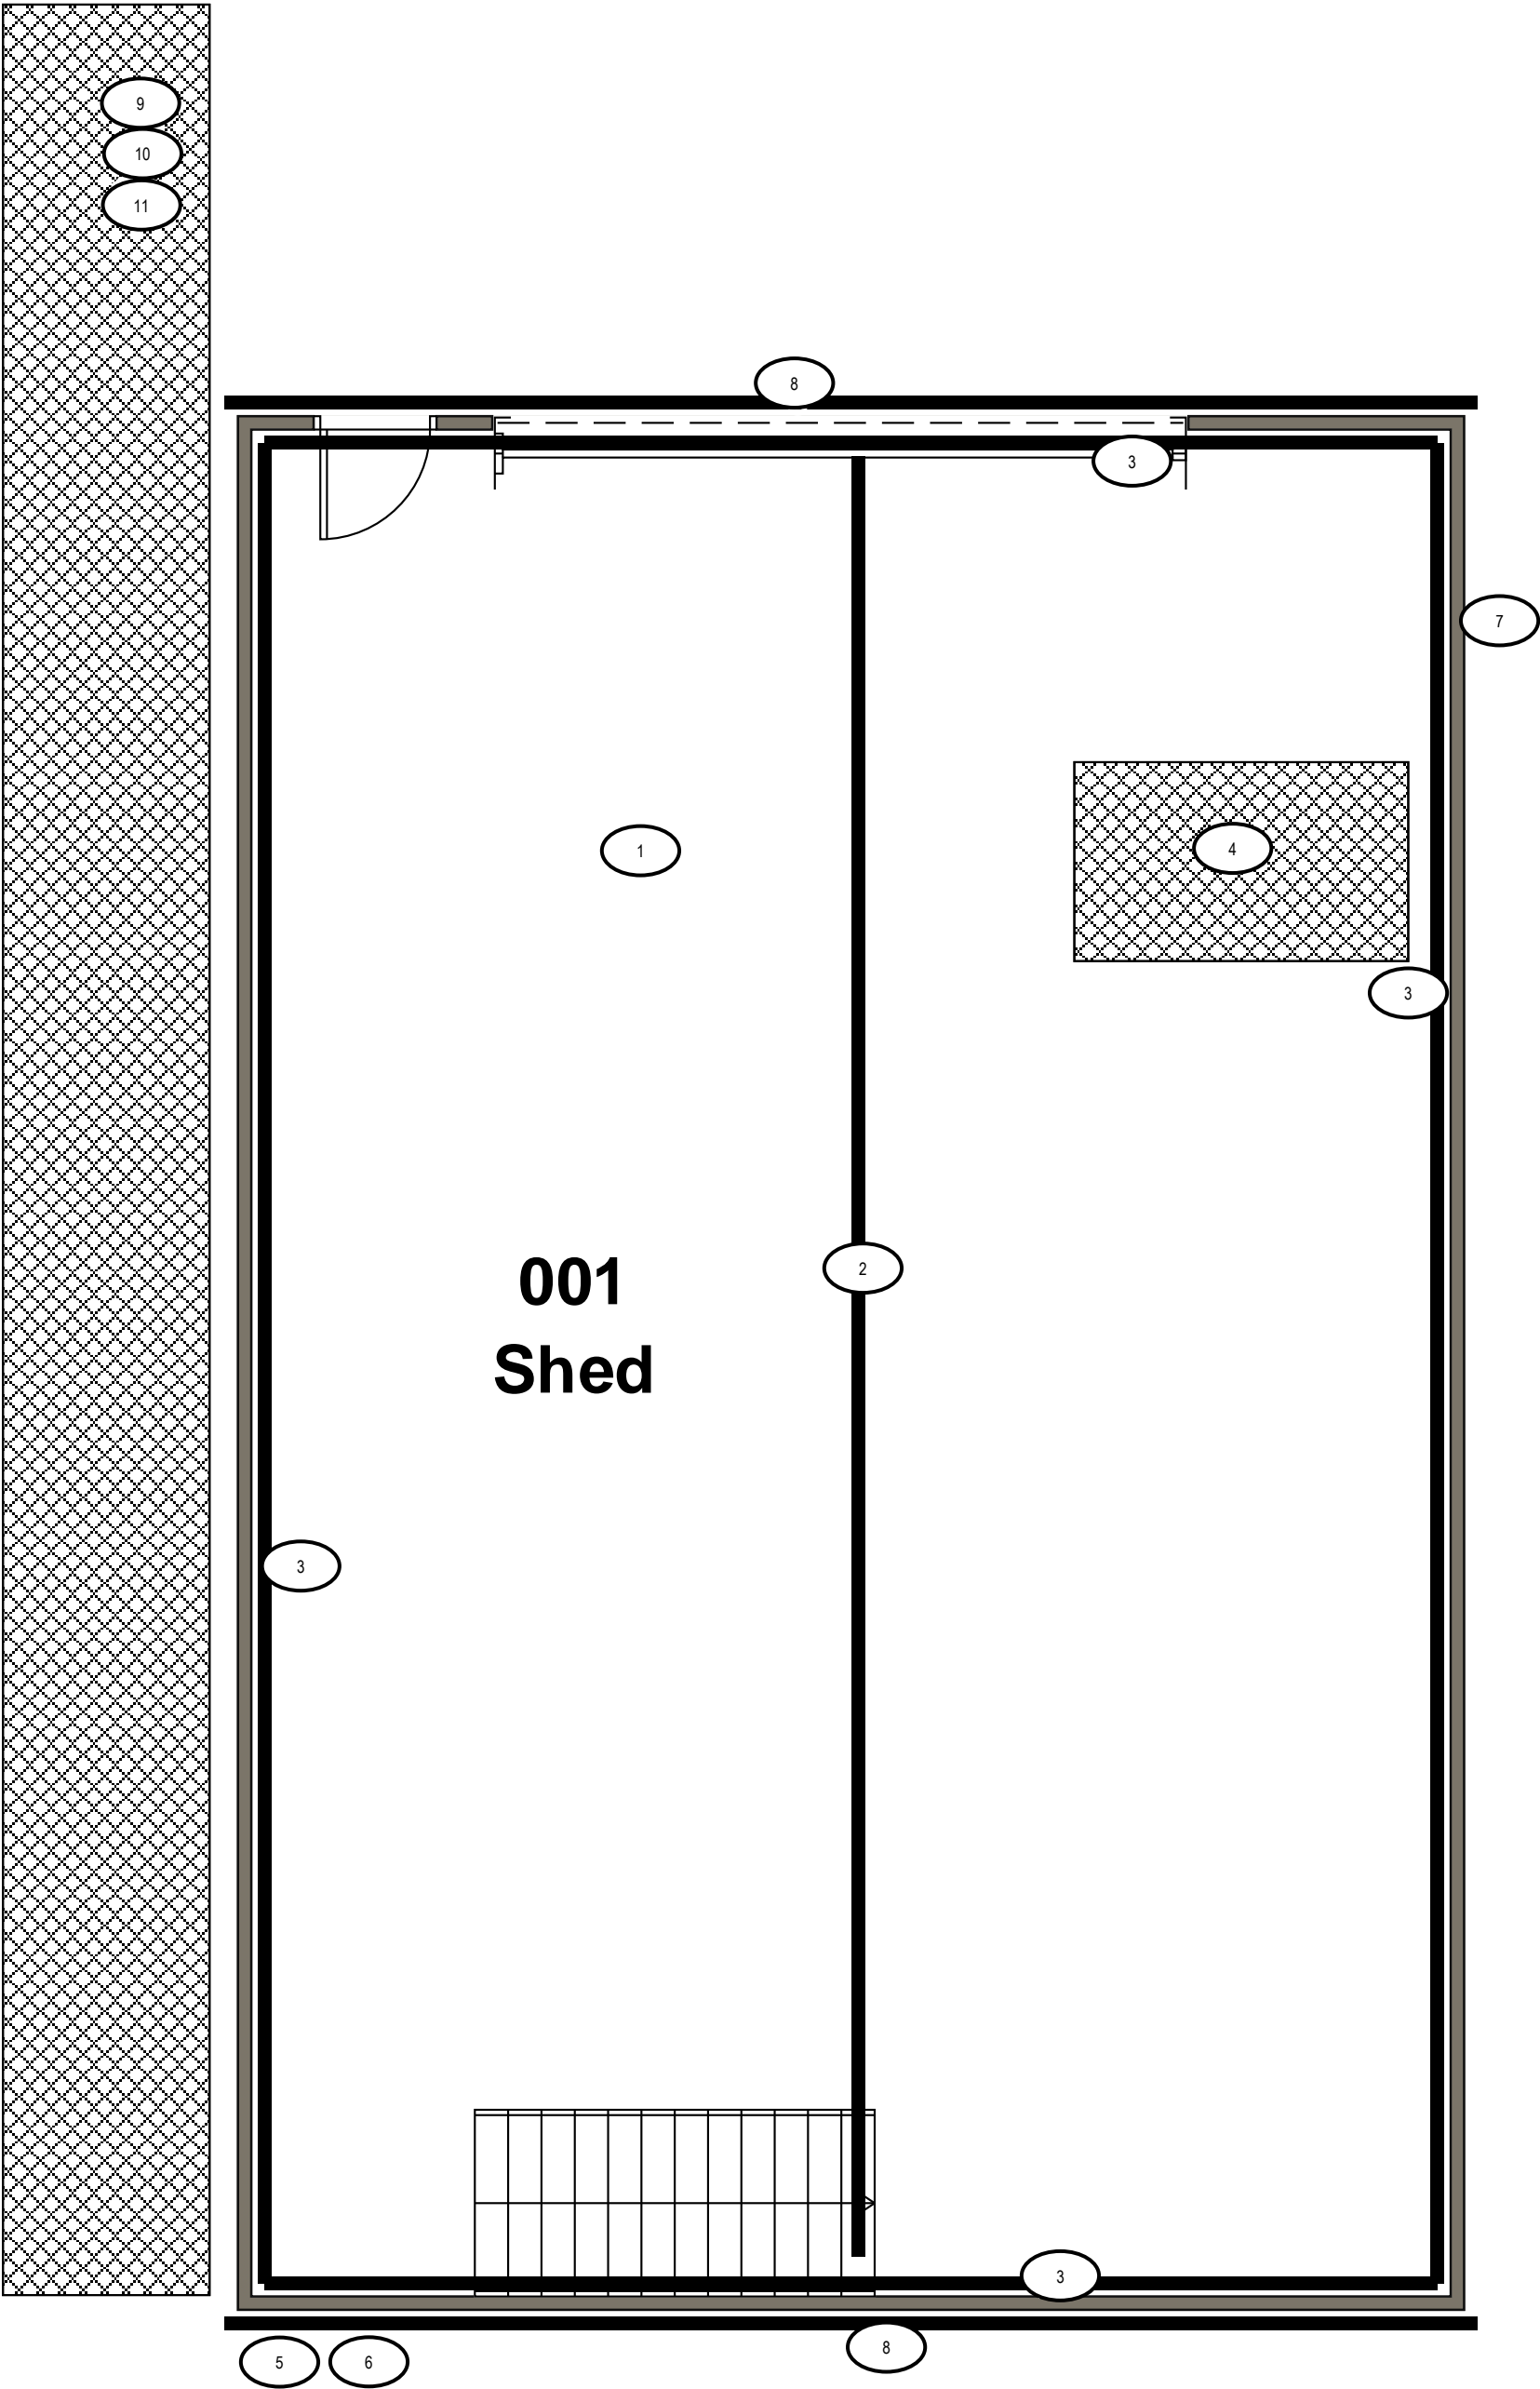
Please note:  
Where provided floor plans should be  
regarded as sketch-plans and for  
identification purposes only. They are  
intended to provide a visual appreciation of  
the buildings surveyed, showing locations of  
suspected ACMs, areas of no access and  
where samples were taken.
