**Re-construction of Chalet at
6 Bayview Terrace
Porthmellon, St.Marys
Isles of Scilly, TR21 0NE
for
Mike Green and Hannah Barclay**

DESIGN AND ACCESS STATEMENT

PRELIMINARY ROOST ASSESSMENT (PRA)

6 BAY VIEW TERRACE, PORTHMELLON, ST MARY'S,
ISLES OF SCILLY

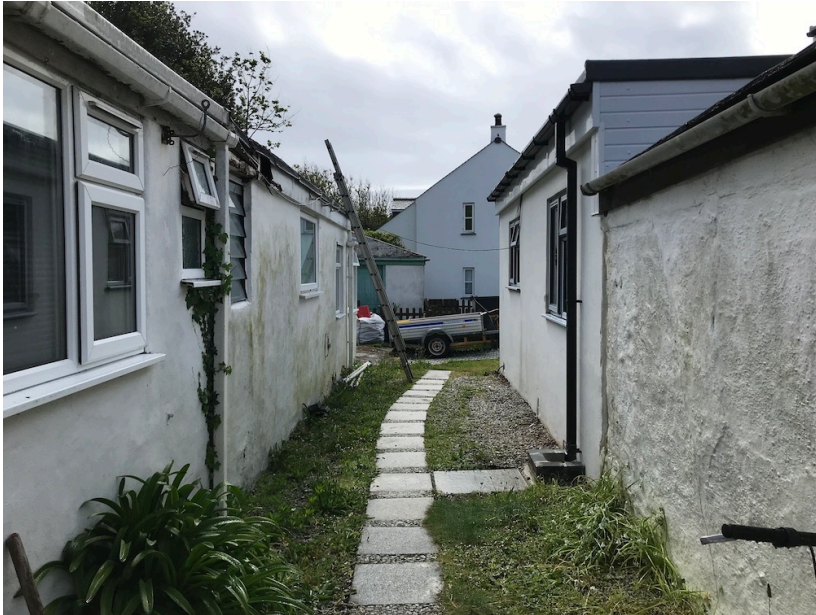
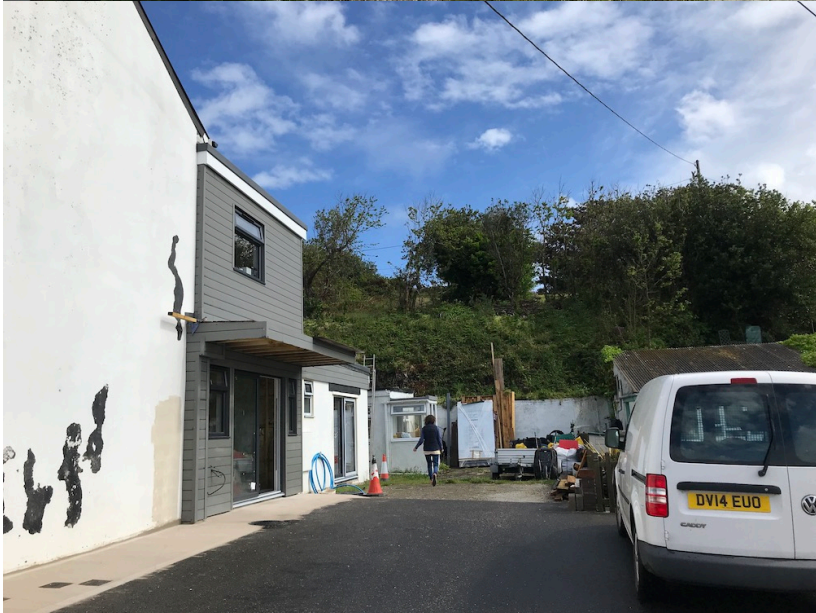
The existing chalet is a single storey flat-roofed building constructed from single-skin concrete blockwork. Unlike the main terrace of six houses, the row of flat-roofed outbuildings at the back of the houses have no real architectural value. They nestle into the hillside with the rear wall of the main living space also serving as a retaining wall. Internally, there is a small entrance lobby, a large open-plan living space and a former shower room and toilet to the rear.

As the top photo above shows, there is a wide pathway separating the chalet from the back of 6 Bayview Terrace.

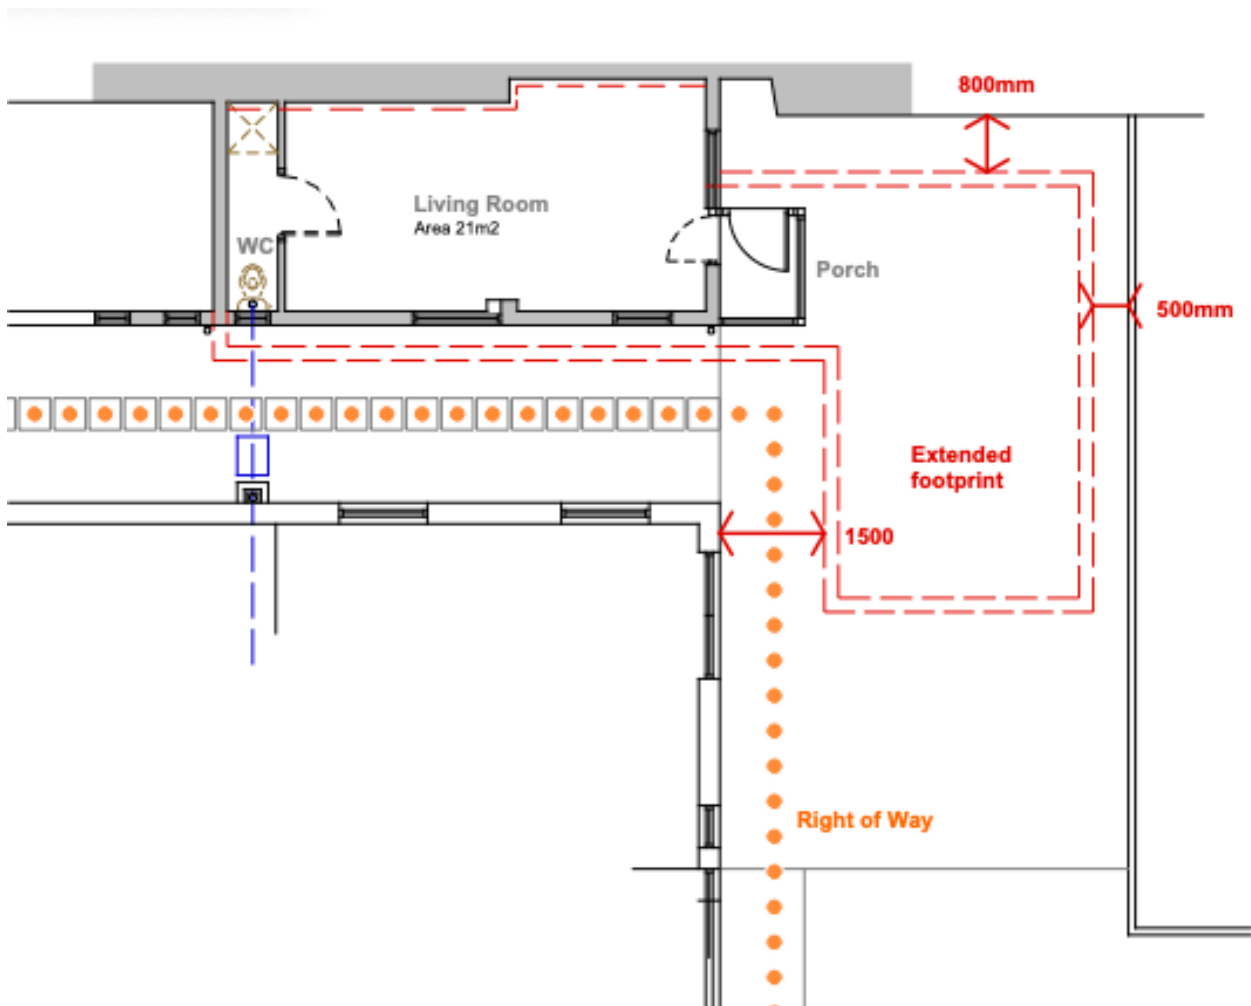
The internal floor area of the chalet measures 23m². This is well below the National Space Standards for housing that stipulate that single bedroom homes should have a minimum of 50 - 58m² of accommodation (also see Design Brief section below). The floor plan on the following page was submitted to the Isles of Scilly Council with a 'Pre-App enquiry' and illustrates the cramped existing internal space. The red dotted lines show the intended increase in footprint.

Above: Existing floor plan with intended layout Indicated in red

Rights of Way: Before submitting this application, Mike and Hannah carefully checked their deeds and Duchy of Cornwall records. Rights of way run in front of the terrace over their land, and also around the rear. The latter right of way is shown on the existing plan in section 2 of this report. These rights have informed the design process and we confirm that they will be uninterrupted as a result of this planning development. During the course of construction, the rights of way will be maintained and made safe at all times.

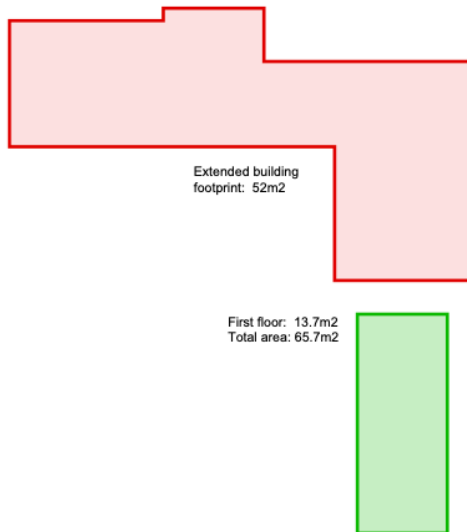
Above: Initial spatial analysis of chalet. Finished designs have slightly improved accommodation to 66m²

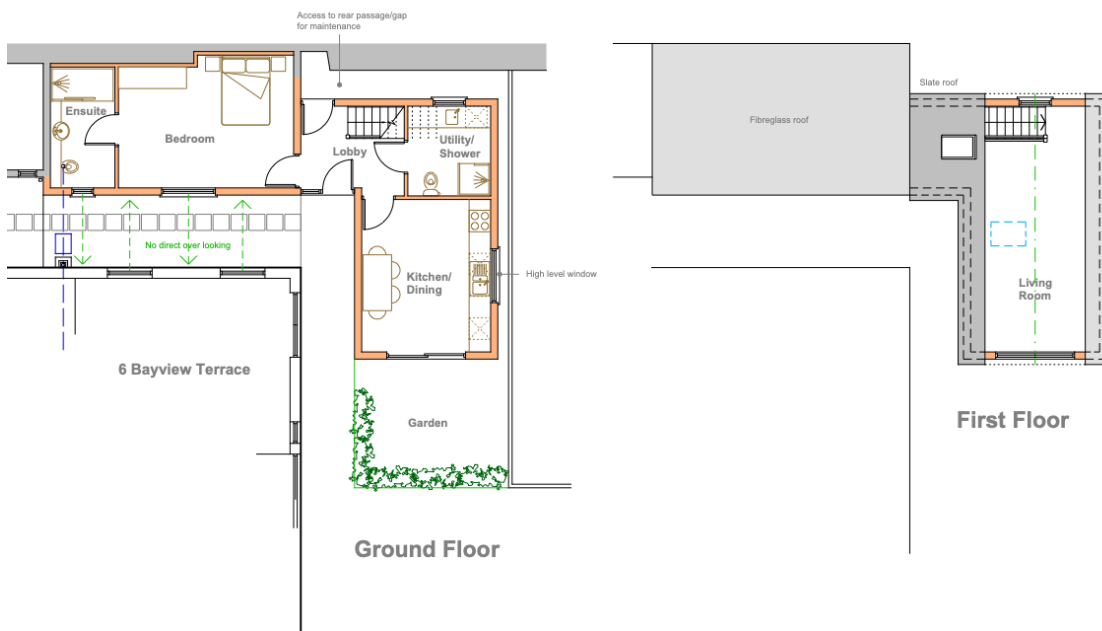
Extracts from the planning drawings are included in this report. The plan below shows the new construction work coloured in orange and the relationship with the existing end-of-terrace house. The extension creates an 'L' shaped chalet with the entrance at the end of the existing footpath in the corner of the building. This produces a very efficient plan-form with minimal internal circulation.

The lobby leads into the ground floor kitchen dining space to the right, the double bedroom to the left within the existing building and also the utility / laundry room. There is a back door providing access to the external lightwell for maintenance of the rear garden retaining wall. There is also a staircase leading to the first floor and access to a small under-stair cupboard.

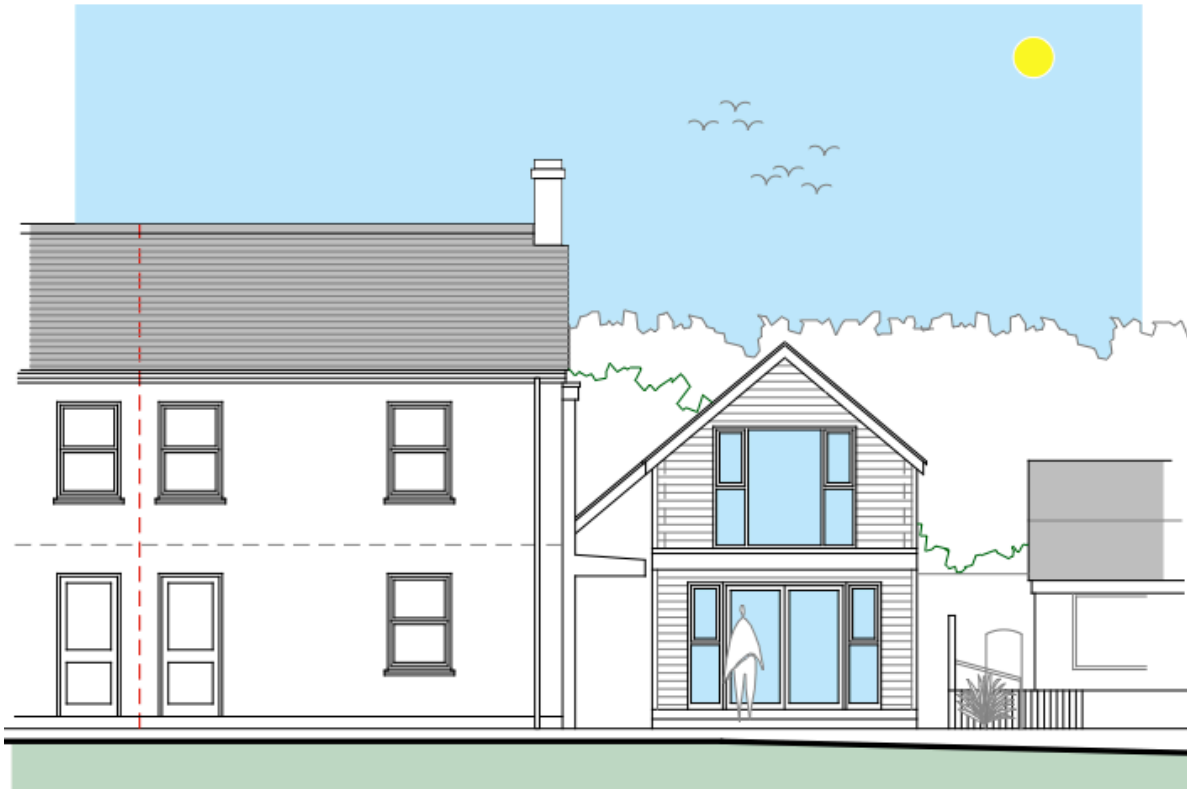
The proposed elevations show the three-dimensional form of the extended chalet with a pitched roof spanning from side to side of the two-storey element. This is the practical way to construct the roof using the shortest wall-to-wall span and keeping the ridge height as low as possible. The traditional roof pitch at 40 degrees is similar to that on the existing terrace. The proposed external wall finishes are grey horizontal composite weather boarding for the external walls and grey fibre-cement tiles for the pitched roof. The weather boarding will match the 'Cladco' cladding on the rear extension to no.6 and a stock of existing roof tiles will be used for the pitched roof, avoiding the need to import roofing materials from the mainland. The existing extended flat roof hidden from public view behind the terrace will be finished in grey liquid applied fibreglass.

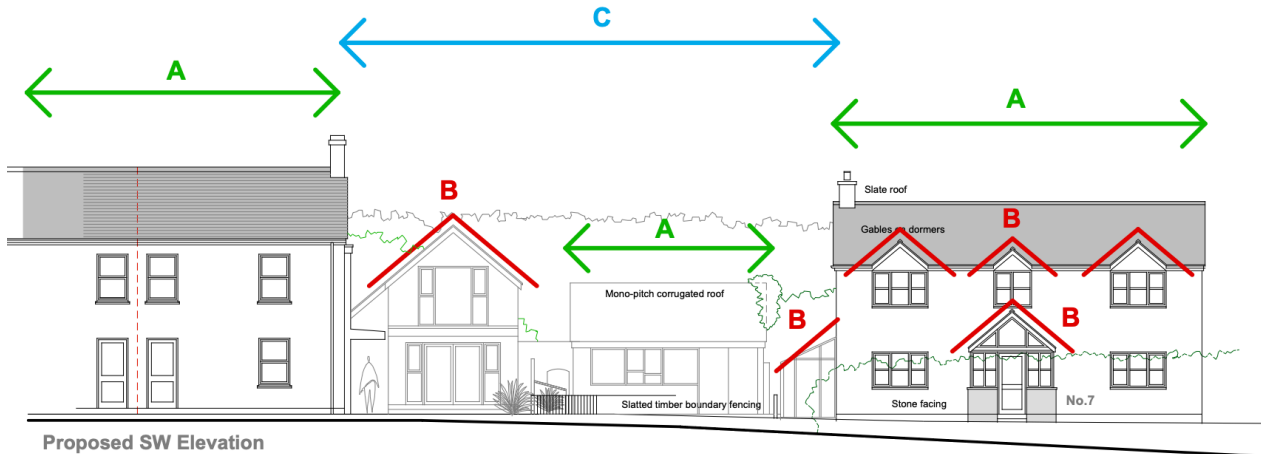
The front-facing gable of the extension was questioned at pre-app stage and it was suggested that this element of the design should be explained in a Design Statement. To help to illustrate the design logic a contextual elevation has been prepared to show the chalet sitting next to its' neighbours. The diagram on the following page shows the long ridge lines of the main terrace and neighbouring detached house running parallel with the front elevation (A). Both of these buildings have pitched gable ends – there is not a hipped roof in sight! The gable on the new extension has been rotated through 90 degrees to face the front elevation (B). This reflects pitched roof dormers and entrance porch on no.7 Bayview next door. These features were

The drawing below shows that there is a clear break of approximately 15.6 metres between the terrace and the new detached house (C). These buildings are clearly the dominant architectural forms and neither the new chalet nor the mono-pitched roof workshop detract from them. The fact that both structures are set back from the main houses also helps to preserve the character of the host buildings.

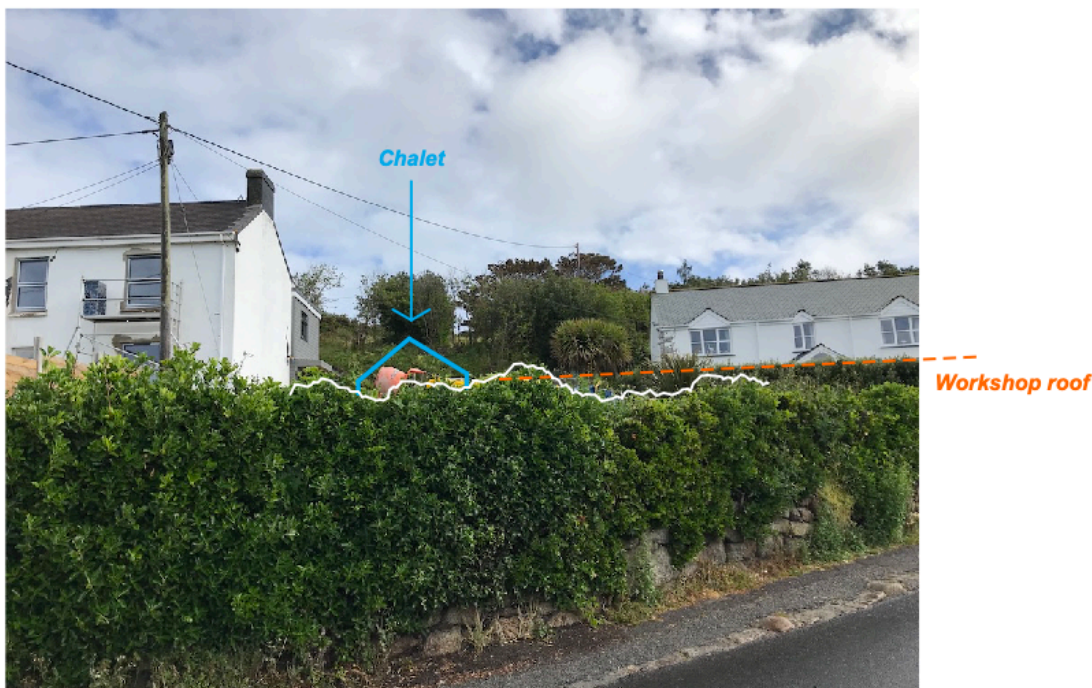
Impact on Conservation Area: The extended chalet will have a negligible impact on the wider Conservation Area. Telegraph Road is the obvious vantage point running in front of Bayview Terrace. The photo below shows the end of the terrace and neighbouring house from the centre of the main road in front of the application site.

From here the tall Scillonian boundary hedge obscures the ground floor of both properties so only the roofscape and upper storeys are really visible. The top of the neighbour's workshop is

scarcely visible behind the hedge (orange dotted line). The top of the gable roof of the chalet will just nudge above the hedge-line but it will hardly be a prominent feature. It is also worth noting that it will sit well below the skyline of trees on the tall bank to the North of the properties.

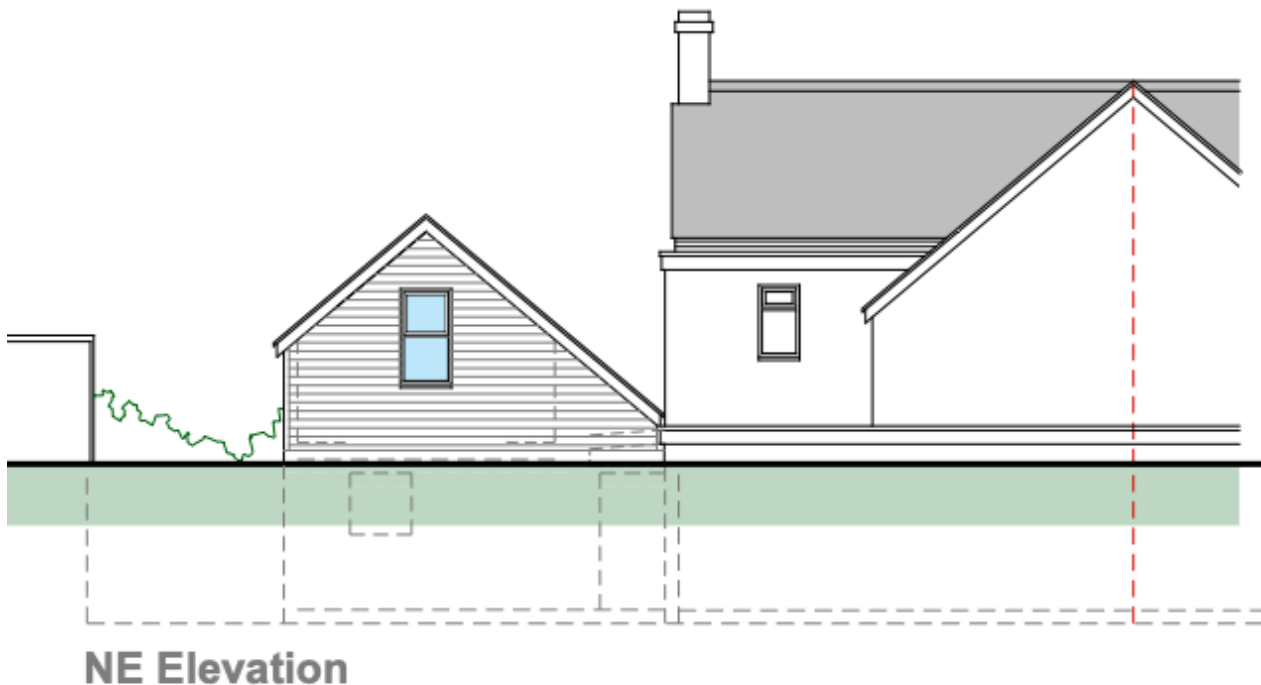
Rear view showing back gable – extract from drawing number 2018-P05

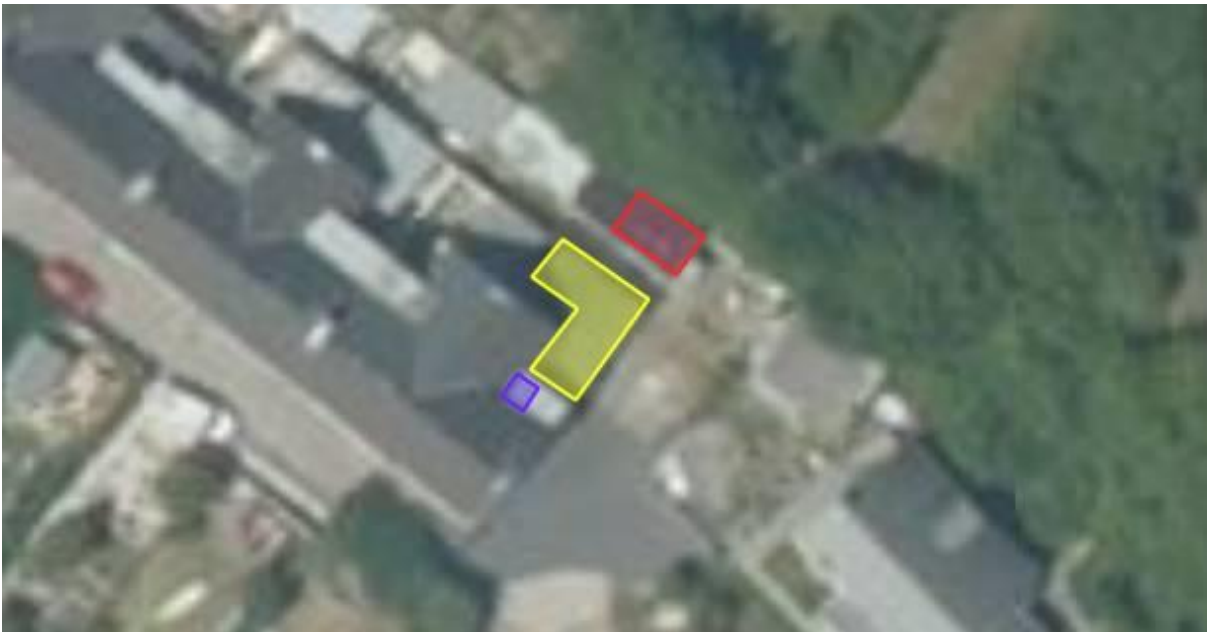
Map 02 – Illustrating the discrete elements of the property surveyed. The **Chalet** is shown in red; the **Garage** is shown in yellow and the **Dormer Bathroom** is shown in blue. Other elements of the property, excepting those directly impacted by the proposals for the dormer bathroom, were not subject to survey.
