Application number: P/23/068/ROV

Application type: Variation/Removal of Condition

Flood Risk Assessment

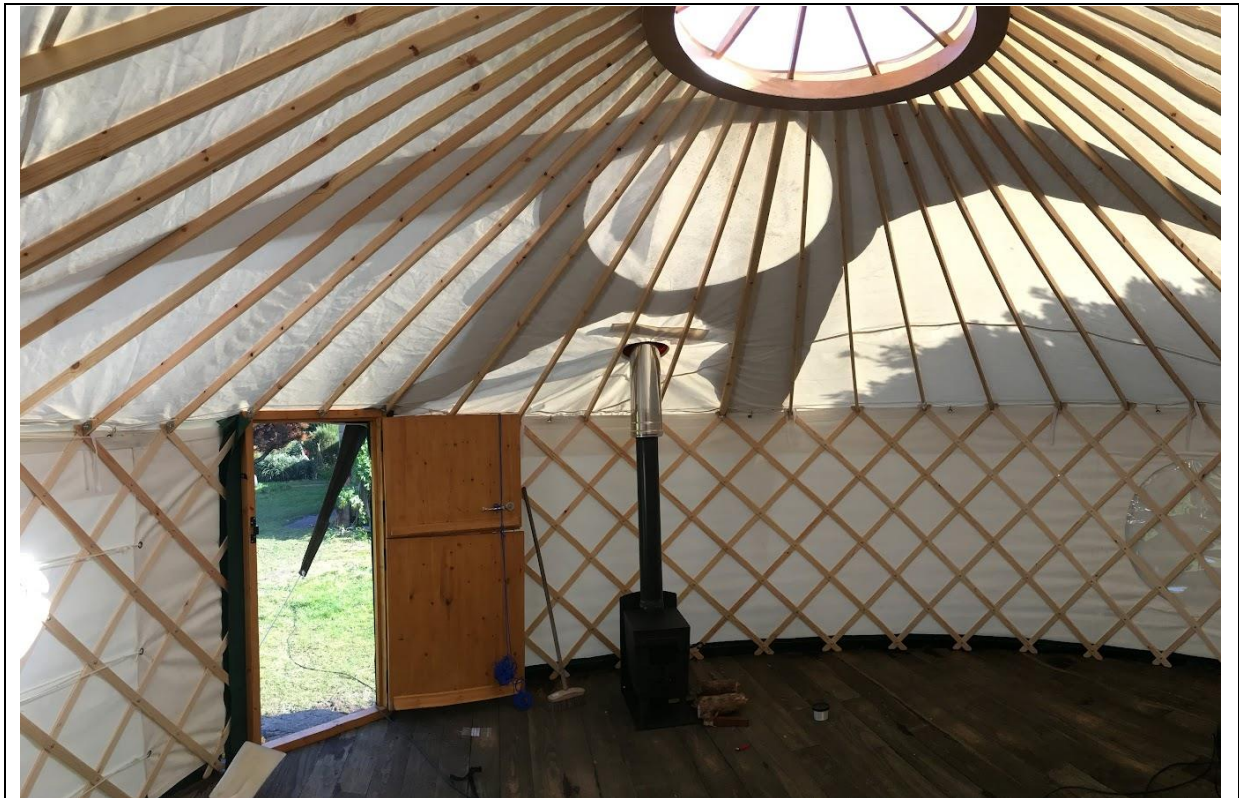
The yurt is constructed of wooden lattice walls with canvas covering.

Photo 1 – showing the structure of the yurt.

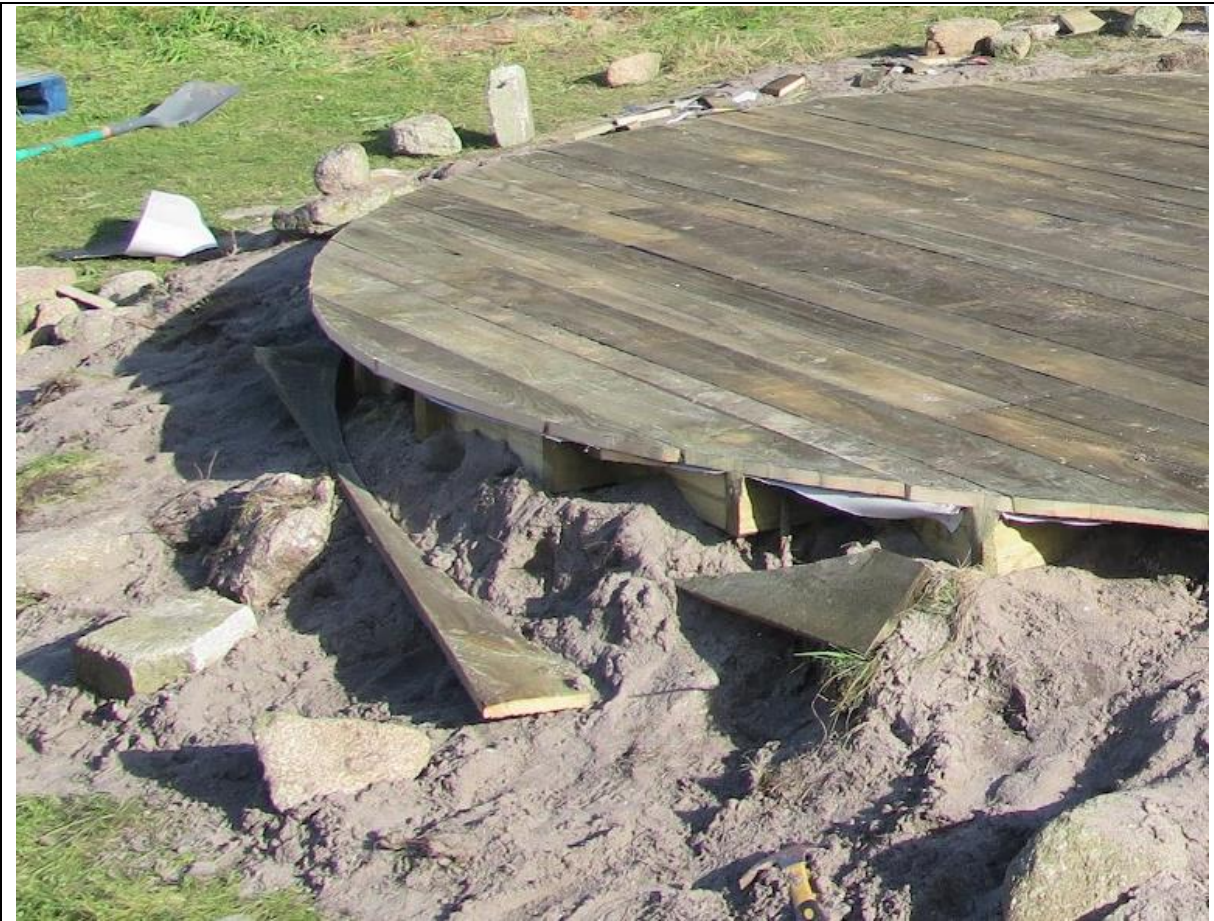
The base is a tanalised wooden timber framework with a tanalised wooden gravel board floor. It is slightly elevated from the ground.

Photo 2 – showing the base of the yurt during construction. The elevation above the surrounding land can be seen.

The yurt base would easily be able to withstand a period of immersion underwater if this occurred – however also note the elevation of the base above the ground level which provides a further element of protection from surface water flooding.

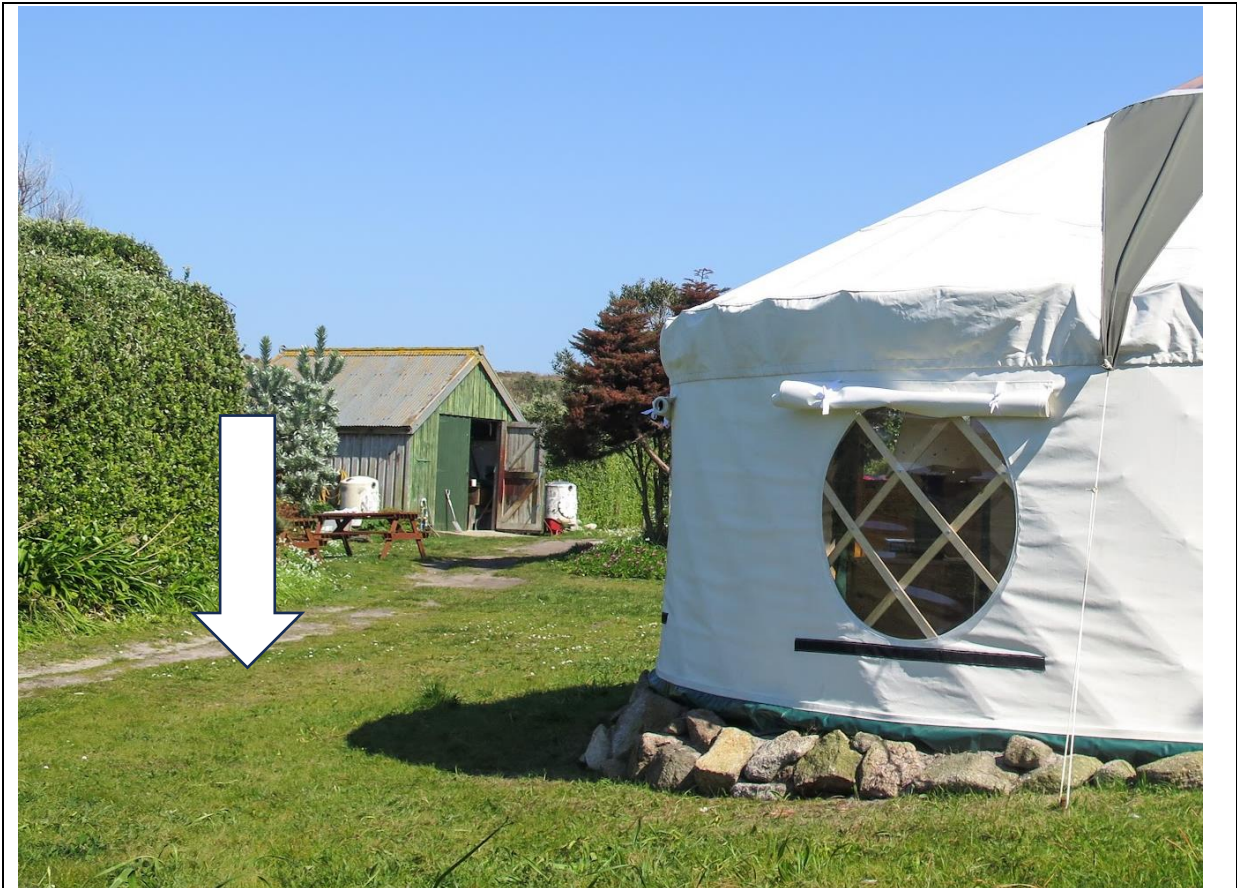
In the event that rainfall was sufficient to overcome the natural resilience of the land, the location of the yurt would mean that adjacent land would flood long before the yurt location was affected. The photograph illustrates the situation of the yurt – the track to the north lies around 50cm lower than the yurt base and, being closer to the potential source of rainwater flooding, would serve as an early warning system if rainwater flooding were to pose a risk to the yurt.

Photo 3 – showing the position of the yurt with the lower-lying track to the north – this is the potential source of rainwater flooding from the vineyard slopes.

The flood map shows that the risk from a 1:1000 event occurring would still result in only a 0-0.25 depth of flood in this location. The yurt is elevated on its base (see Photo 3) which would mean that even in this storm event, it is likely that it would stay dry.

This summary provides a detailed site-specific assessment of the potential sources of flooding; the risk to property and people, and the various site specific considerations which affect this. Measures which might ordinarily be built into a development to mitigate risk of flooding, such as elevated finished floor levels; ground levels to encourage water away from the structure (see Photo 3); and ensuring safe access/egress/evacuation are all built into the existing structure.

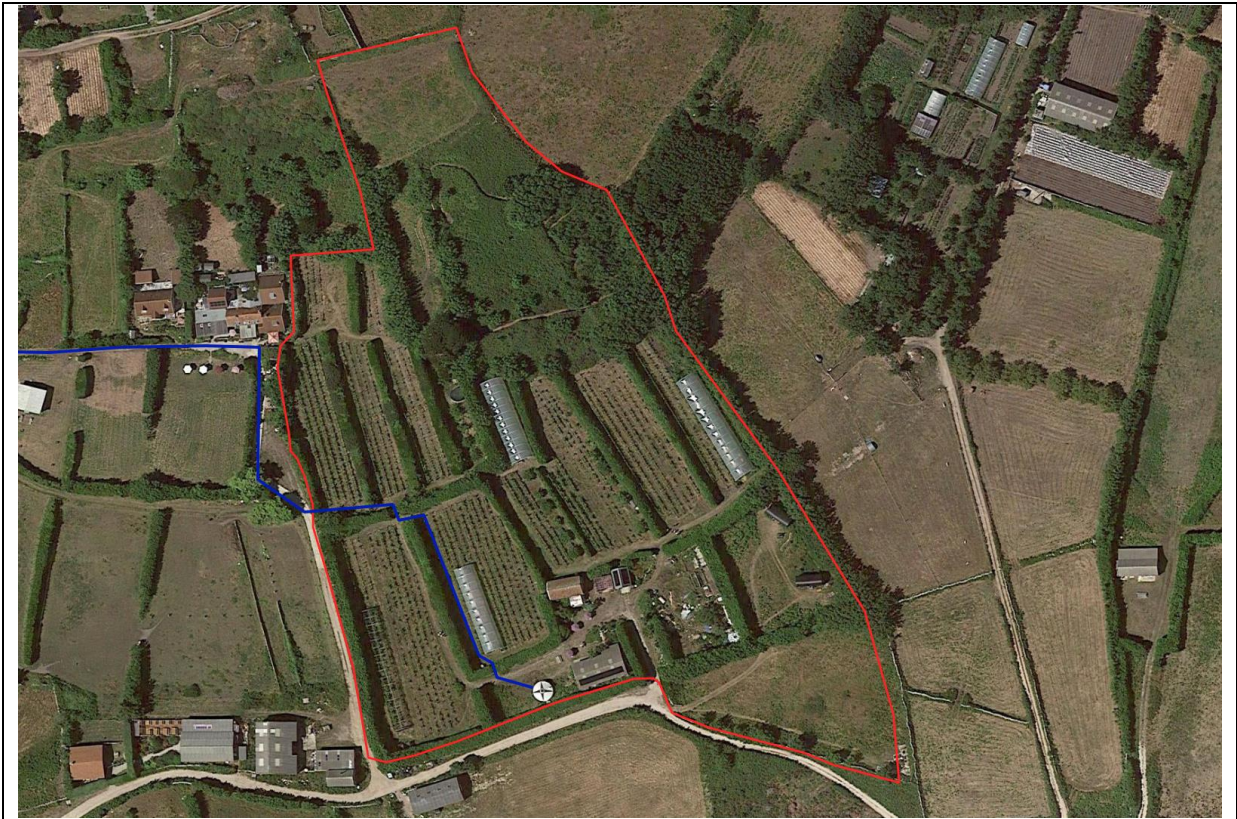
There is a clear evacuation route off the vineyard which would allow the occupants to reach a place of safety even in the most extreme scenario – this is shown on the map below.

Photo 6 – showing the yurt and the evacuation route (blue) which is all upslope to a point beyond the flood risk zone. The vineyard land holding is illustrated in red.
