PRELIMINARY ECOLOGICAL APPRAISAL & PRELIMINARY BAT ROOST ASSESSMENT OF:

TREVEAN, HIGHER TOWN, ST MARTIN'S, ISLES OF SCILLY, TR25 0QL

Client: Mr Mark Travers Our reference: BS30A - 2020 Planning reference: P/20/039 Report date: 17th June 2020 Author: James Faulconbridge MRes, MCIEEM Report peer reviewed: Darren Mason

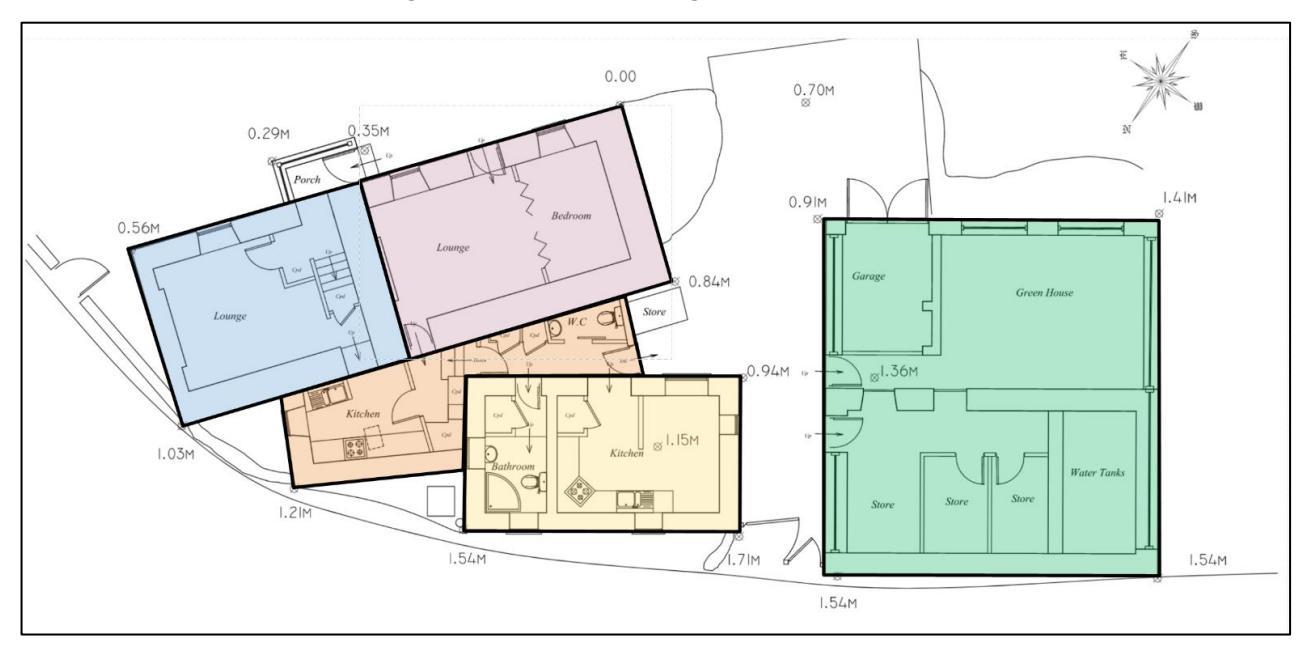
- an two-storey component with a higher ridge line (shown in blue in Figure 02 below);
- a two-storey component with a lower ridge line (shown in purple);
- a single-storey kitchen (shown in yellow) and;
- a single-storey linking porch and second kitchen (shown in orange) attaching the main kitchen to the main two-storey components.

In addition to the main residential dwelling formed of the four contiguous components, there is a separate detached workshop/glasshouse (shown in green).

Figure 02 – showing the structurally or physically distinct components of the property – reproduced from the Existing Plans submitted by the Applicant in support of Planning Application P/20/026. This map pertaining to a different application is used to provide consistency between the two reports produced which deal with proposals relating to the same buildings.

Application P/20/039 concerns the conversion of the existing detached glasshouse/workshop (shown in green on Figure 02) into a studio/workshop space. This includes erecting an extension to

the south-west, and a porch to the north-east connecting it with the existing kitchen (shown in yellow in Figure 02). Minor modifications to the existing single-storey link section (shown in orange in Figure 02) will also occur – it is understood that this relates to the replacement of the existing roof coverings with a glazed canopy.

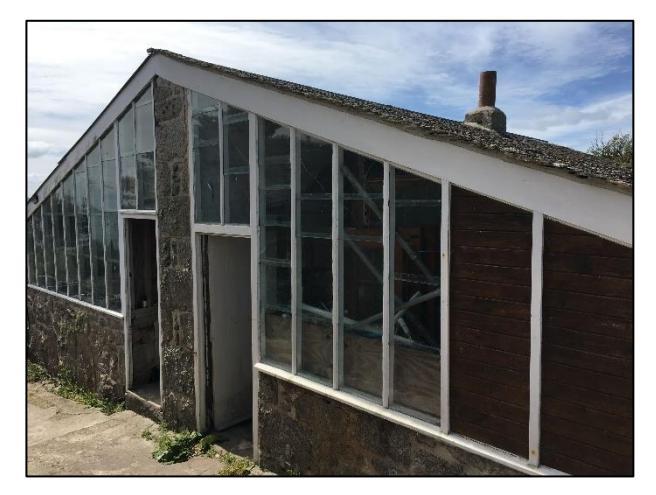
Photo 01 – north-eastern gable of the existing glasshouse/workshop where the porch linking to the main residential dwelling is proposed.

A number of nesting birds are confirmed in the building, utilising access features associated with the apex at each gable end. A sealed triangular void runs beneath the ridgeline and it is believed that nesting birds are accessing sites associated with this void. Species confirmed include house sparrow and starling.

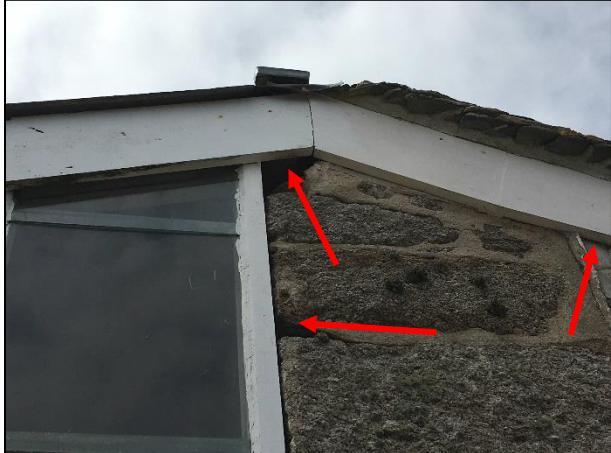
Photo 02 – showing the gap into the sealed ridge void from the north-eastern; gaps between timber frame elements and adjacent blockwork; and gaps behind fascia/barge boards.

The stonework is generally in good condition though there are minor gaps in the pointing throughout and occasional gaps in the south-western gable end where pipes enter the wall or have been removed. Minor gaps could be identified above the timbers which line the wall-plate on the south-eastern aspect. Barge boards on the eaves and gable verges have gaps created by the junction between the linear board and the irregular texture of the stonework to which they are attached. These present potential roosting opportunities behind the boards themselves as well as allowing access to the wall plate and to potential gaps associated with the roof structure.

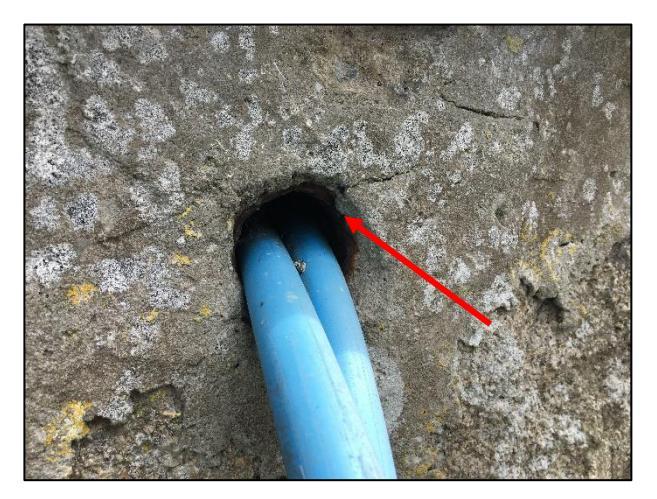
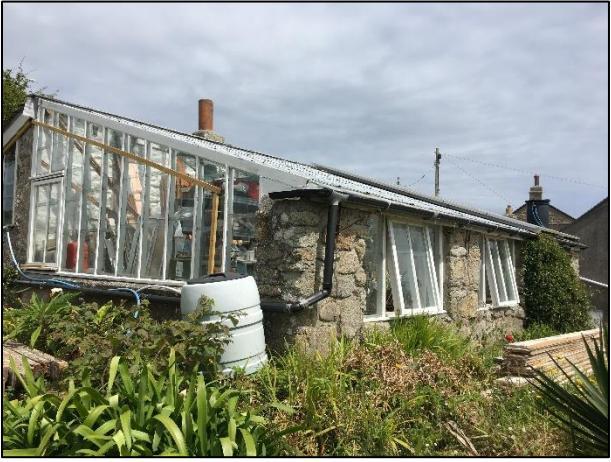
Photo 03 – showing an example of an access feature Photo 04 – showing the building photographed in the south-western aspect where pipework enters the wall.

from the south-west.

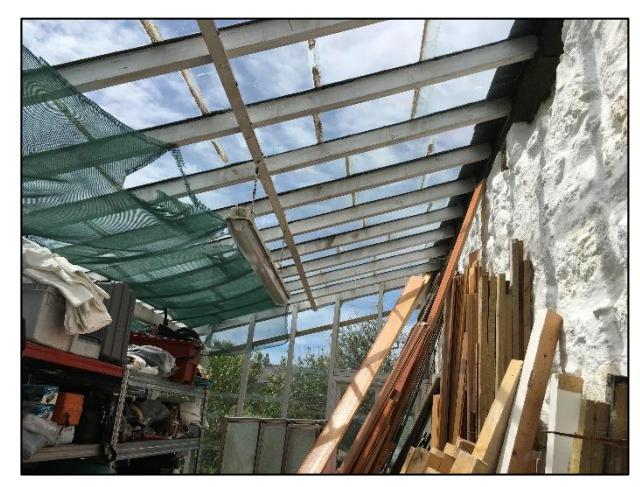
Photo 05 – showing the interior of the building to the south-east with significant areas of glazing. The central wall below the ridge is seen to the right.

No potential roosting features are identified associated with the south-eastern aspect due to the predominance of glazing in the structure; to the north-west the roof has exposed rafters and purlins with plastering in between to seal the tiles from the internal space. There is potential for minor roosting opportunities to occur beneath these.

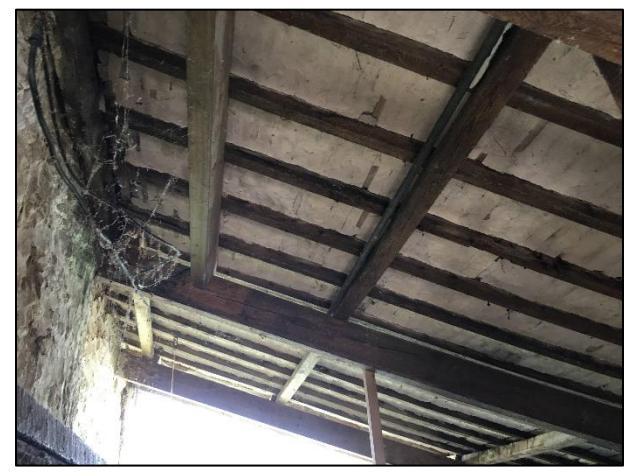
Photo 06 – showing the interior of the building to the north-west with plastering between the rafters. The central wall below the ridge is seen to the left.

The structure is constructed around a central wall which runs beneath the ridge and represents the central support – it is above this feature that the triangular sealed void formed by the pitch of the roof is located. It was not possible to access or otherwise inspect this feature internally. This may represent suitable roosting opportunities.

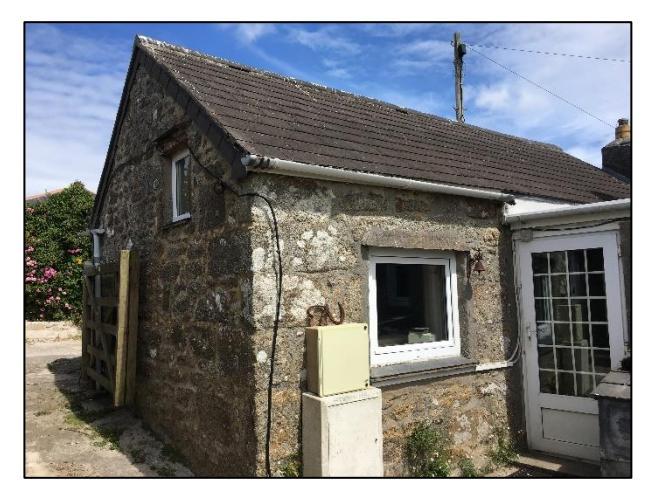
Photo 07 – showing the south-western and southeastern aspects of the kitchen building with the single-storey link section visible to the left.

The existing kitchen is granite built and single-storey with a pitched, slate-tiled roof with ridge tiles. The tiles are generally well fitted – however a lifted ridge tile presumed to have a ventilation function is present which could potentially provide access to a roosting opportunity.

The walls of the building are well-pointed throughout. uPVC windows are well-fitted and in good condition, with no gaps noted except for a minor gap in the timber lintel above the gable window. There are hanging tiles which line the gable verge and these have minor gaps beneath.

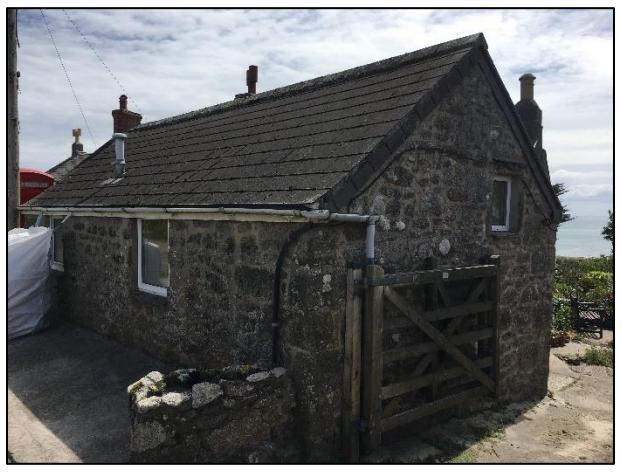
Photo 08 – showing the south-western and northwestern (roadside) aspects of the kitchen building

Barge boards on the eaves have gaps created by the junction between the linear board and the irregular texture of the stonework to which it is attached. These present potential roosting opportunities behind the boards themselves as well as allowing access to the wall plate and to potential gaps between the felting and the slate tiles associated with the roof structure. The boards on the south-eastern aspect are generally tighter fitting and well-cobwebbed indicating a lack of recent use by bats, but more open gaps exist on the north-western aspect.

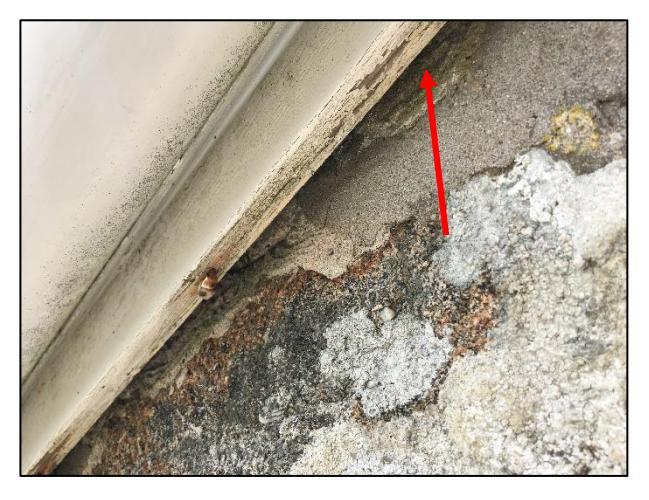
Photo 09 – showing a typical gap associated with a fascia/barge board

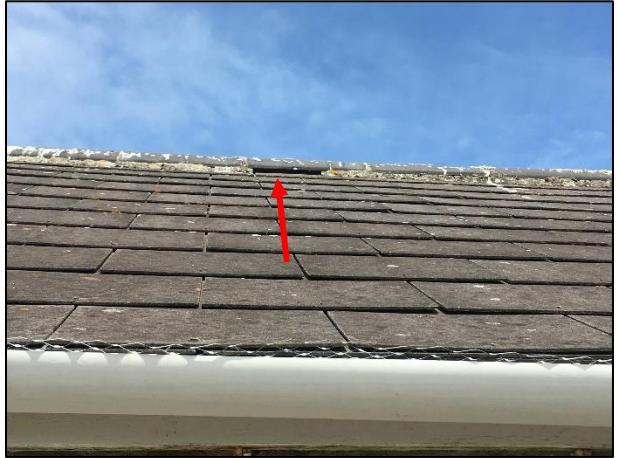
Photo 10 – showing the gap in the ridge tile on the south-eastern aspect of the roof

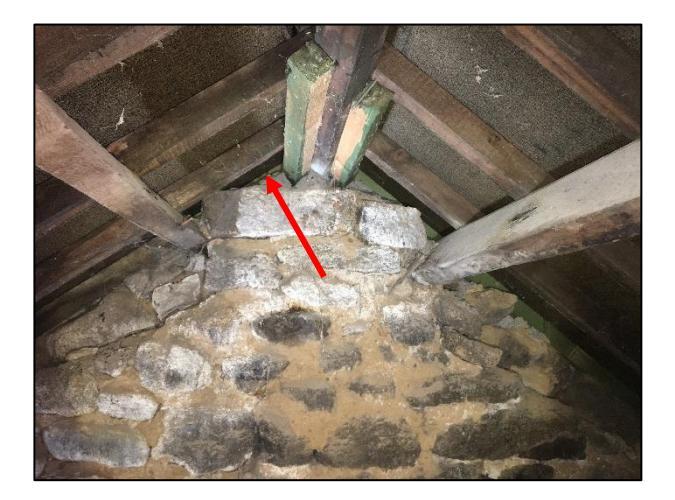
Photo 11 – showing the internal roof void - the location of the confirmed roost is highlighted.

Scattered droppings characteristic of pipistrelle were recorded at the time of survey – a small congregation were identified below an apex timber close to the gable with individual droppings identified elsewhere including upon the loft hatch. A DNA analysis subsequently confirmed this identification (see Appendix 1). The scattered distribution indicates flight within the void, whilst the congregation of droppings closer to the gable indicates roosting associated with the timbers. The number of droppings of varying degrees of freshness indicates roosting by individual or small numbers of bats as a non-breeding summer roost – it is not considered that the number, character

and distribution would be consistent with exploratory behaviour and therefore confirmation of roosting is determined. The evidence is not consistent with a maternity colony; however there are further areas of the loft which could not be accessed safely due to the size and structure of the void and it cannot be ruled out that further roosts occur in these areas. Other evidence of small mammals included mouse and lesser white-toothed shrew droppings.

The DNA analysis of droppings found within the loft of the kitchen means that the kitchen void is a confirmed roost for common pipistrelle – further surveys to characterise this use would be required but the distribution is consistent with a non-breeding summer roost.
