Preliminary Bat & Bird Assessment

Blockhouse, Tresco, Isles of Scilly, TR24 0QQ

5th March 2021

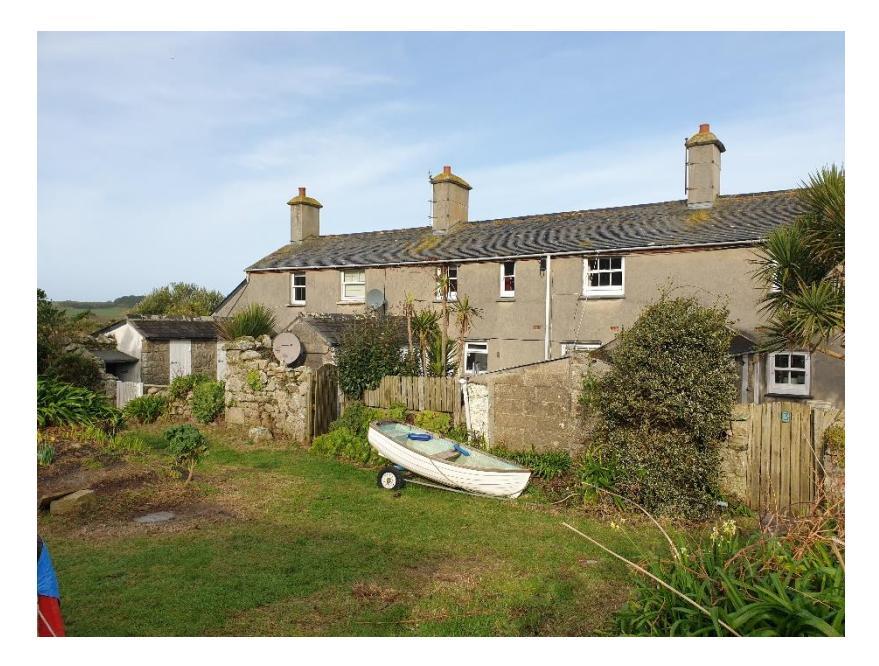
Figure 1: Southern elevation of 1 and 2 Blockhouse cottages

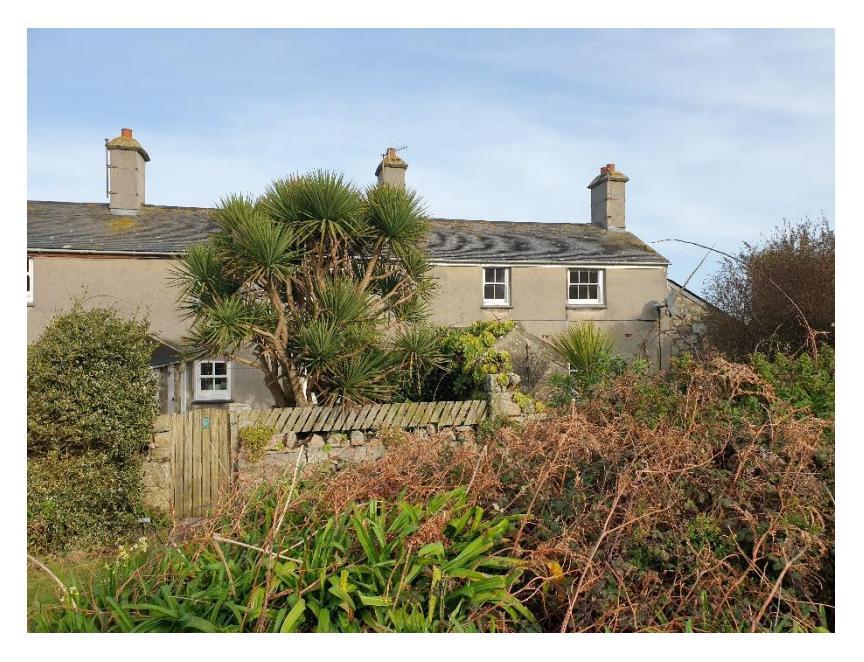
Figure 2: Southern elevation of 3 and 4 Blockhouse cottages

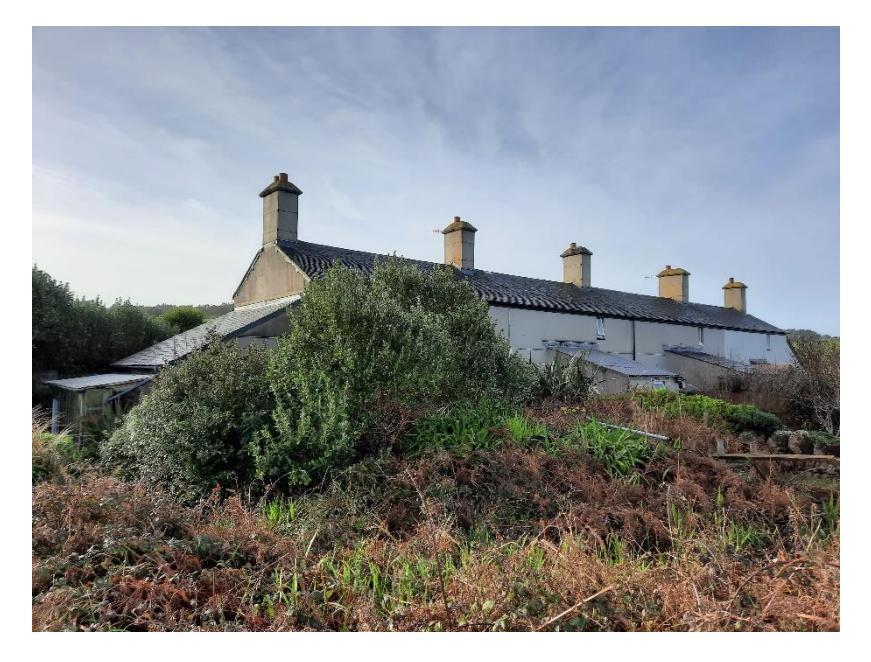
Figure 3: Northern and eastern elevations of Blockhouse cottages

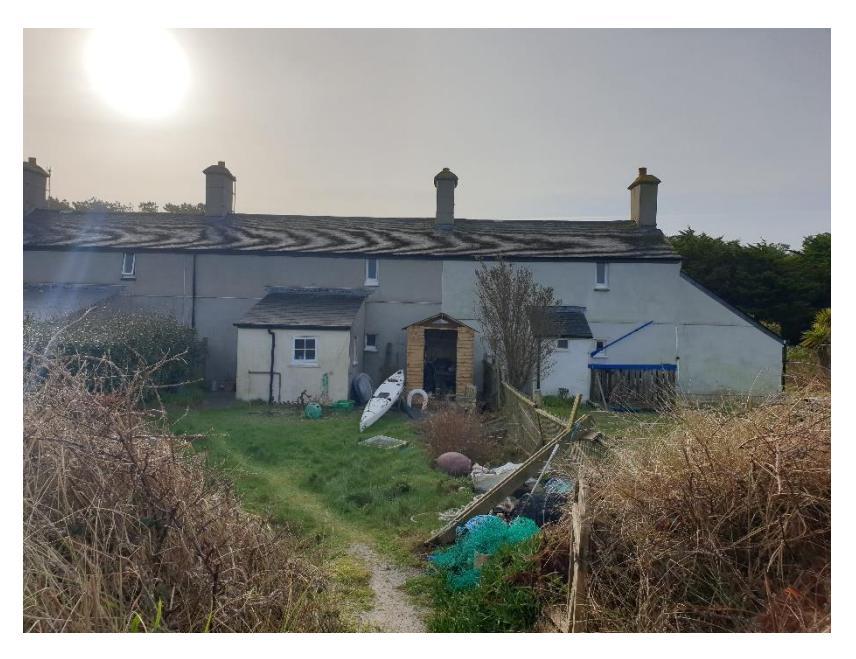
Figure 4: Northern elevation of 1 and 2 Blockhouse cottages

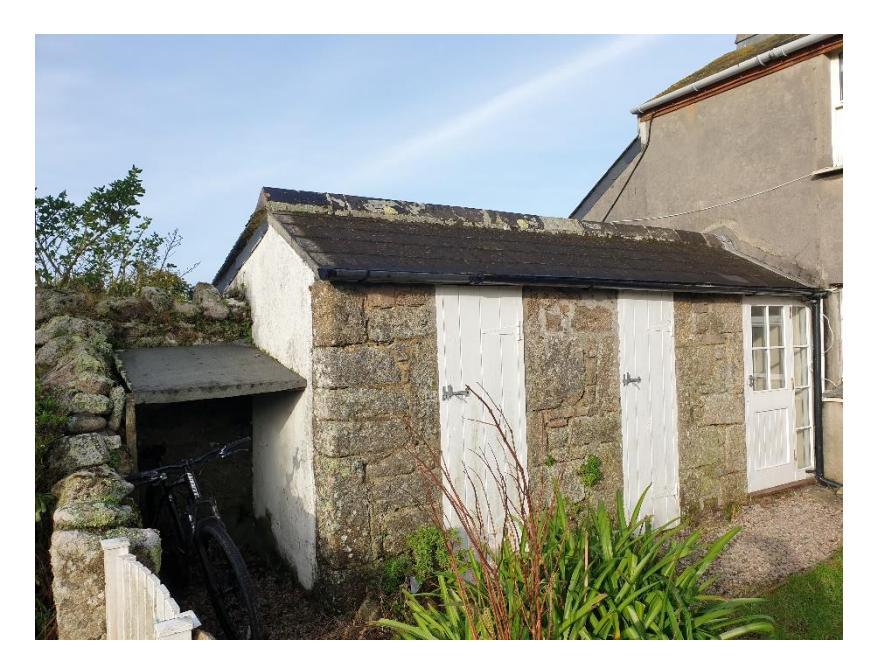
Figure 5: View of one of the outbuildings on the northern elevation of the terraced cottages.

On the southern elevation there are four single-storey, stone/concrete block attached outbuildings with either mono-pitched or pitched roofs covered with either composite/traditional slate or corrugated cement fibre with composite ridge tiles (Figs. 5 & 6). The outbuildings feature lead flashing, occasional small, glazed windows and wooden doors. The external walls are part cement rendered and part exposed/painted stonework. Gaps were observed within all of the outbuildings, notably beneath lifted roof slates, above doors, under lead flashing, under the eaves, within the stonework and behind hanging slates. All of these features could provide potential roost sites for crevice-dwelling bats or bat access to the underside of the roofs and/or interior rooms (Fig 6).

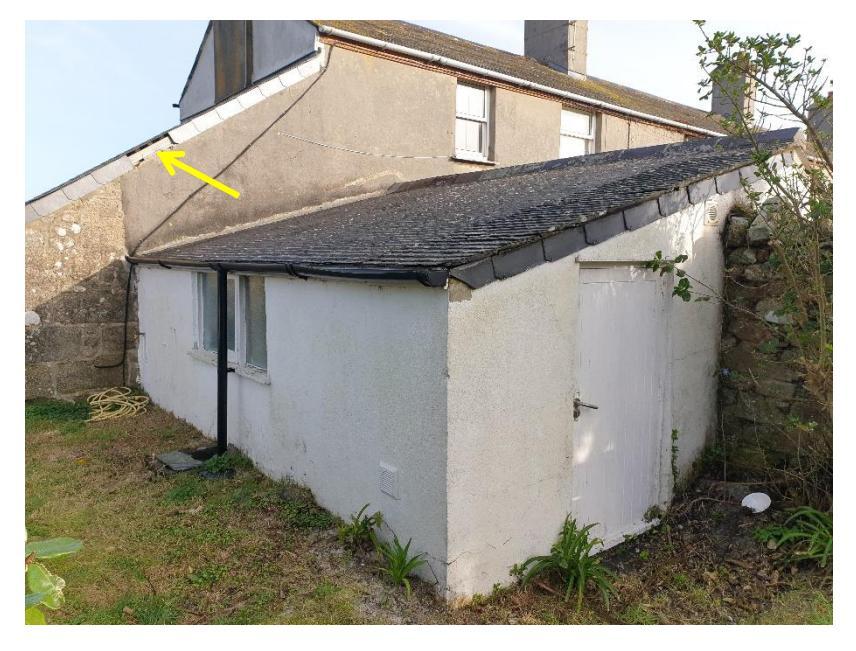
Figure 6: Southern and western elevation of outbuilding 1, also showing hole in roof from missing hanging slate on cottage 1 lean-to (yellow arrow)

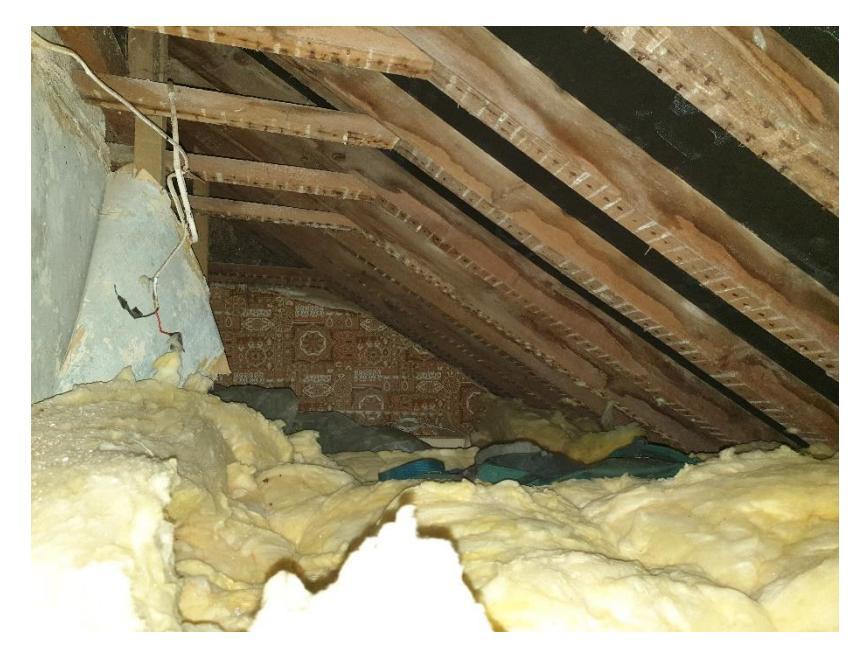
<u>Void 1</u> is dark and features thick mineral loft insulation on the floor, with a synthetic roof membrane lining the roof. The walls are either plastered or wallpapered and the wall tops are open to the interior of the void. No evidence of roosting bats was found within this void, although it was not possible to fully inspect this area due to the thick layers of insulation covering the ceiling joists.

Figure 7: Interior of void 1, cottage 1 (viewed towards the south)

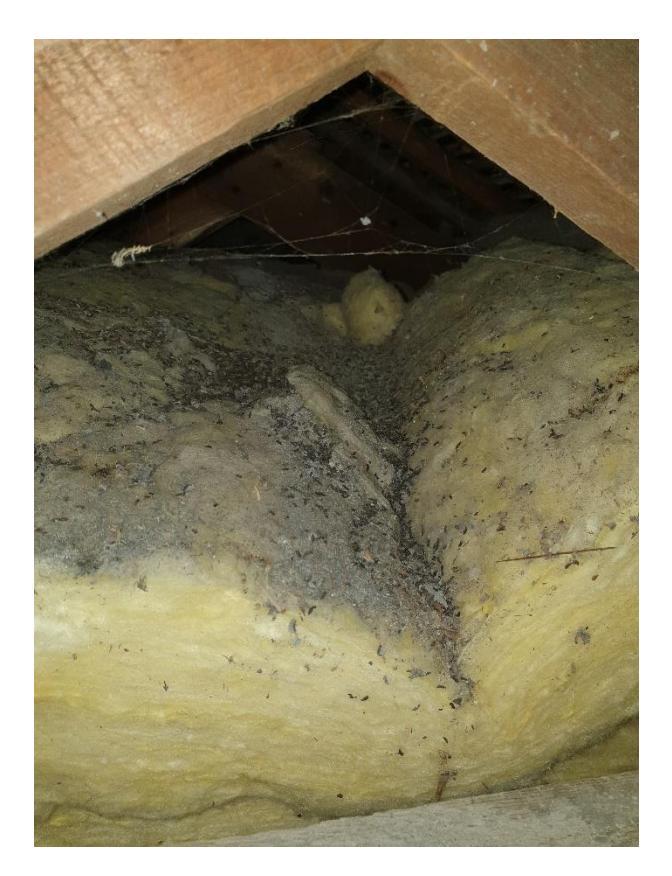
<u>Void 3</u> is in the centre of the property, over cottage 2, and is of the same composition as void 1. Within this void on top of the insulation a light scattering of bat droppings was noted throughout, with a large accumulation of several hundred mixed-age bat droppings noted underneath the ridge in the centre of the void (Fig. 8). The droppings were characteristic of a long-eared bat spp., likely

to be brown long-eared bat (*Plecotus auritus*) as the site is outside the known range of grey longeared bat (*Plecotus austriacus*). NB: species present must be confirmed with DNA analysis of bat droppings.

Figure 8: Accumulation of bat droppings within void 3, cottage 2 (viewed towards the east).

Building works must be informed with two bat emergence or re-entry surveys undertaken between May and September; one of which should be carried out between May and August. In addition, a static monitoring survey is recommended through the installation of a remote detector into the interior of each of the roof voids over Cottages 2 and 3 for 5 consecutive nights between May and September. The survey information will be required to inform the planning application and subsequent works. These surveys will determine the species, number of individuals, bat access points and timings of usage. DNA analysis of collected bat droppings (one sample per cottage 2 and 3) is required to confirm the species present.

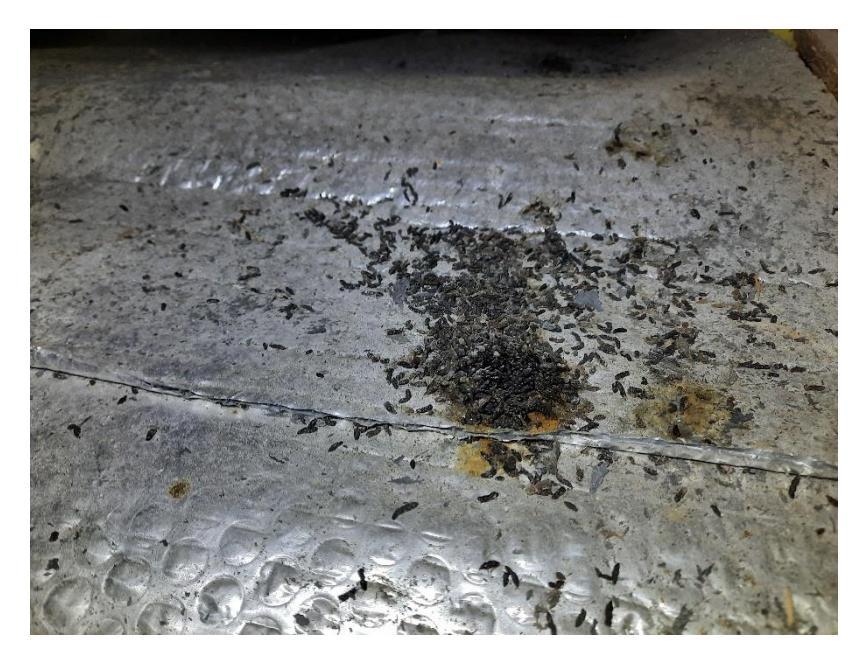
<u>Void 4</u> spans the length of cottage 3, the composition is largely the same as the other cottages, but the roof tiles are unlined. There was rolled insulation and a metallic insulation sheet covering the joists. Scattered bat droppings were observed throughout the void with concentrations observed under the apex (*c.* 500, Fig 9), likely from the same bat species as those found within void 3. Gaps were seen at the wall tops (Fig 10) and gaps were seen within the chimney stonework, which provide potential bat access into the void.

Figure 9: View of one of the piles of bat droppings found within void 4, cottage 3.

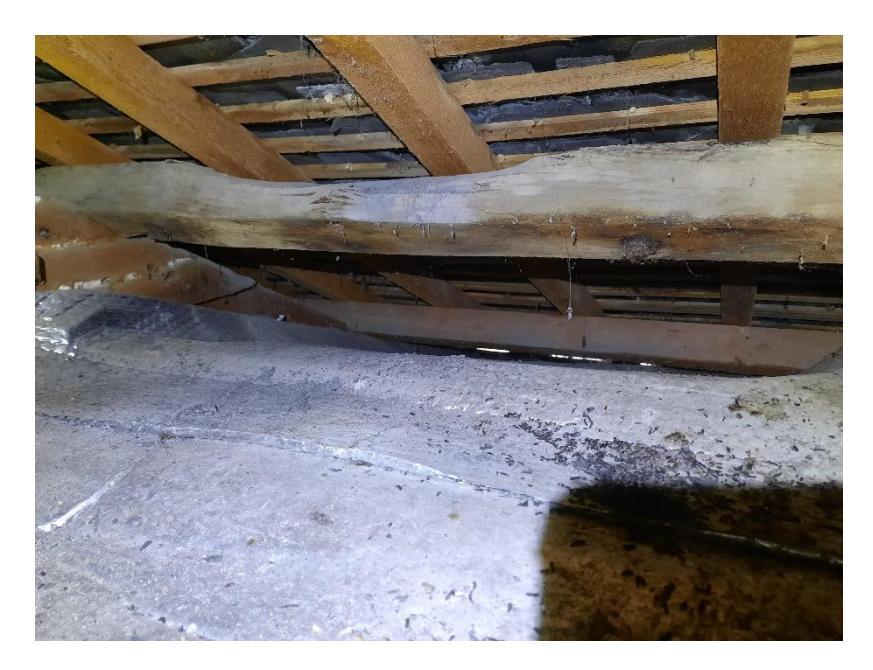
Figure 10: View of gaps at the wall tops of void 4 within cottage 3.

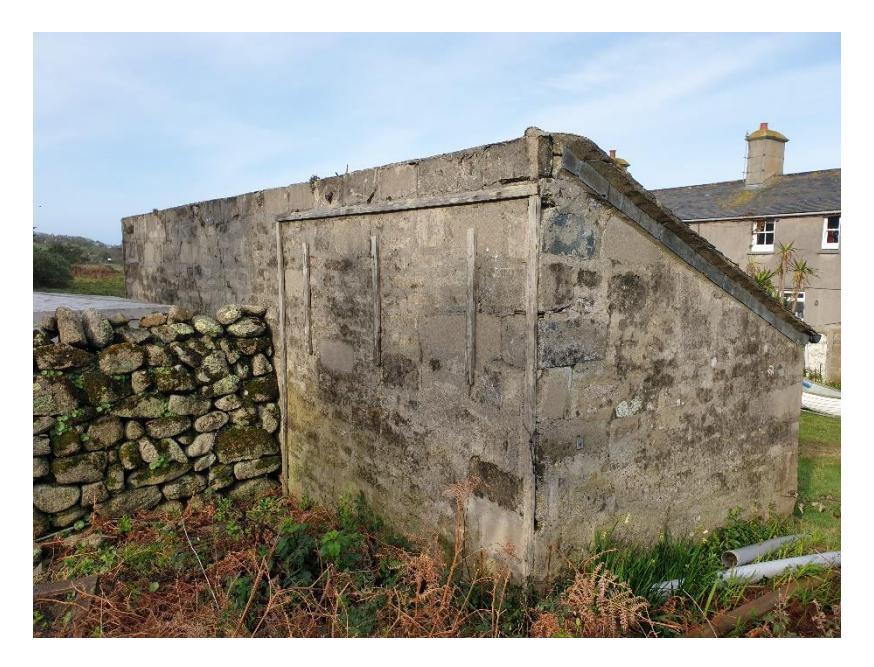
The detached outbuilding lies to the south of the cottages. It has a mono-pitched scantle slate roof and the external walls are either bare stone or cement washed (Figs. 11-12). There is a low stone wall attached to the southern elevation of this building, which surrounds an electrical substation. There are notable crevices within this wall with some potential for roosting bats. There are notable gaps underneath lifted roof slates, which provide potential roost sites for crevice-dwelling bats and also potential bat access into the building interior. There are hanging slates on the eastern and western elevations, although these appear well-bedded with mortar, with few gaps. The building features plastic guttering and downpipes, timber doors and timber framed windows covered with plastic/timber boarding and slate sills. There is a hole in the eastern door and in the roof at the eastern end of the building, and gaps at the eaves on the western elevation, all of which enable potential bat access into the interior.

Figure 11: Southern and eastern elevations of detached outbuilding, showing attached stone wall

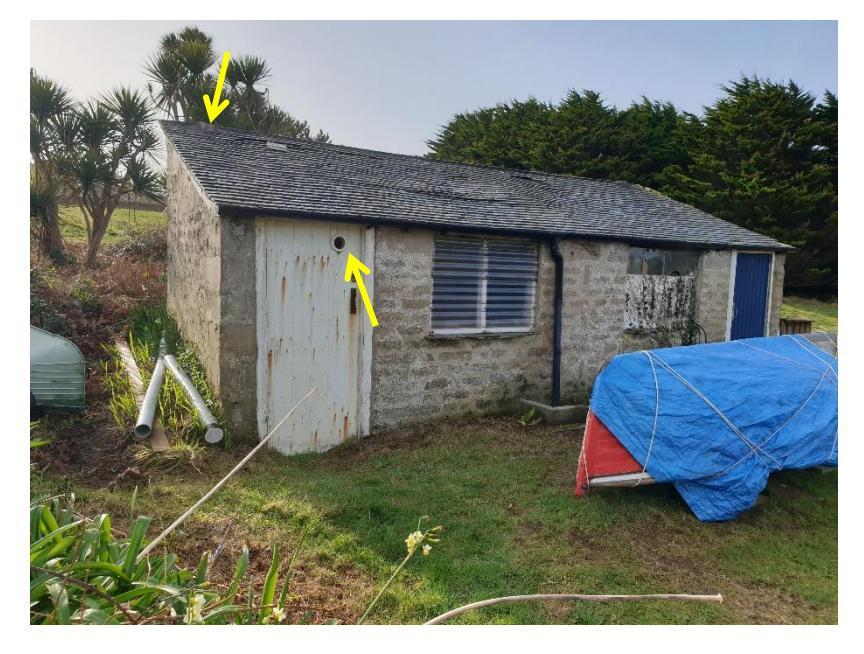
Figure 12: Northern elevation of detached outbuilding, showing holes in door and roof (yellow arrows)

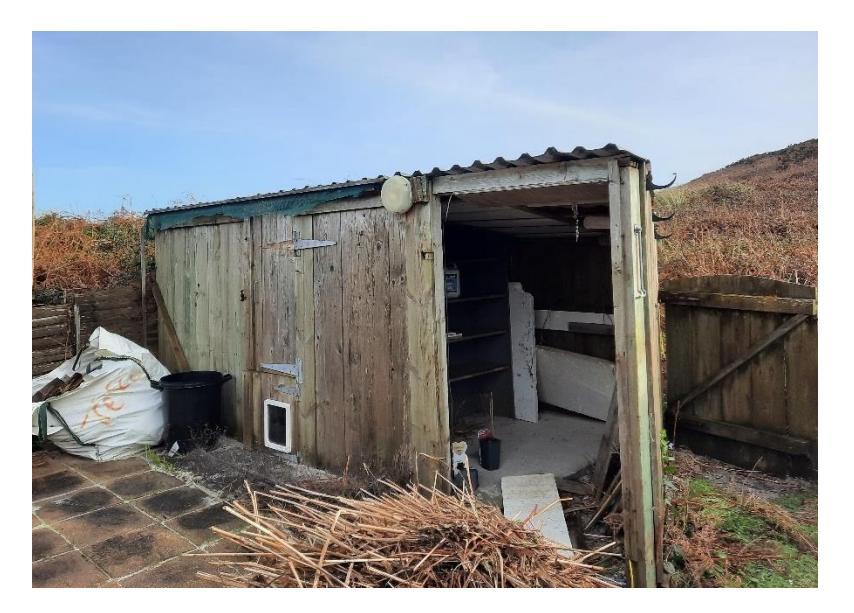
A timber shed was also present to the rear of Cottage 3, this was of timber construction with a corrugated sheet flat roof (Fig 13). This was open and draughty internally, consisting of a single room with no significant crevices or enclosed spaces with potential for roosting bats noted.

Figure 13: Western elevation of timber shed

The timber shed was assessed as being of **'negligible suitability'** for roosting bats.

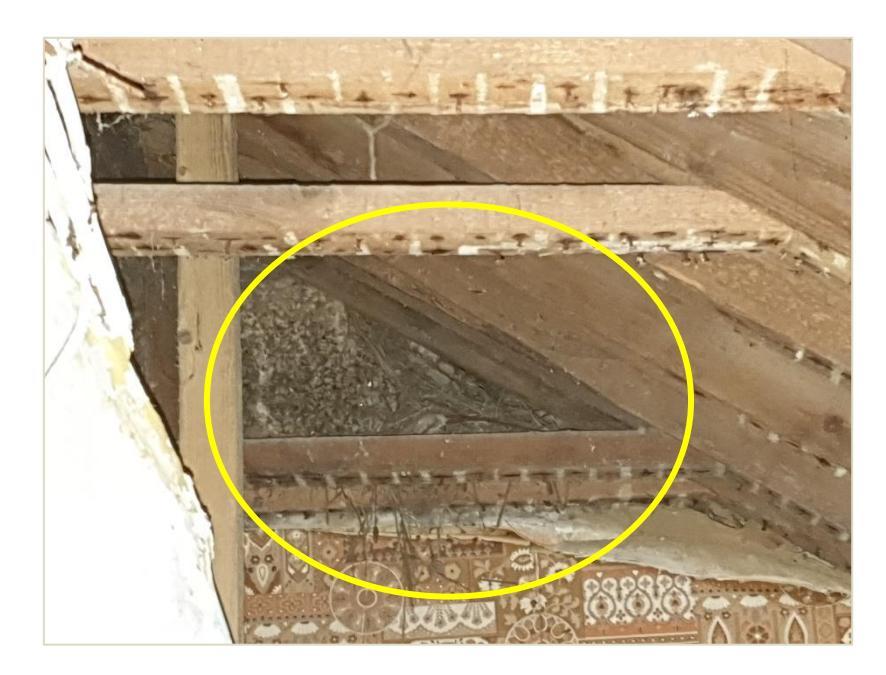
Old bird nesting material, possibly from a starling (*Sturnus vulgaris*) nest, was noted on the wall top within void 1 over the western lean-to (Fig. 14). The external hole created by the missing hanging slate on the southern elevation here provides potential access for birds into this roof void. Within the shed to the north of Cottage 3, an old barn swallow (*Hirundo rustica*) nest was present with two old eggs observed inside (Fig 15).

Figure 14: Old bird nest material on wall top of roof void 1 (yellow circle) (viewed towards the south).

Remnants of old bird's nests were found within void 1 and within the shed. Demolition works should either be undertaken between October and February, when birds will not be nesting, or, alternatively, preceded with a thorough search for nesting birds (to be undertaken by a suitably experienced person). If, during works, an active bird nest is uncovered, works within 5m of the nest must stop immediately (as soon as it is safe to do so) and delayed until nesting activity has ceased. Works are most likely to be delayed between April and July.

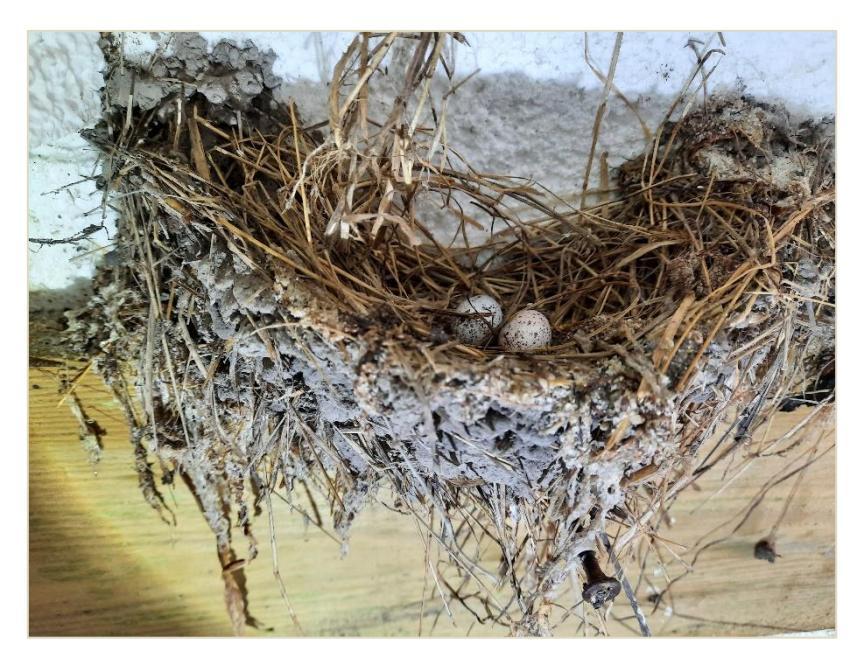
Figure 15: Old nest and eggs of a barn swallow within the shed in the garden of cottage 3.

Provision for nesting birds, including nesting swallows, should be made within the replacement dwelling or associated outbuildings post-development, in the form of pre-fabricated nest boxes. Suitable products for swallows include the No. 10 Schwegler Swallow Nest, or equivalent. Nest boxes should be located on a north or east facing elevation. Swallow nest boxes should be located within a partially enclosed area such as a porch or outbuilding.
