PLANNING STATEMENT **RAVEEN, CHURCH STREET, ST MARY'S.**

INTRODUCTION

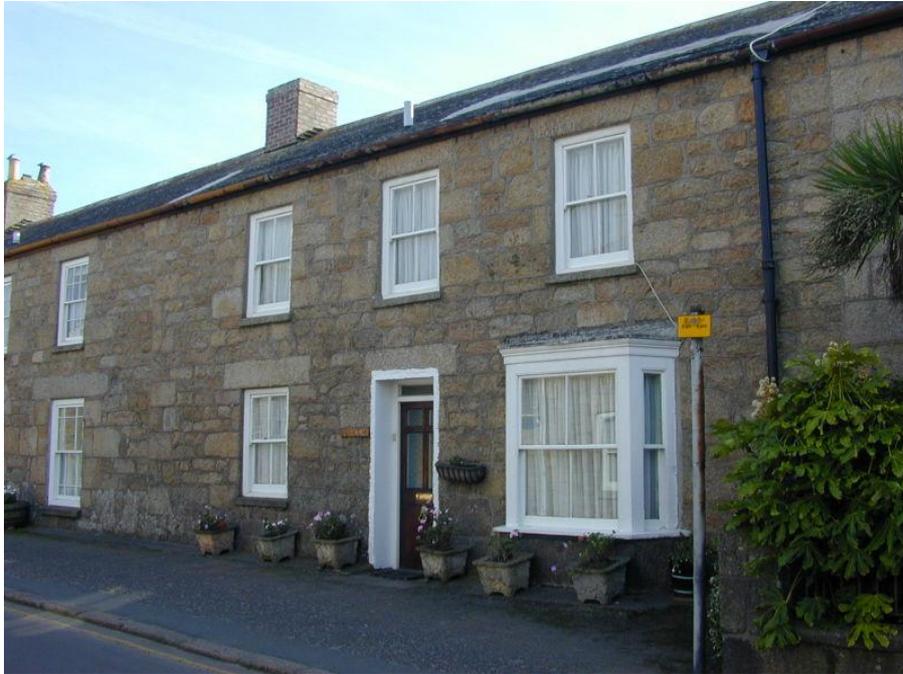
Raveen is a Grade II listed building, whose importance lies in its location within a terrace. The above photograph shows that the importance of the building is in its front elevation. The rear of the property, like many others within the terrace has been the subject of much alteration over the years. The object of this application is to address some of the problems of this building and thus to extend its future life.
