Fairways

Porthcressa, St Marys, Isles of Scilly

DESIGN AND ACCESS STATEMENT 20th October 2015

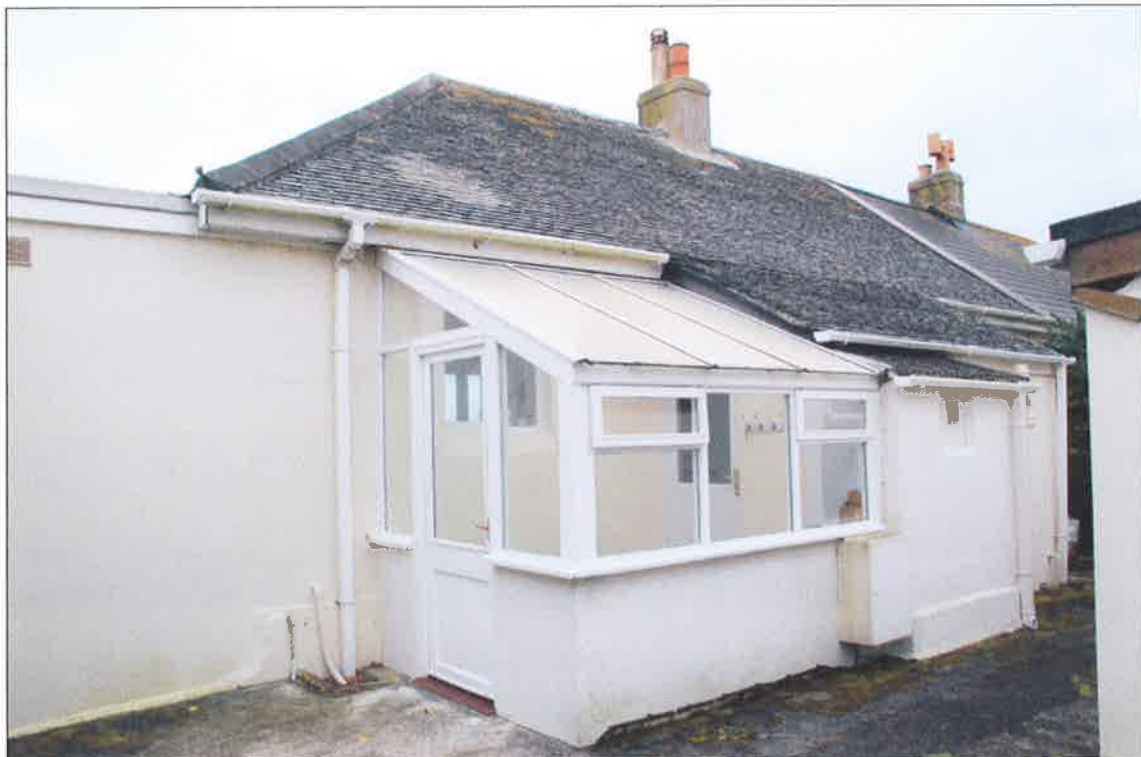
Rear (North) Elevation

The rear roofslope of Fairways is the last remaining section of this pair of buildings to retain a wet-laid natural slate covering. This area of roof covering is in extremely poor condition, having suffered storm damage and natural degradation of the fixings as a result of water penetration. In particular, the area around the chimney is leaking badly. In addition, a small area of extended roof has a corrugated asbestos roof covering.

Whilst the remainder of the roofslopes on this pair of properties are finished in synthetic slate, we propose replacing the rear slope with natural grey slate, fixed with dark grey stainless steel clips. The existing dark grey ridge tiles will be re-used where possible, or replaced with matching units.
