# NORTH ELEVATION

DRAWING / REF No.: NH/10516/ELEV-NTH/01

CUSTOMER NAME: LANISSA WAKEFIELD & CYNTHIA RICKMAN  
 SITE ADDRESS: NEWMAN HOUSE, THE GARRISON, ST MARYS, TR21 0LS  
 DATE DRAWN: NOVEMBER 2016  
 SCALE: 1:50  
 DRAWN BY: LESLIE CORNELL

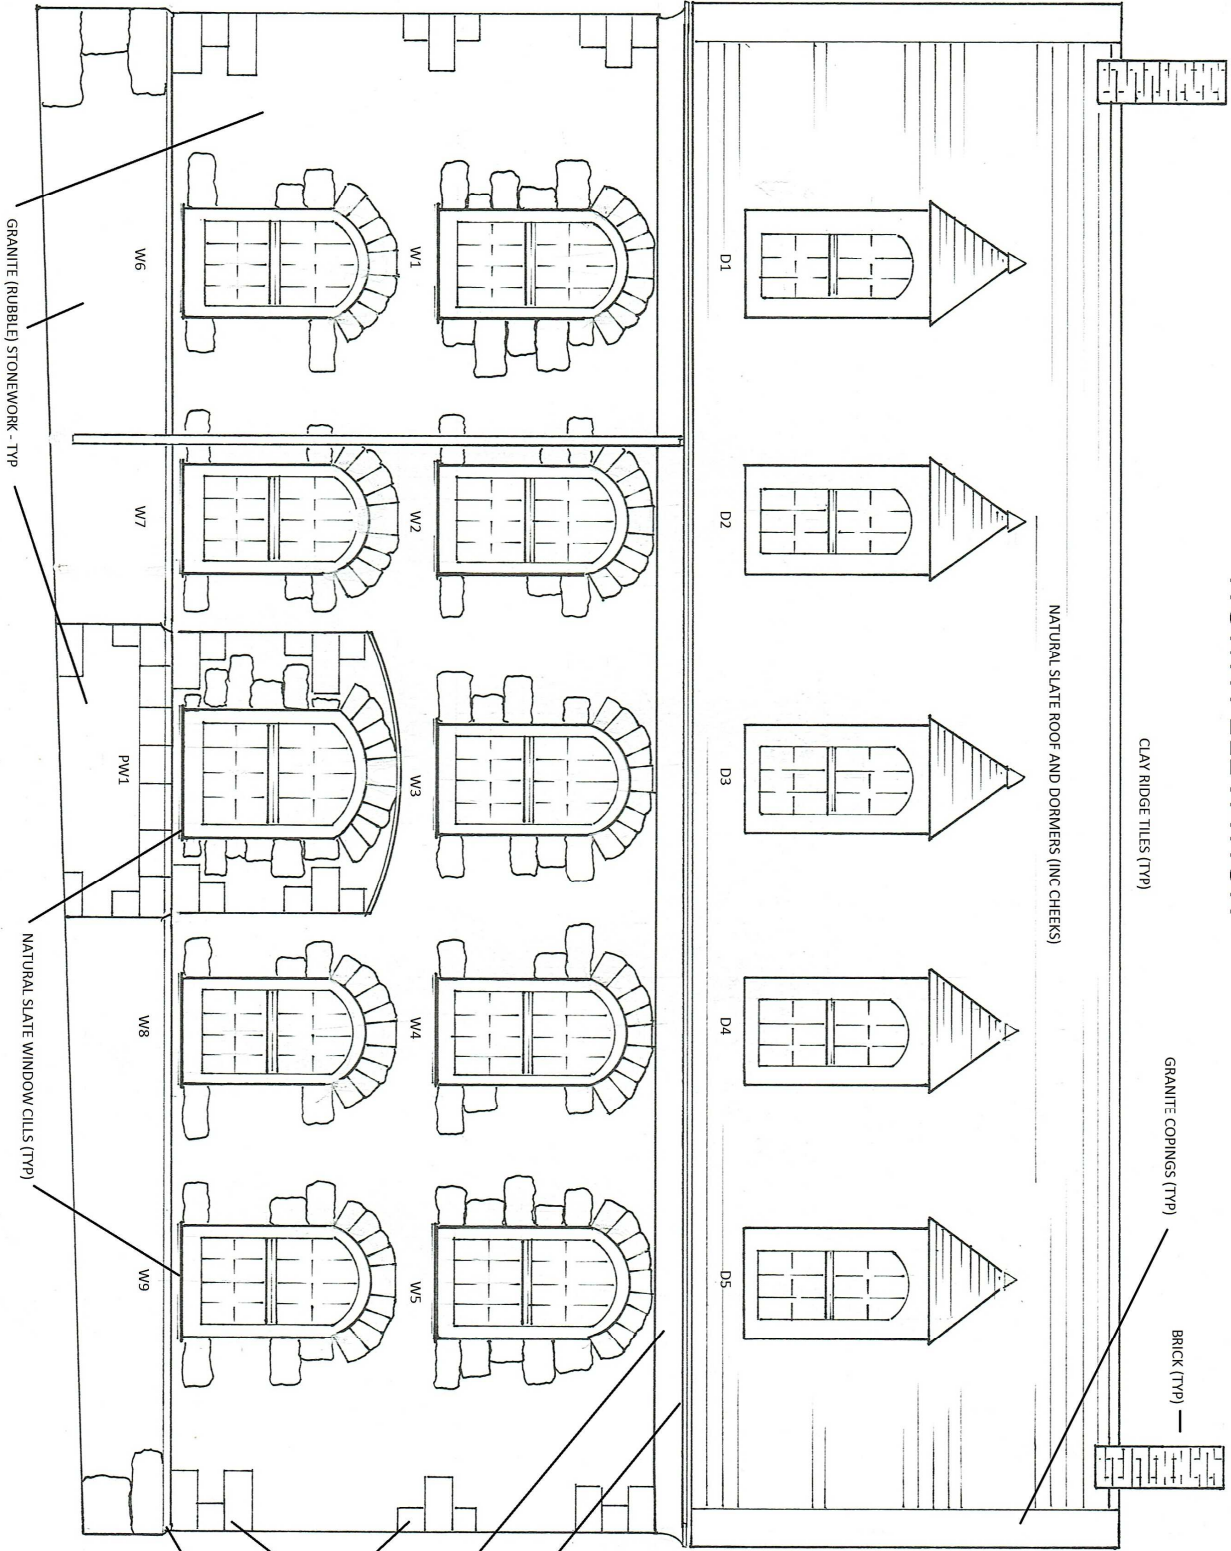
1. Existing jointing applications [to all stonework] is cementitious
2. All weather flashings to be inspected - inc parapet copings and ridge
3. Cast-iron rainwater systems to be cleaned and inspected
4. D1 - D5 In situ restoration/decoration to sashes and frames
5. D1 - D5 Hipped Dormers-Inspection of slates, valleys & ridges
6. W1 - W9 (as Item 4)
7. PW1 (as Item 4)
- 8.
- 9.
- 10.
- 11.
- 12.
