# Plan View (Shower Kitchen Block)

Plan View  
Proposed interior

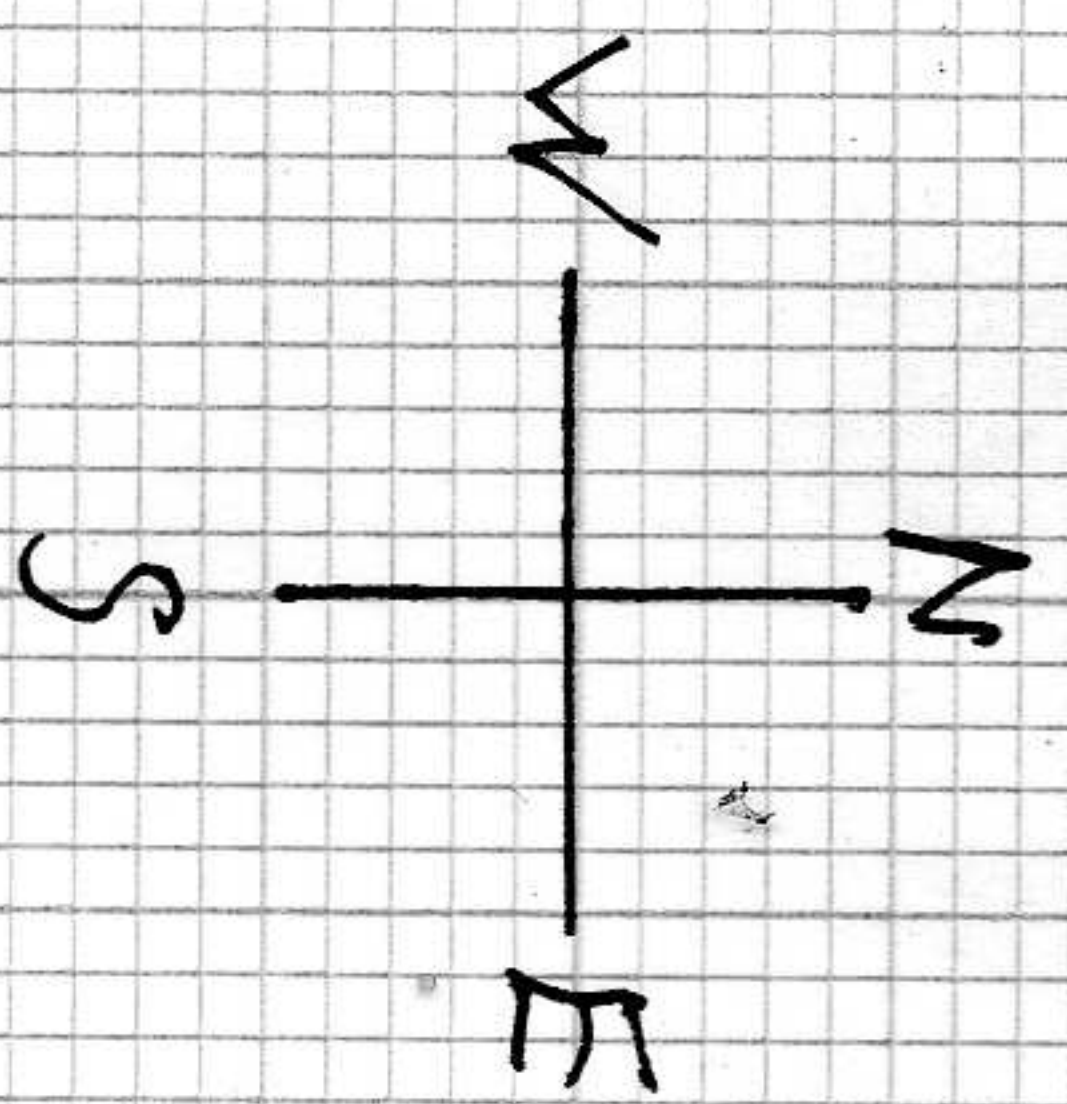
South Elevation

Corrugated roofing to be replaced, like for like

fascia  
existing  
guttering  
to be  
renewed

Shuttered concrete

2x existing  
500gpd (22734)  
water tanks

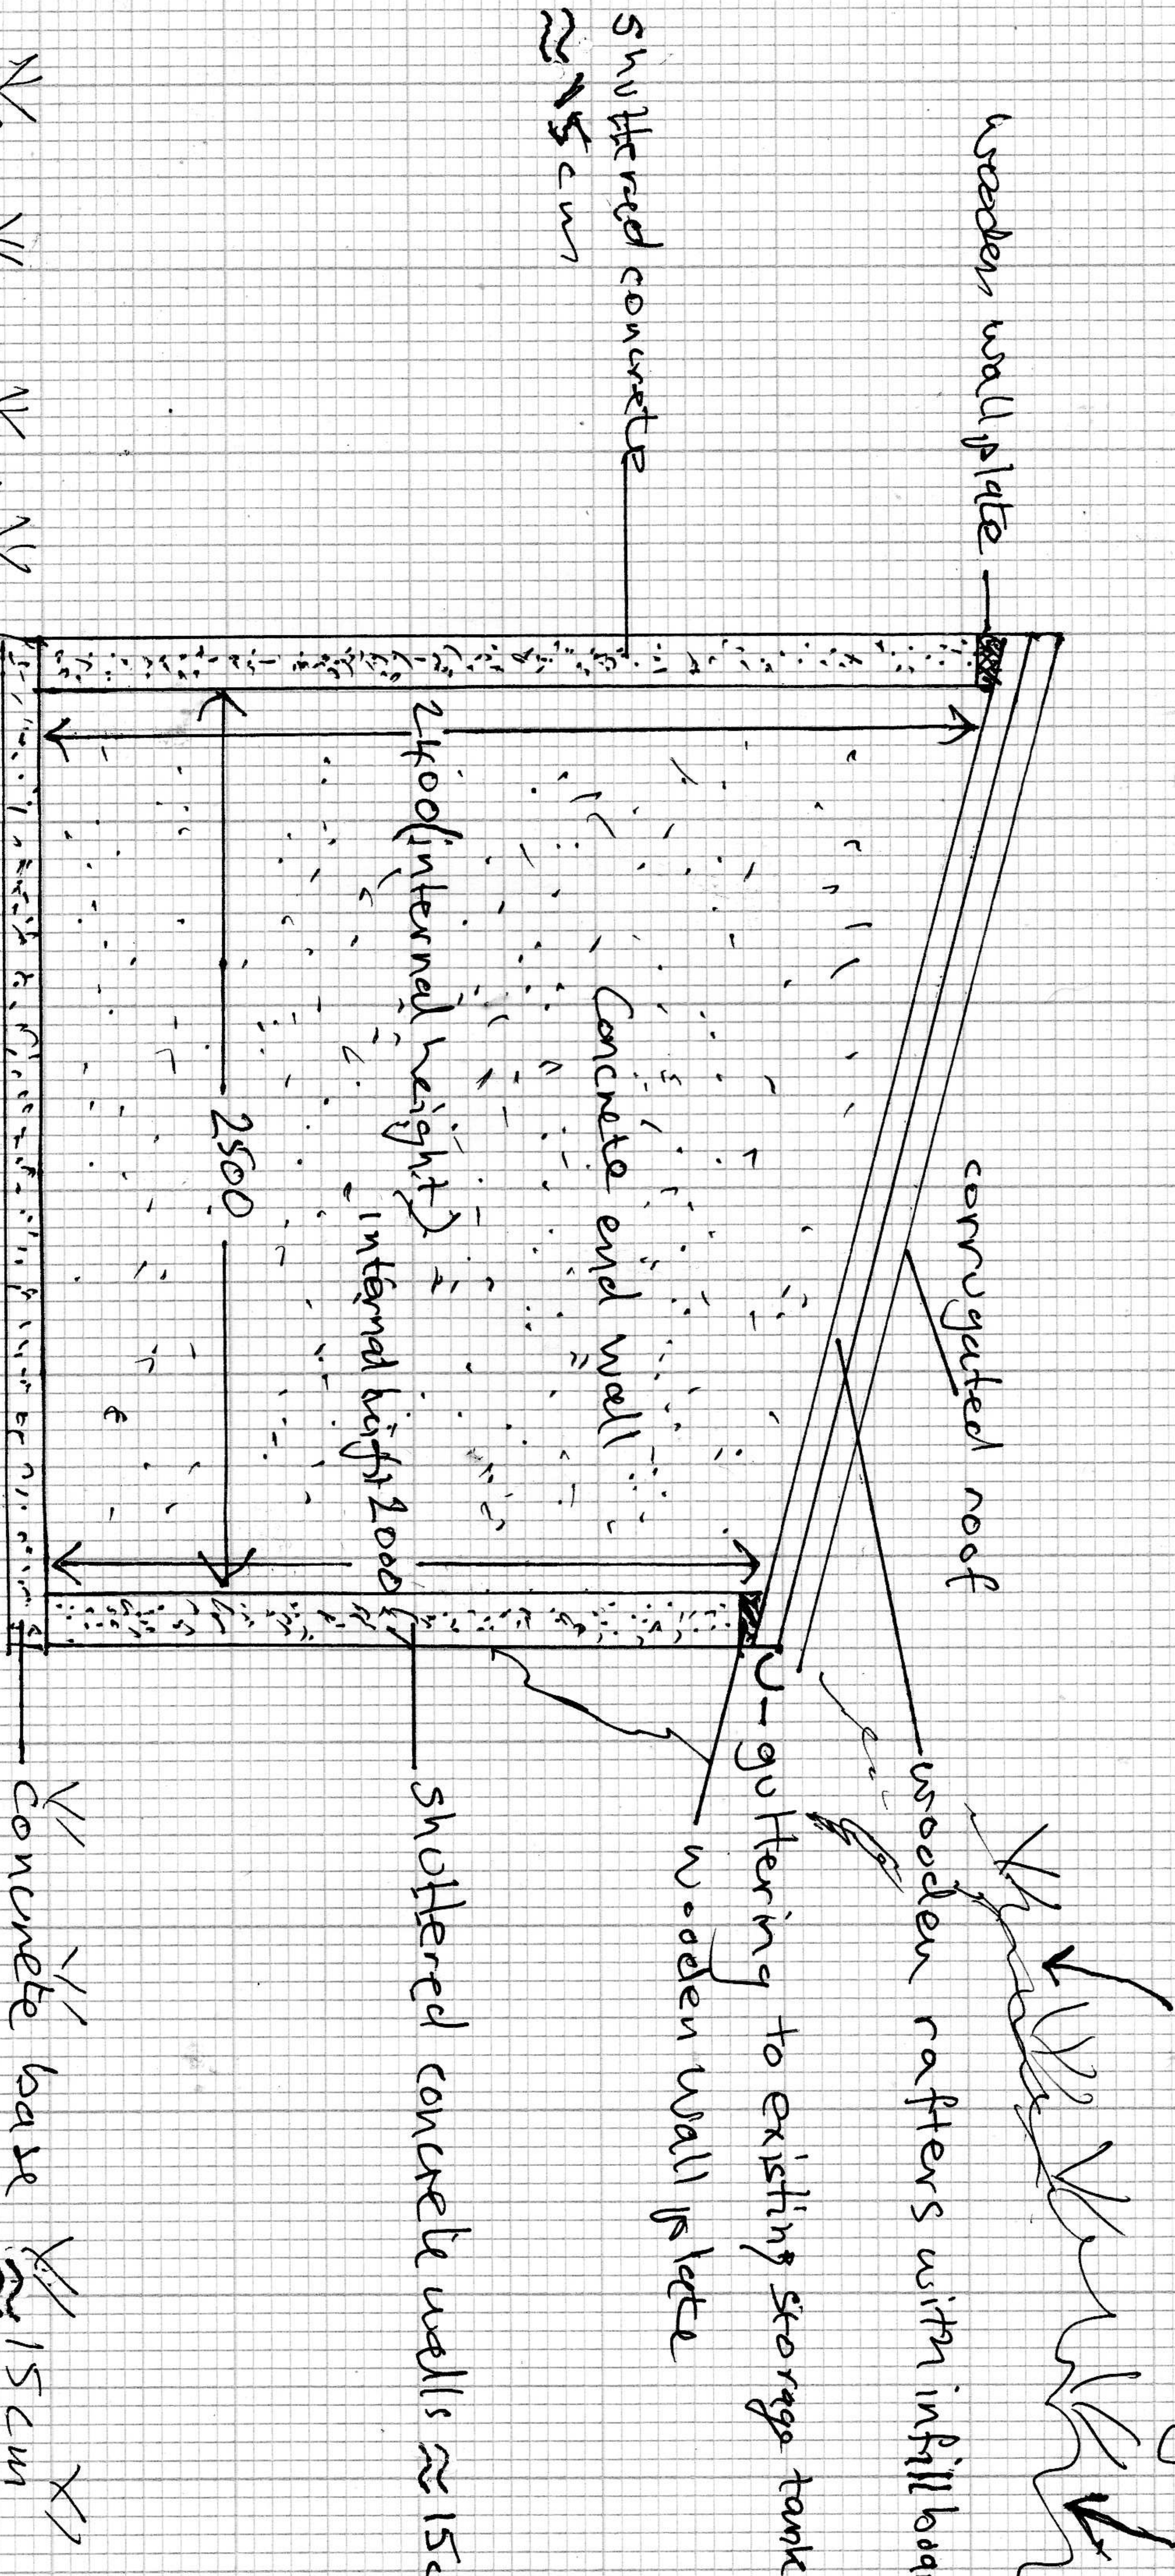
# Western Elevation

Blown sand  
and marram grass

guttering to existing  
storage tanks

corrugated roof sheets

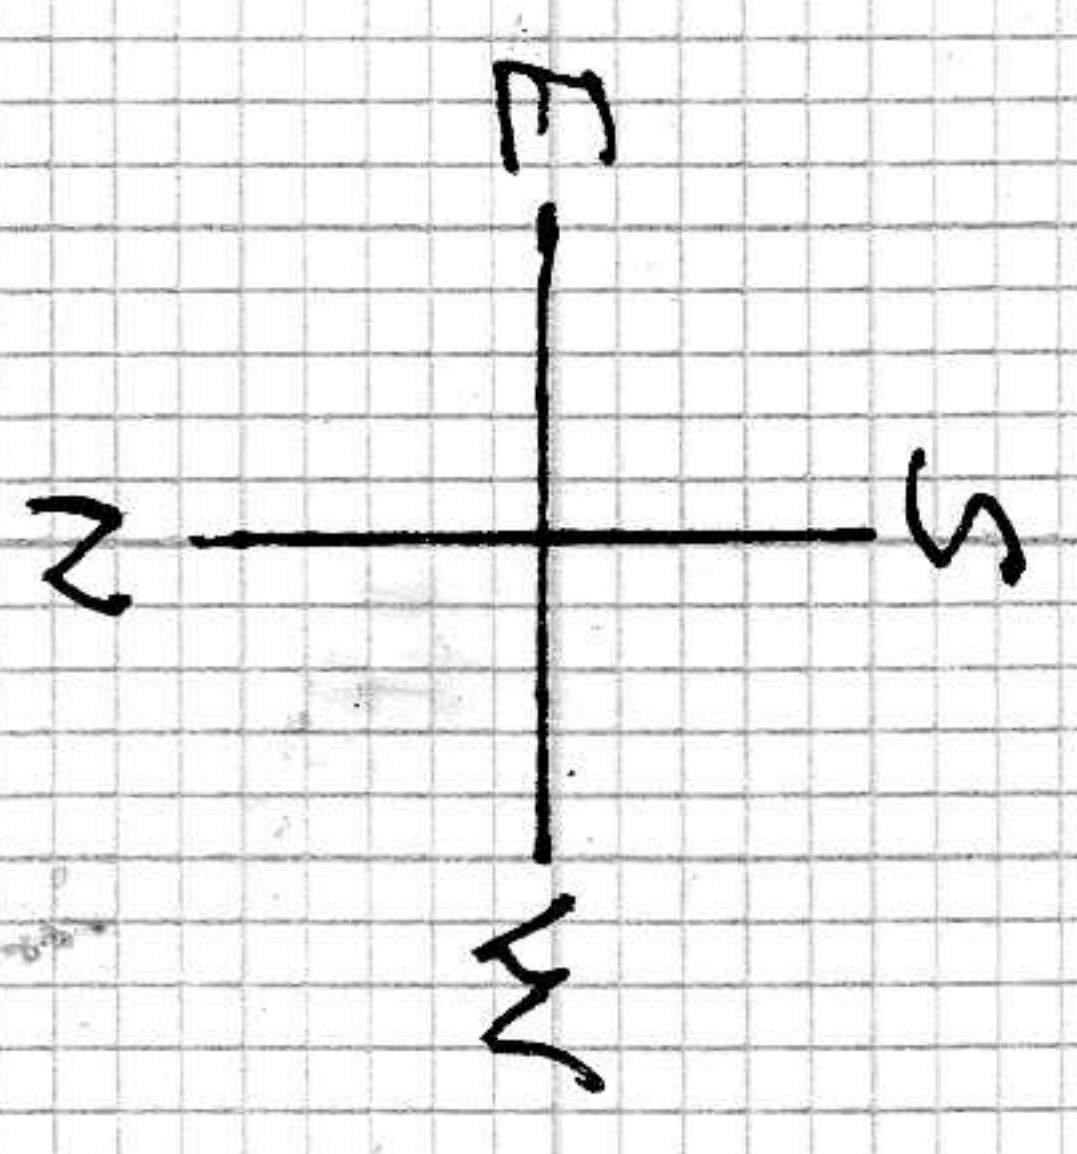
Front Elevation

blown sand + marram grass

wooden  
wall plate  
≈ 20cm

Shuttered concrete

Door Opening 2000

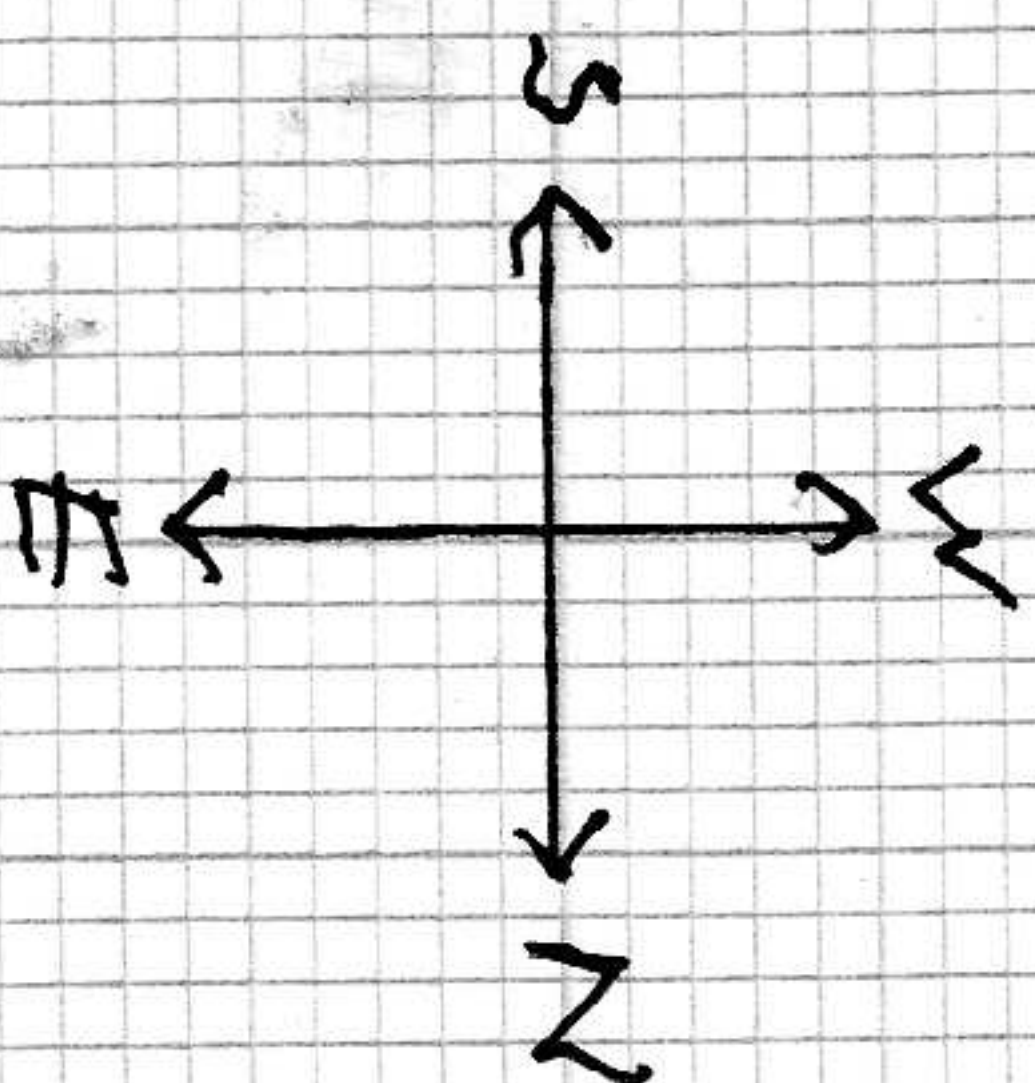
# Eastern Elevation

wooden wall plate  
≈ 20cm

wooden  
wall plate ≈ 20cm

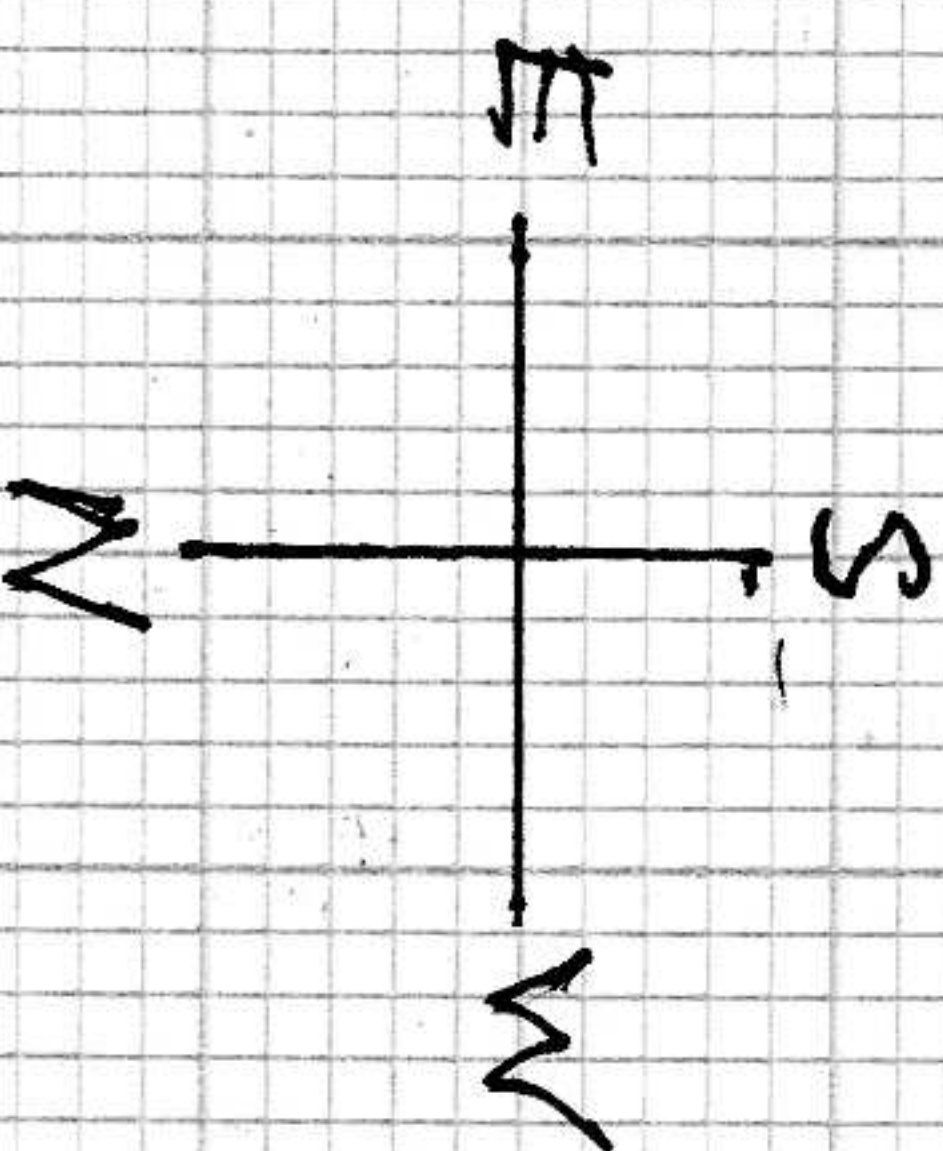
Existing guttering

Shuttered concrete  $\approx 15\text{ cm}$   
topped with wooden  
scaffold plate to  
support rafters

Existing concrete flooring  
throughout  $\approx 15\text{ cm}$  deep

corrugated roofing throughout  
supported by rafters (100x50)

Existing  
2x  
water  
tanks  
 $\approx 1000$   
gal

shuttered concrete  $\approx 15\text{ cm}$

replaced guttering
