Supporting Document

P/18/017 FUL

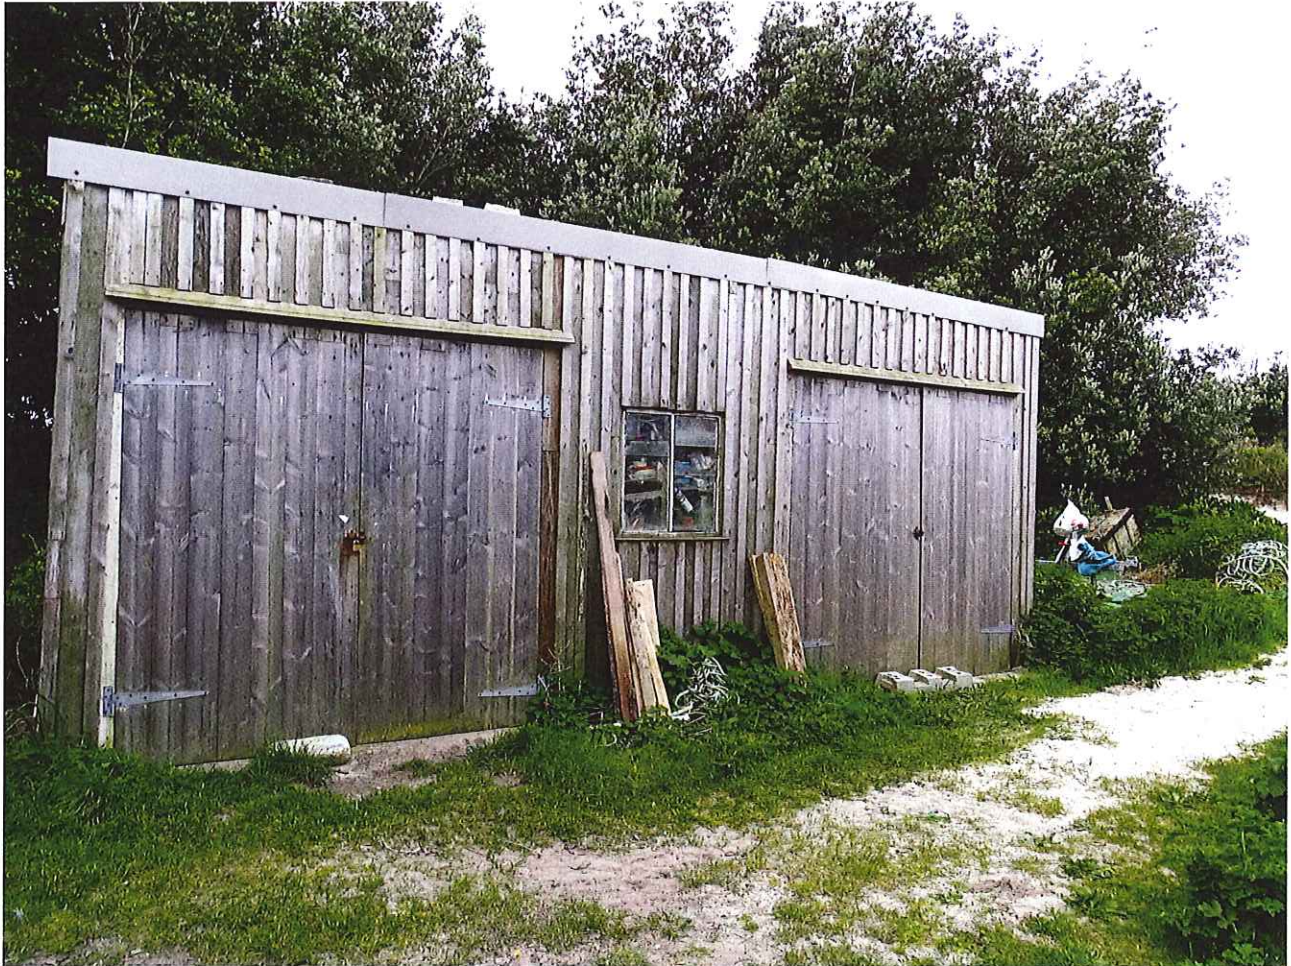
Existing building is timber framed and timber clad. Extension of store planned for right hand end.

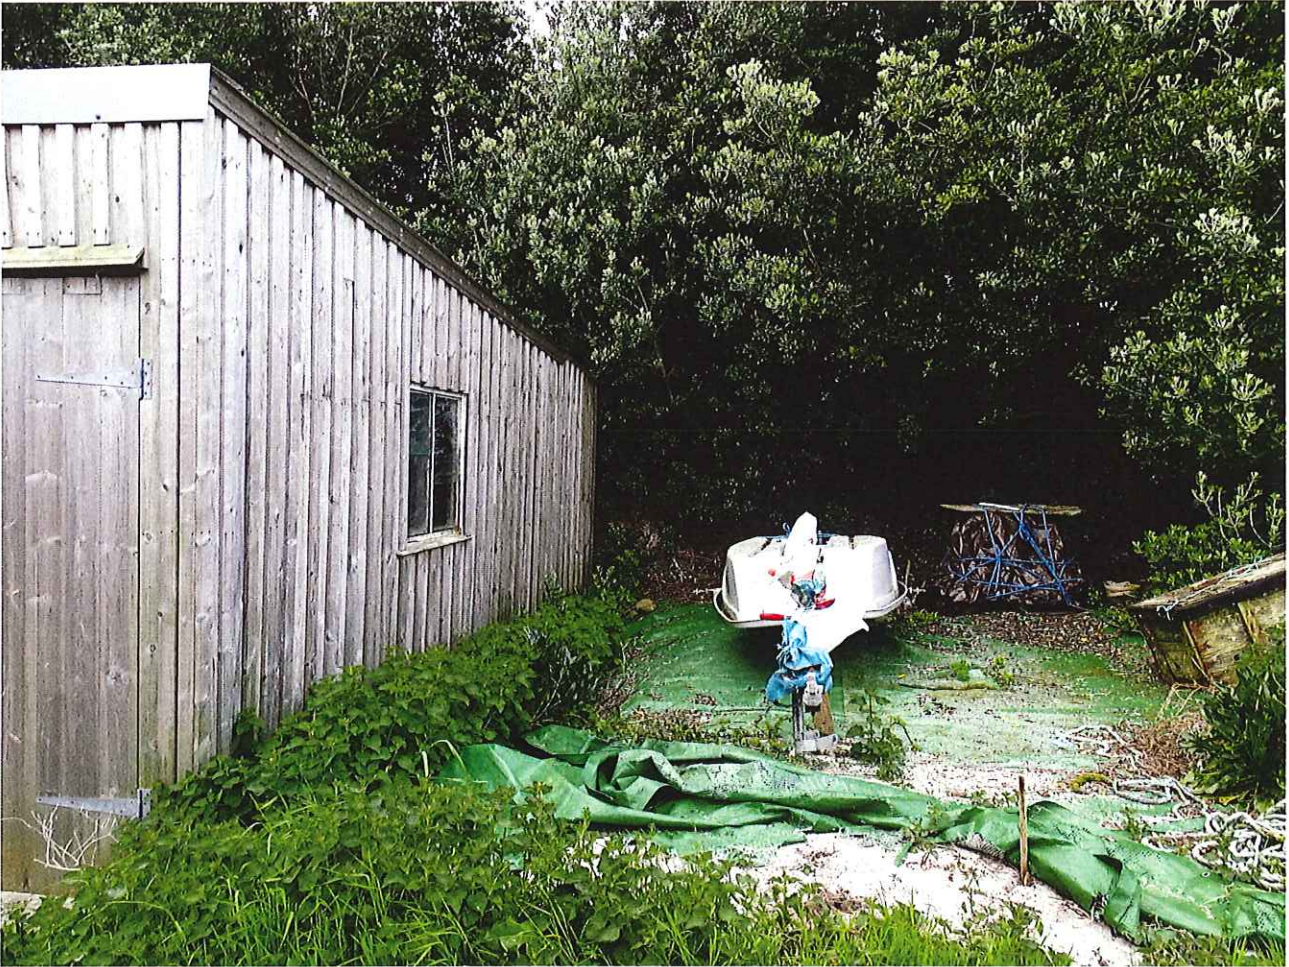
Area where extended store is planned.

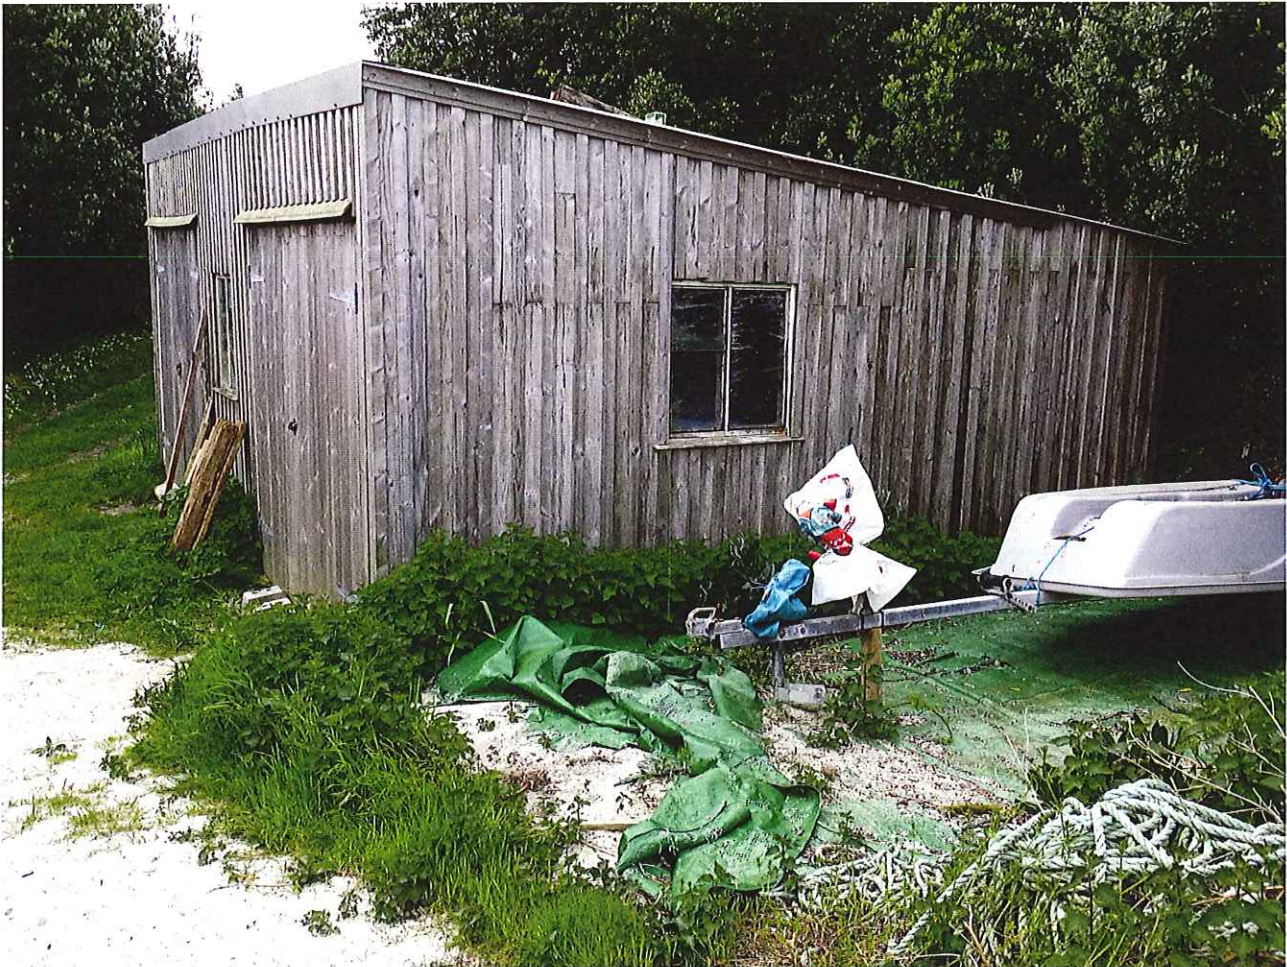
Intention is to remove cladding from right hand end and leave underlying frame.
Window will be removed and a door aperture will be put in its place (shown by green line).
This will lead through to extended store, which will be timber clad to match existing building.

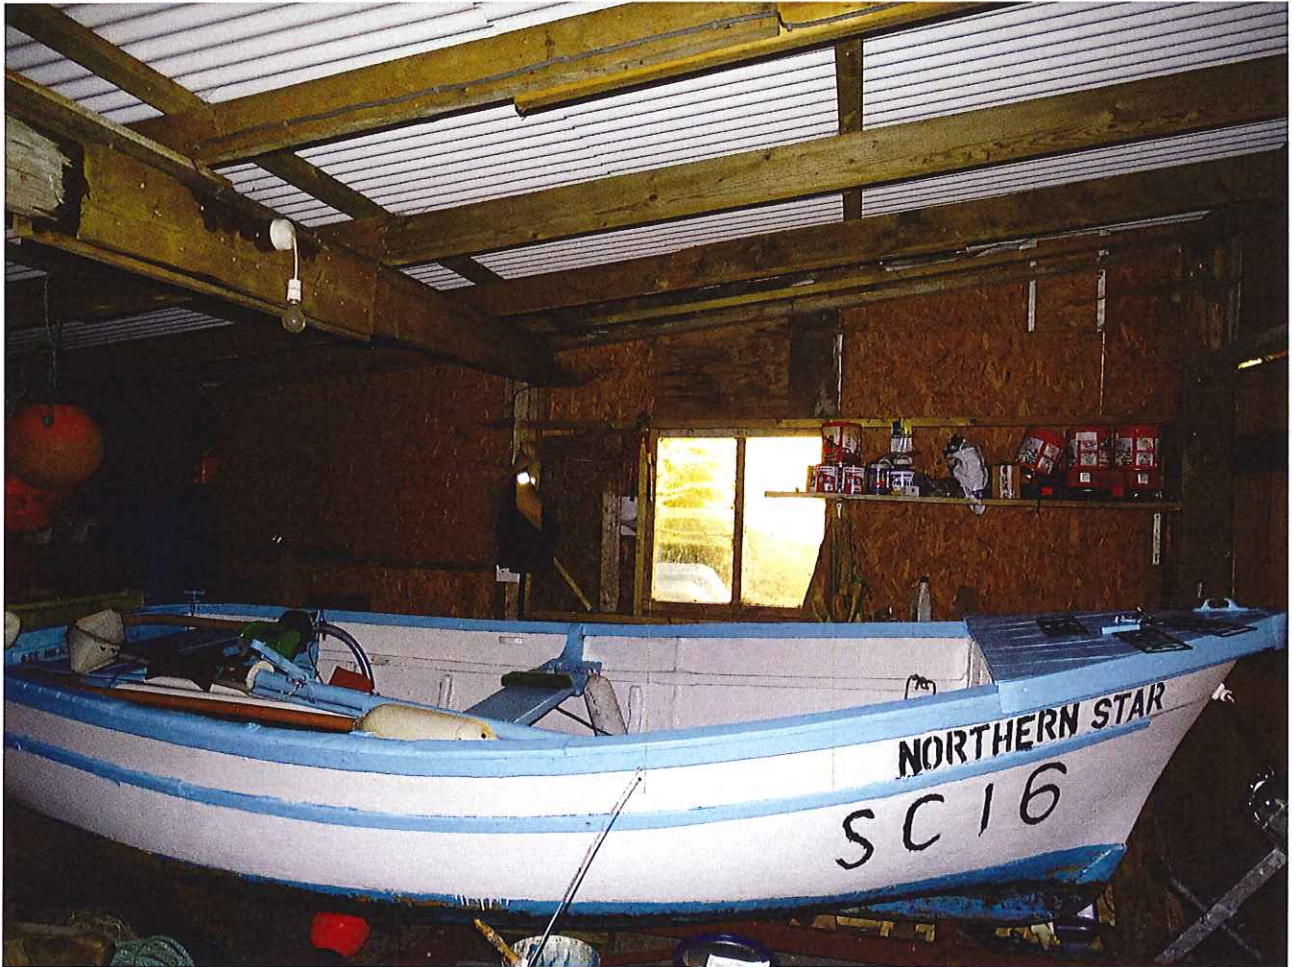
View from inside existing store showing window that will become door aperture to extended store, shown by green lines.

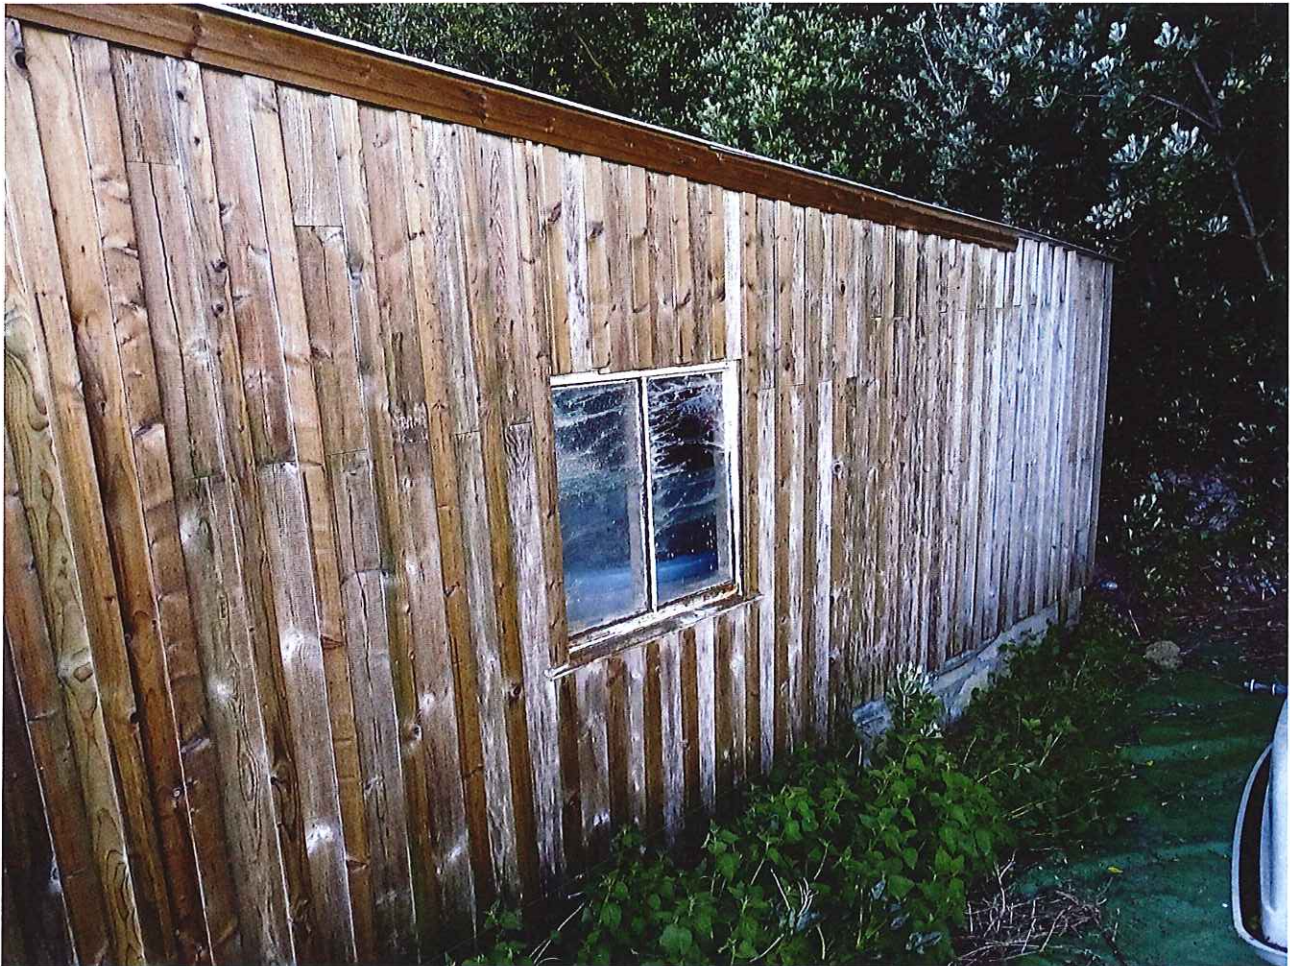
Green line indicates level of extension floor, stepped up 0.42m above floor of existing building.
Cladding and window from this end will be re-applied to right hand end of extension.

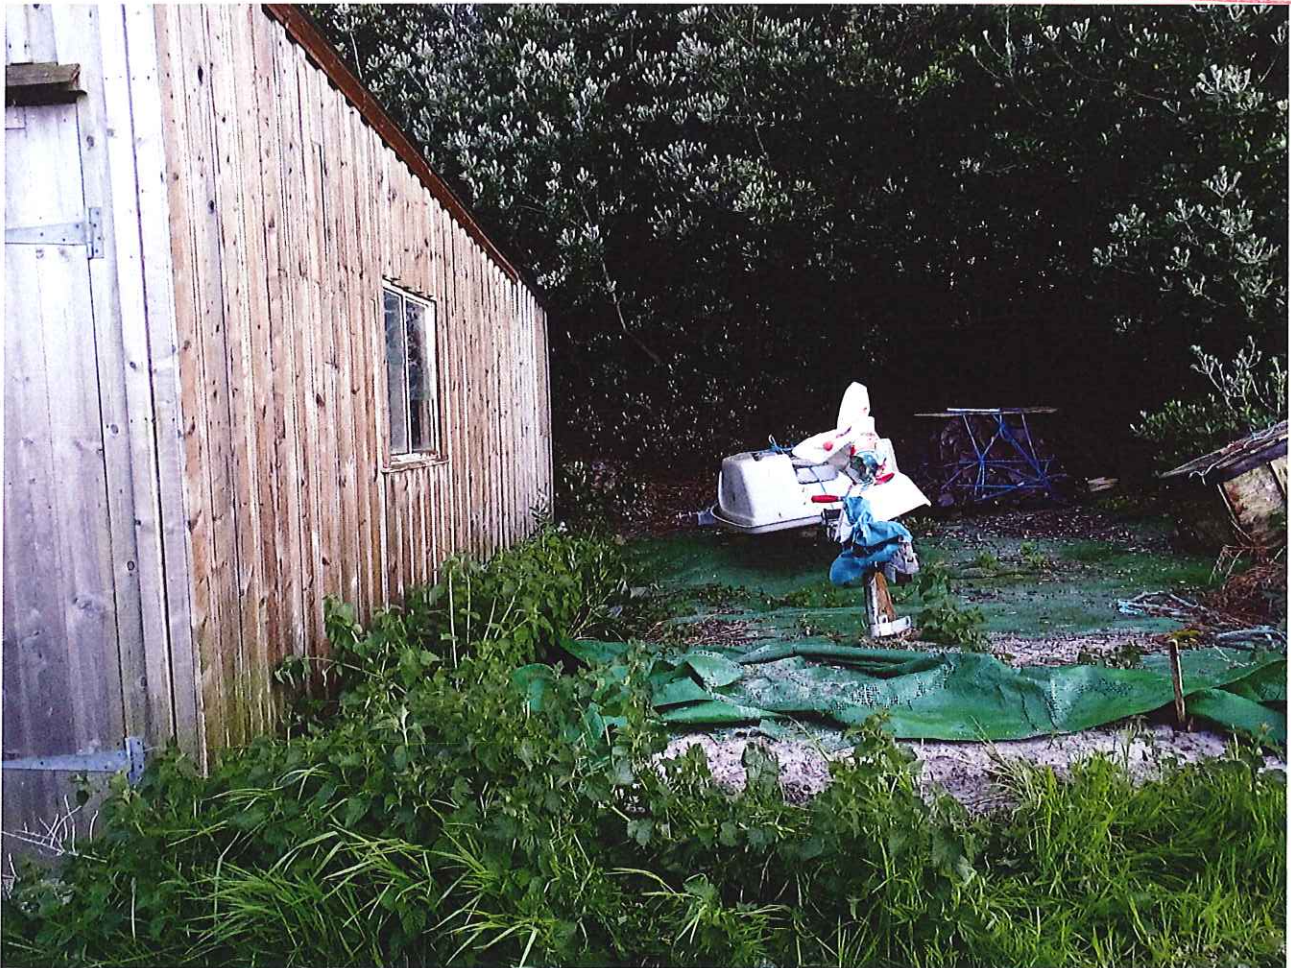
Level of extension floor. Groundwork will remove approx 0.50 m of sand to provide rubble base and concrete slab for extension floor. Sand removed will be used for building work and remainder distributed to adjacent beach. Increased height of extension floor required due to slight slope of track at site. Increased height will allow doors in extension to open.
