McFarlands Down, St Mary's

Isles of Scilly

Proposed Plans and Elevations

Plot B

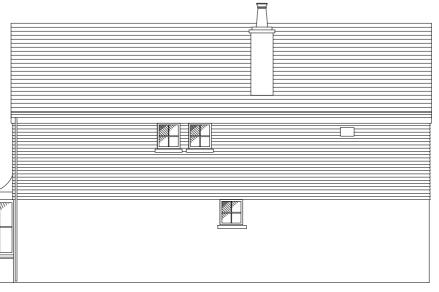
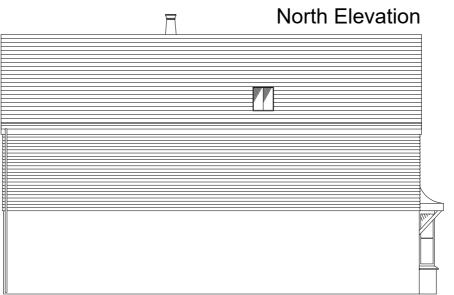
South Elevation

WALLS - PAINTED RENDER WITH RENDER FORMED PLINTH AND CURVED EXTERNAL CORNERS. FIRST FLOOR CLAD WITH REBATED FEATHEREDGE HORIZONTAL TIMBER CLADDING - PAINTED.

ROOF - NATURAL SLATE, NAILED - NO CLIPS, CONCRETE RIDGE TILES WINDOWS - TIMBER DOUBLE GLAZED, GLAZING OBSCURED TO BATHROOMS. DOORS - TIMBER PANELLED WITH GLAZING FASCIA BOARDS - PAINTED TIMBER RAINWATER GOODS - PAINTED METAL HALF ROUND GUTTERS AND ROUND DOWNPIPES
