CLIENT  
**DCA Consultants**

PROJECT  
**Isle of Scilly Museum**

TITLE  
**NW Elevation - Existing**

DRAWING NUMBER  
**241601-PUR-01-ZZ-DR-A-1103**

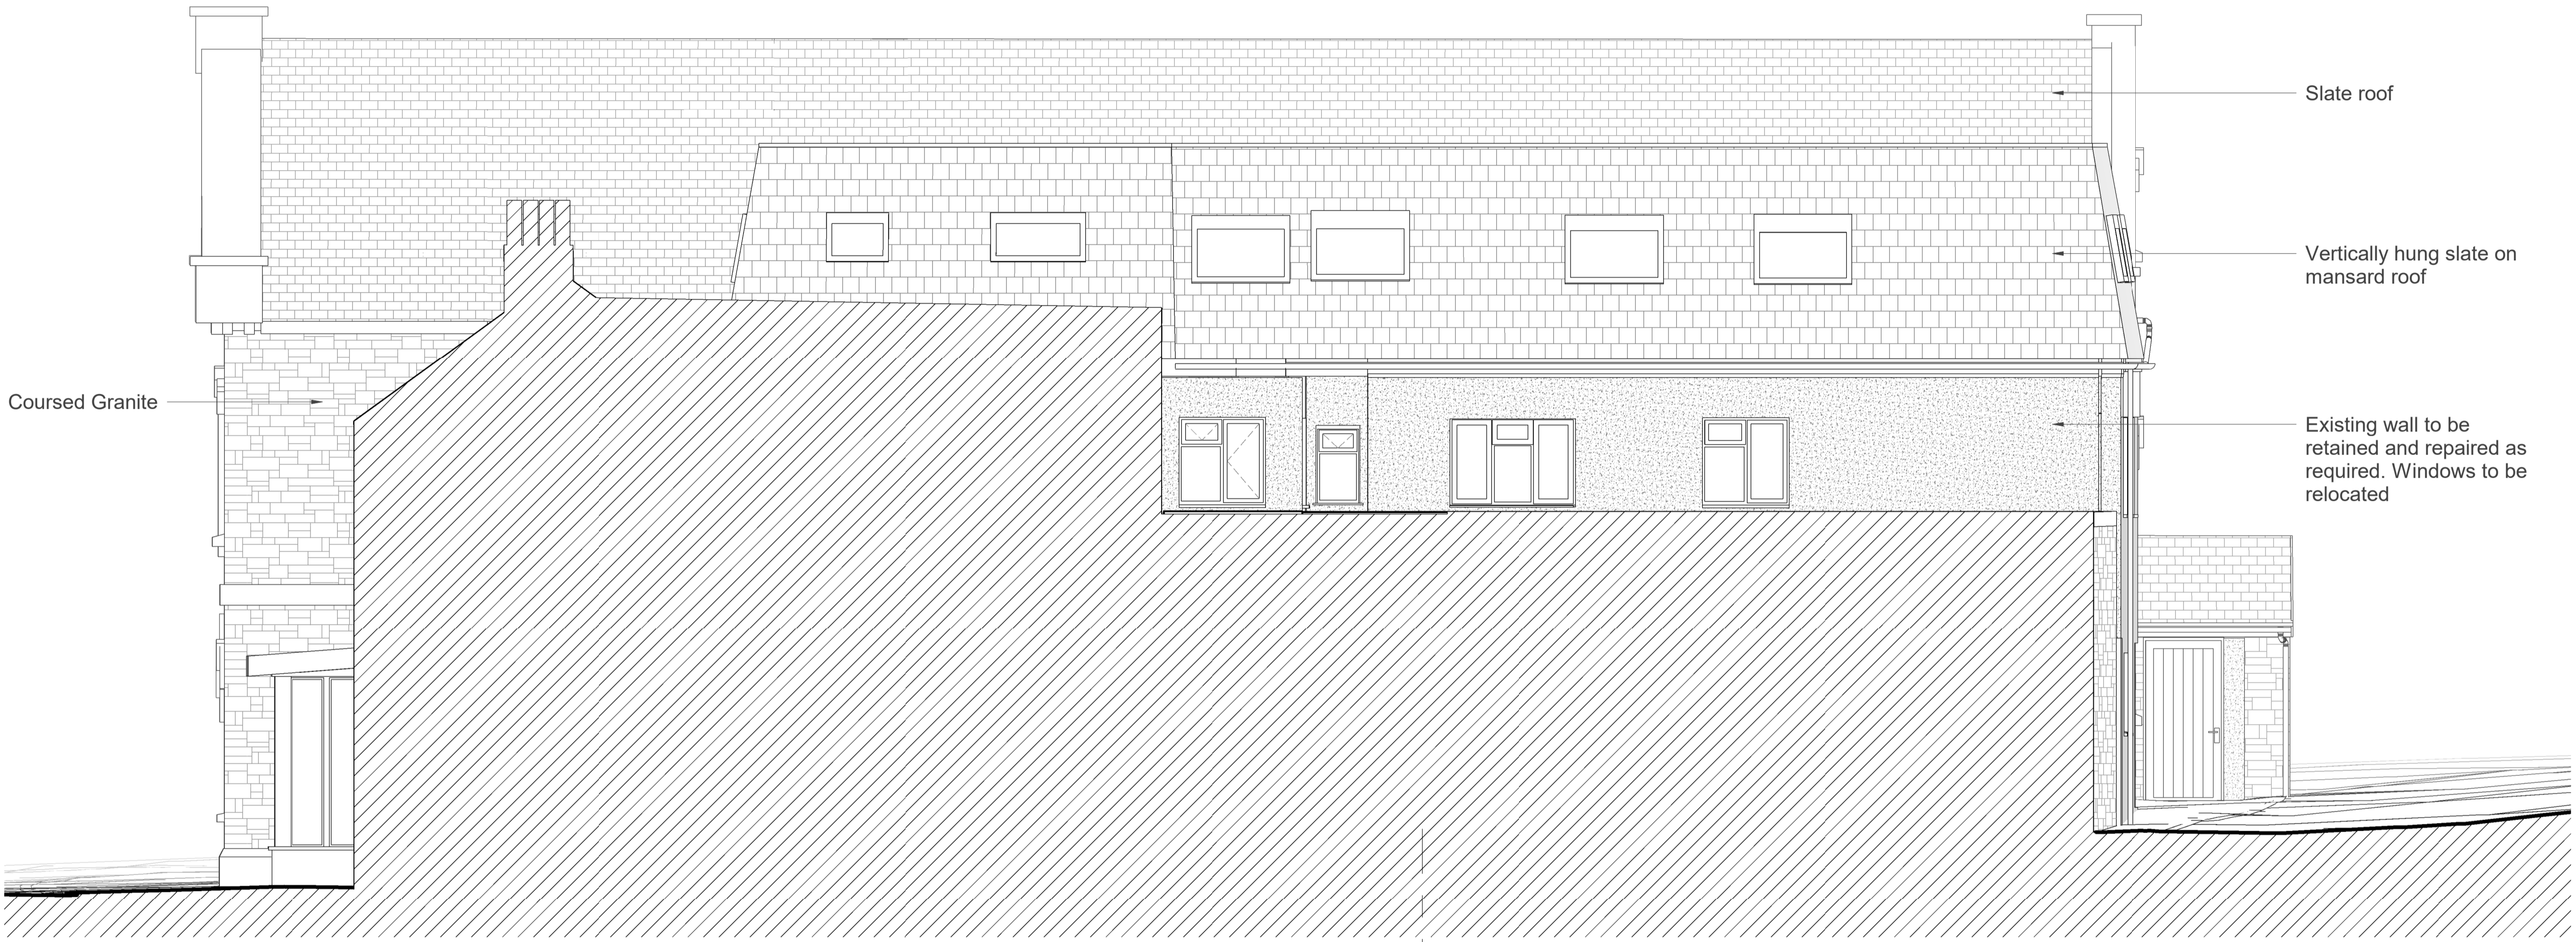
**1 North West Elevation - Existing**  
1 : 50

Slate roof

Vertically hung slate on mansard roof

Existing wall to be retained and repaired as required. Windows to be relocated

Coursed Granite
