PERMISSION FOR DEVELOPMENT

Application No: P/23/022/ROV **Date Application Registered:** 4th April 2023

Site address: Valhalla Abbey Road Tresco Isles Of Scilly TR24 0QQ
Proposal: Variation of condition 2 (Approved Plans) of planning permission P/21/108/HH (Demolition of lean-to extension, construction of new single storey extension, installation of new dormer windows, construction of new swimming pool and other internal and external alterations. (Affecting setting of a listed building)) to make minor amendments to the approved scheme.

Bat Survey Report

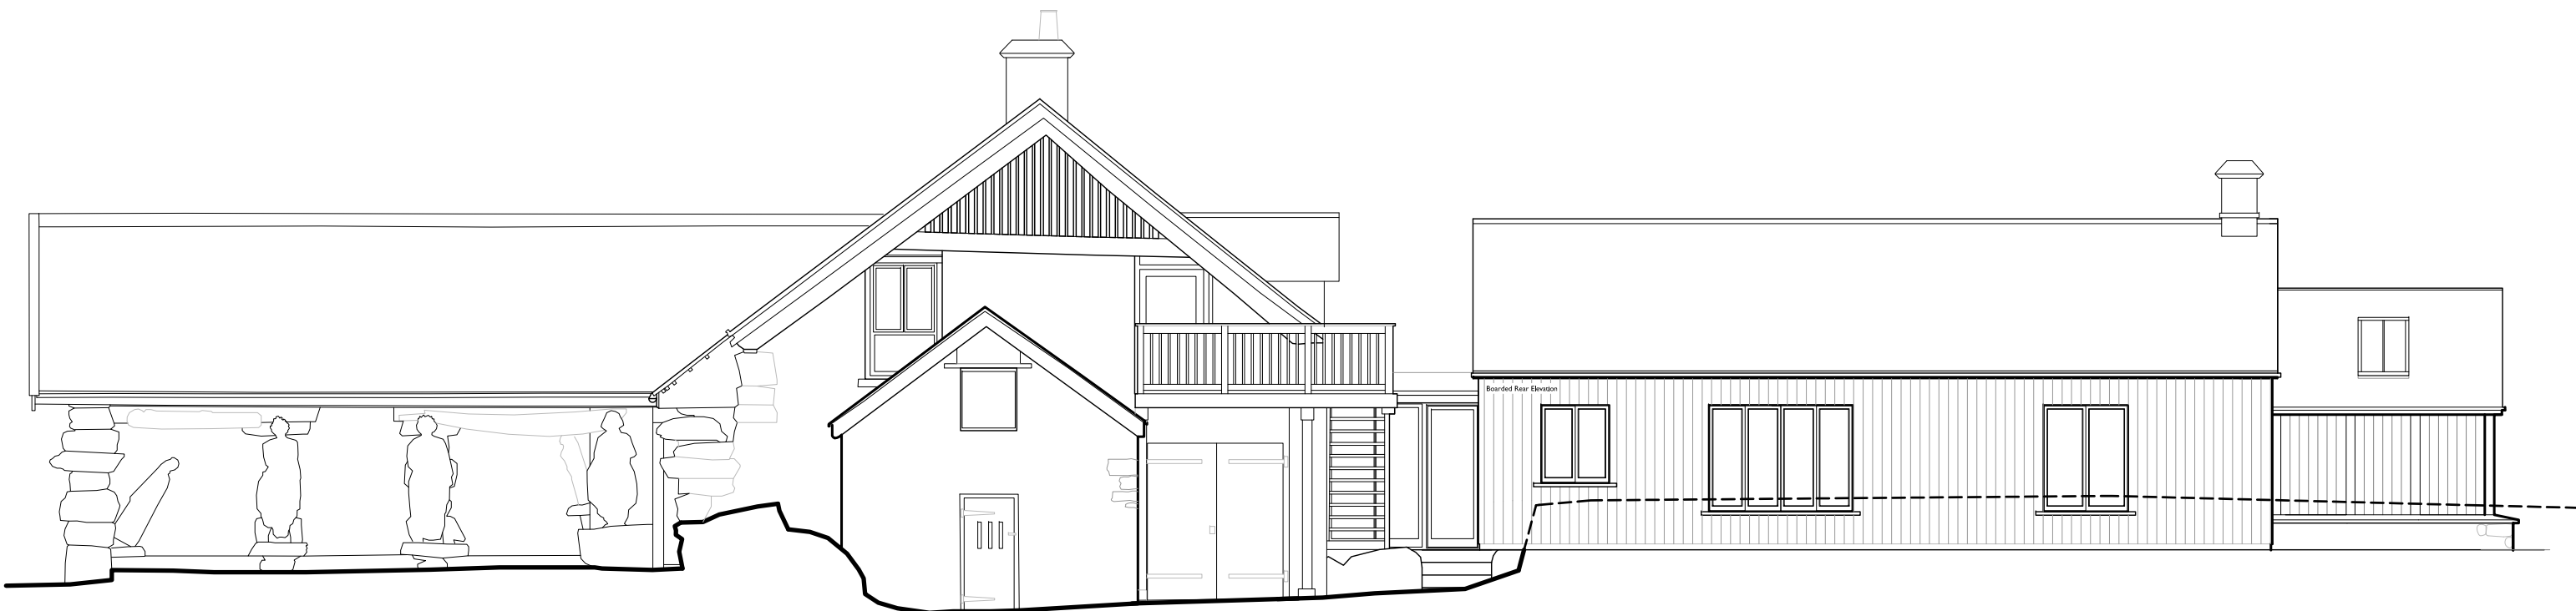
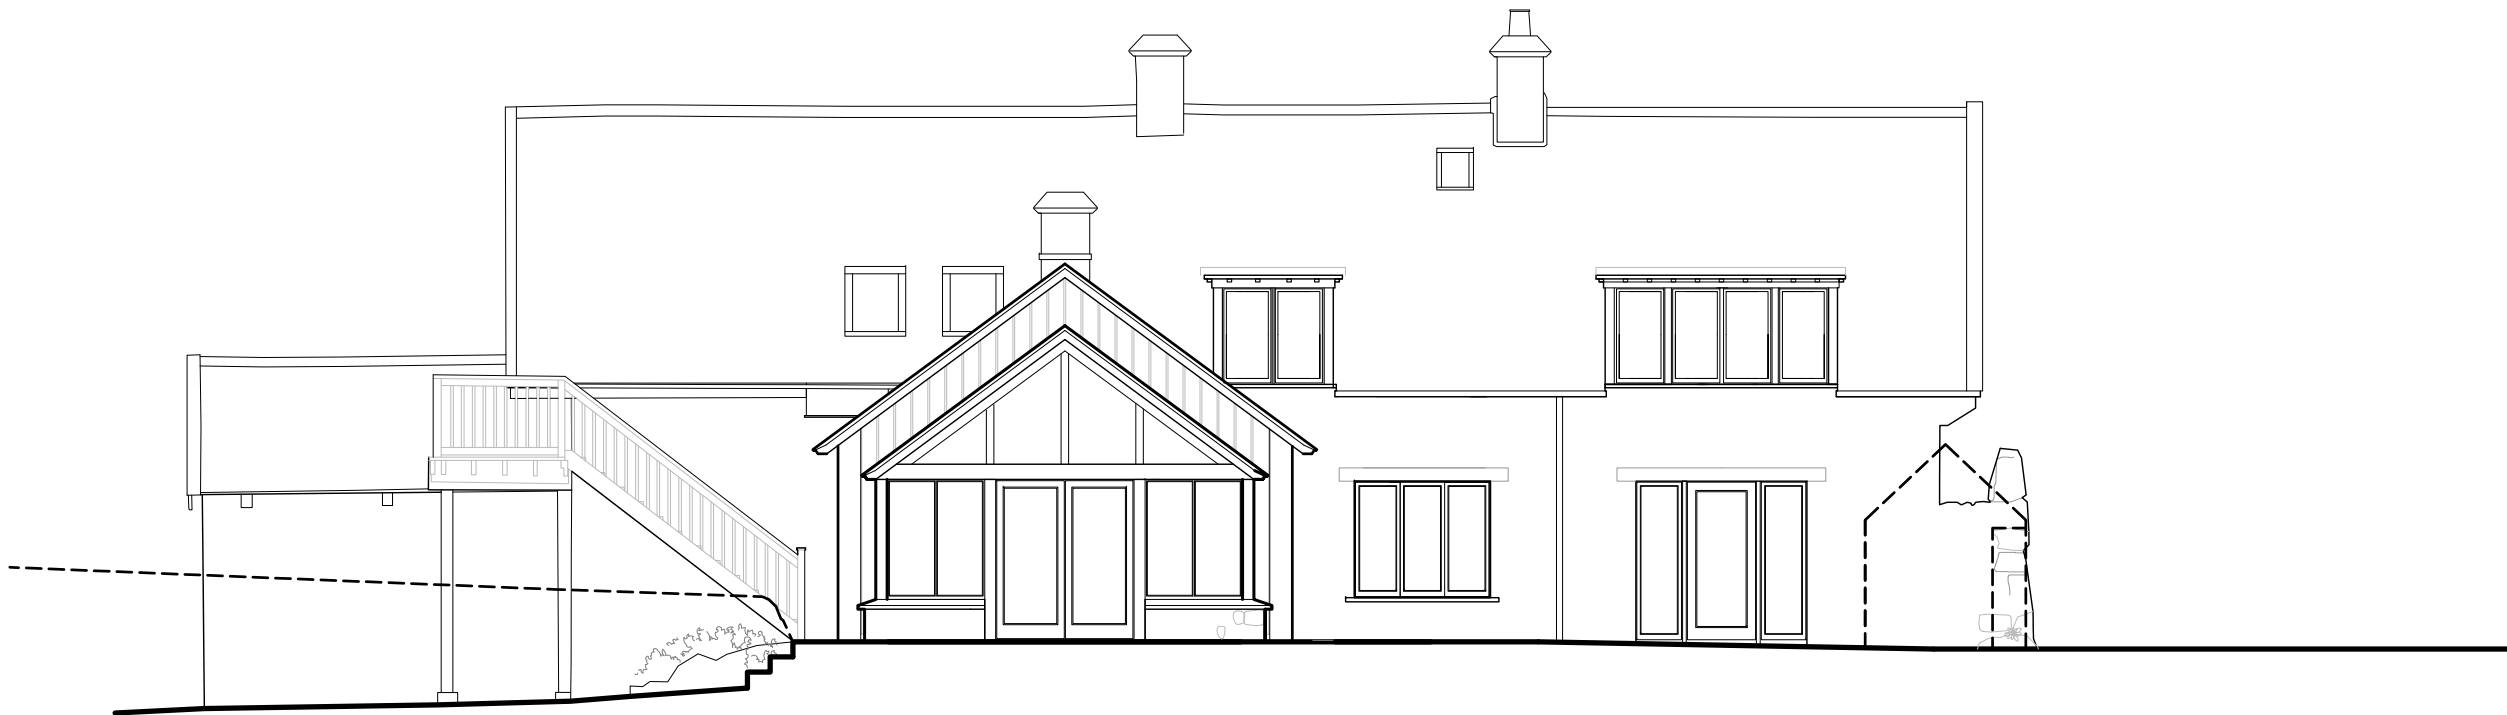
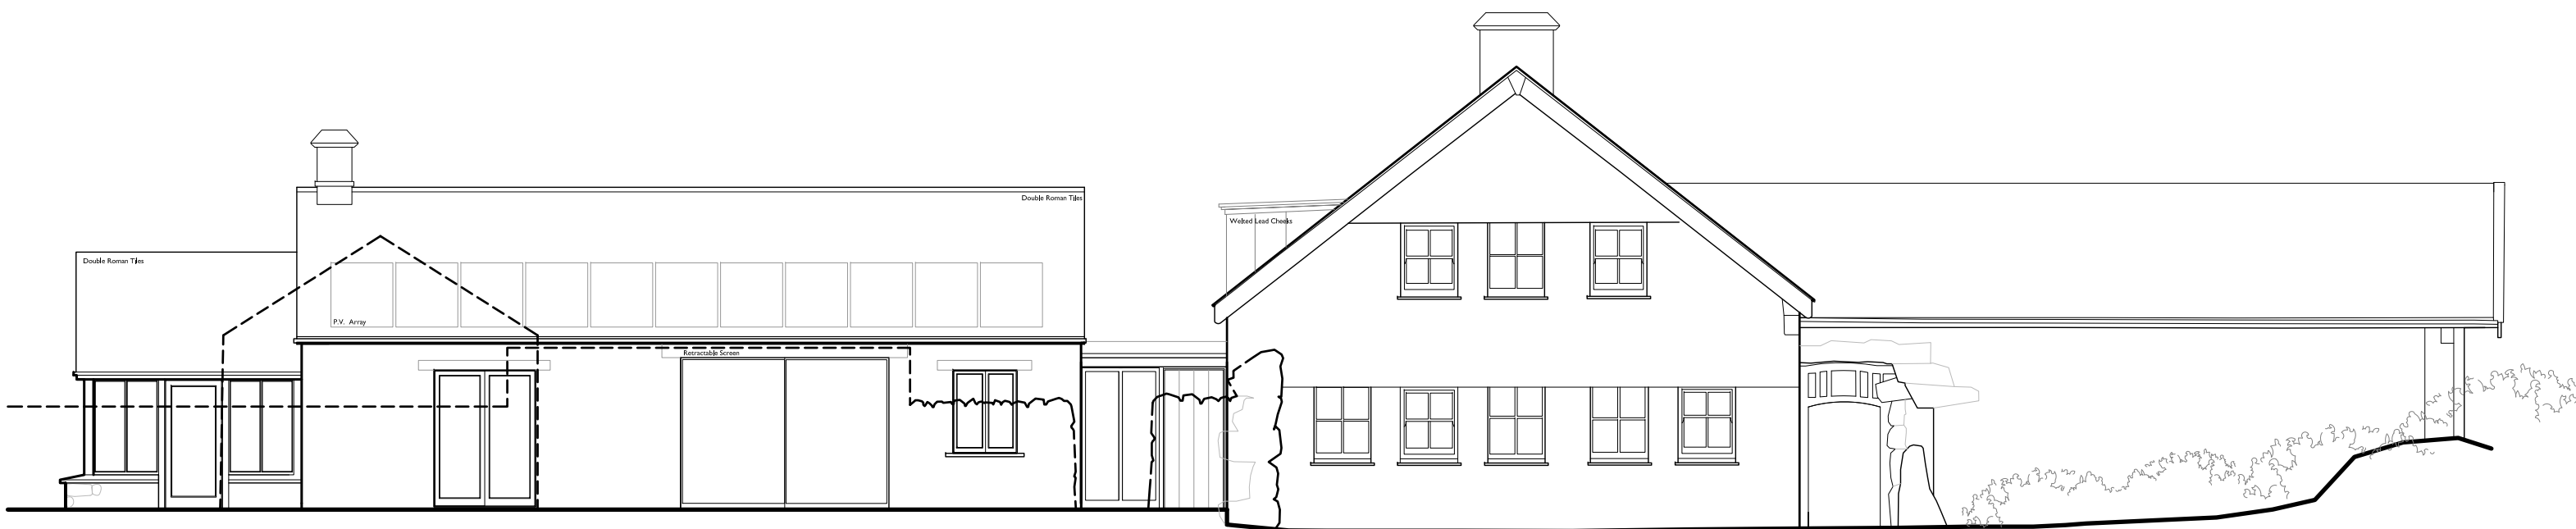
NORTH ELEVATION

WEST ELEVATION

SOUTH ELEVATION

EAST ELEVATION

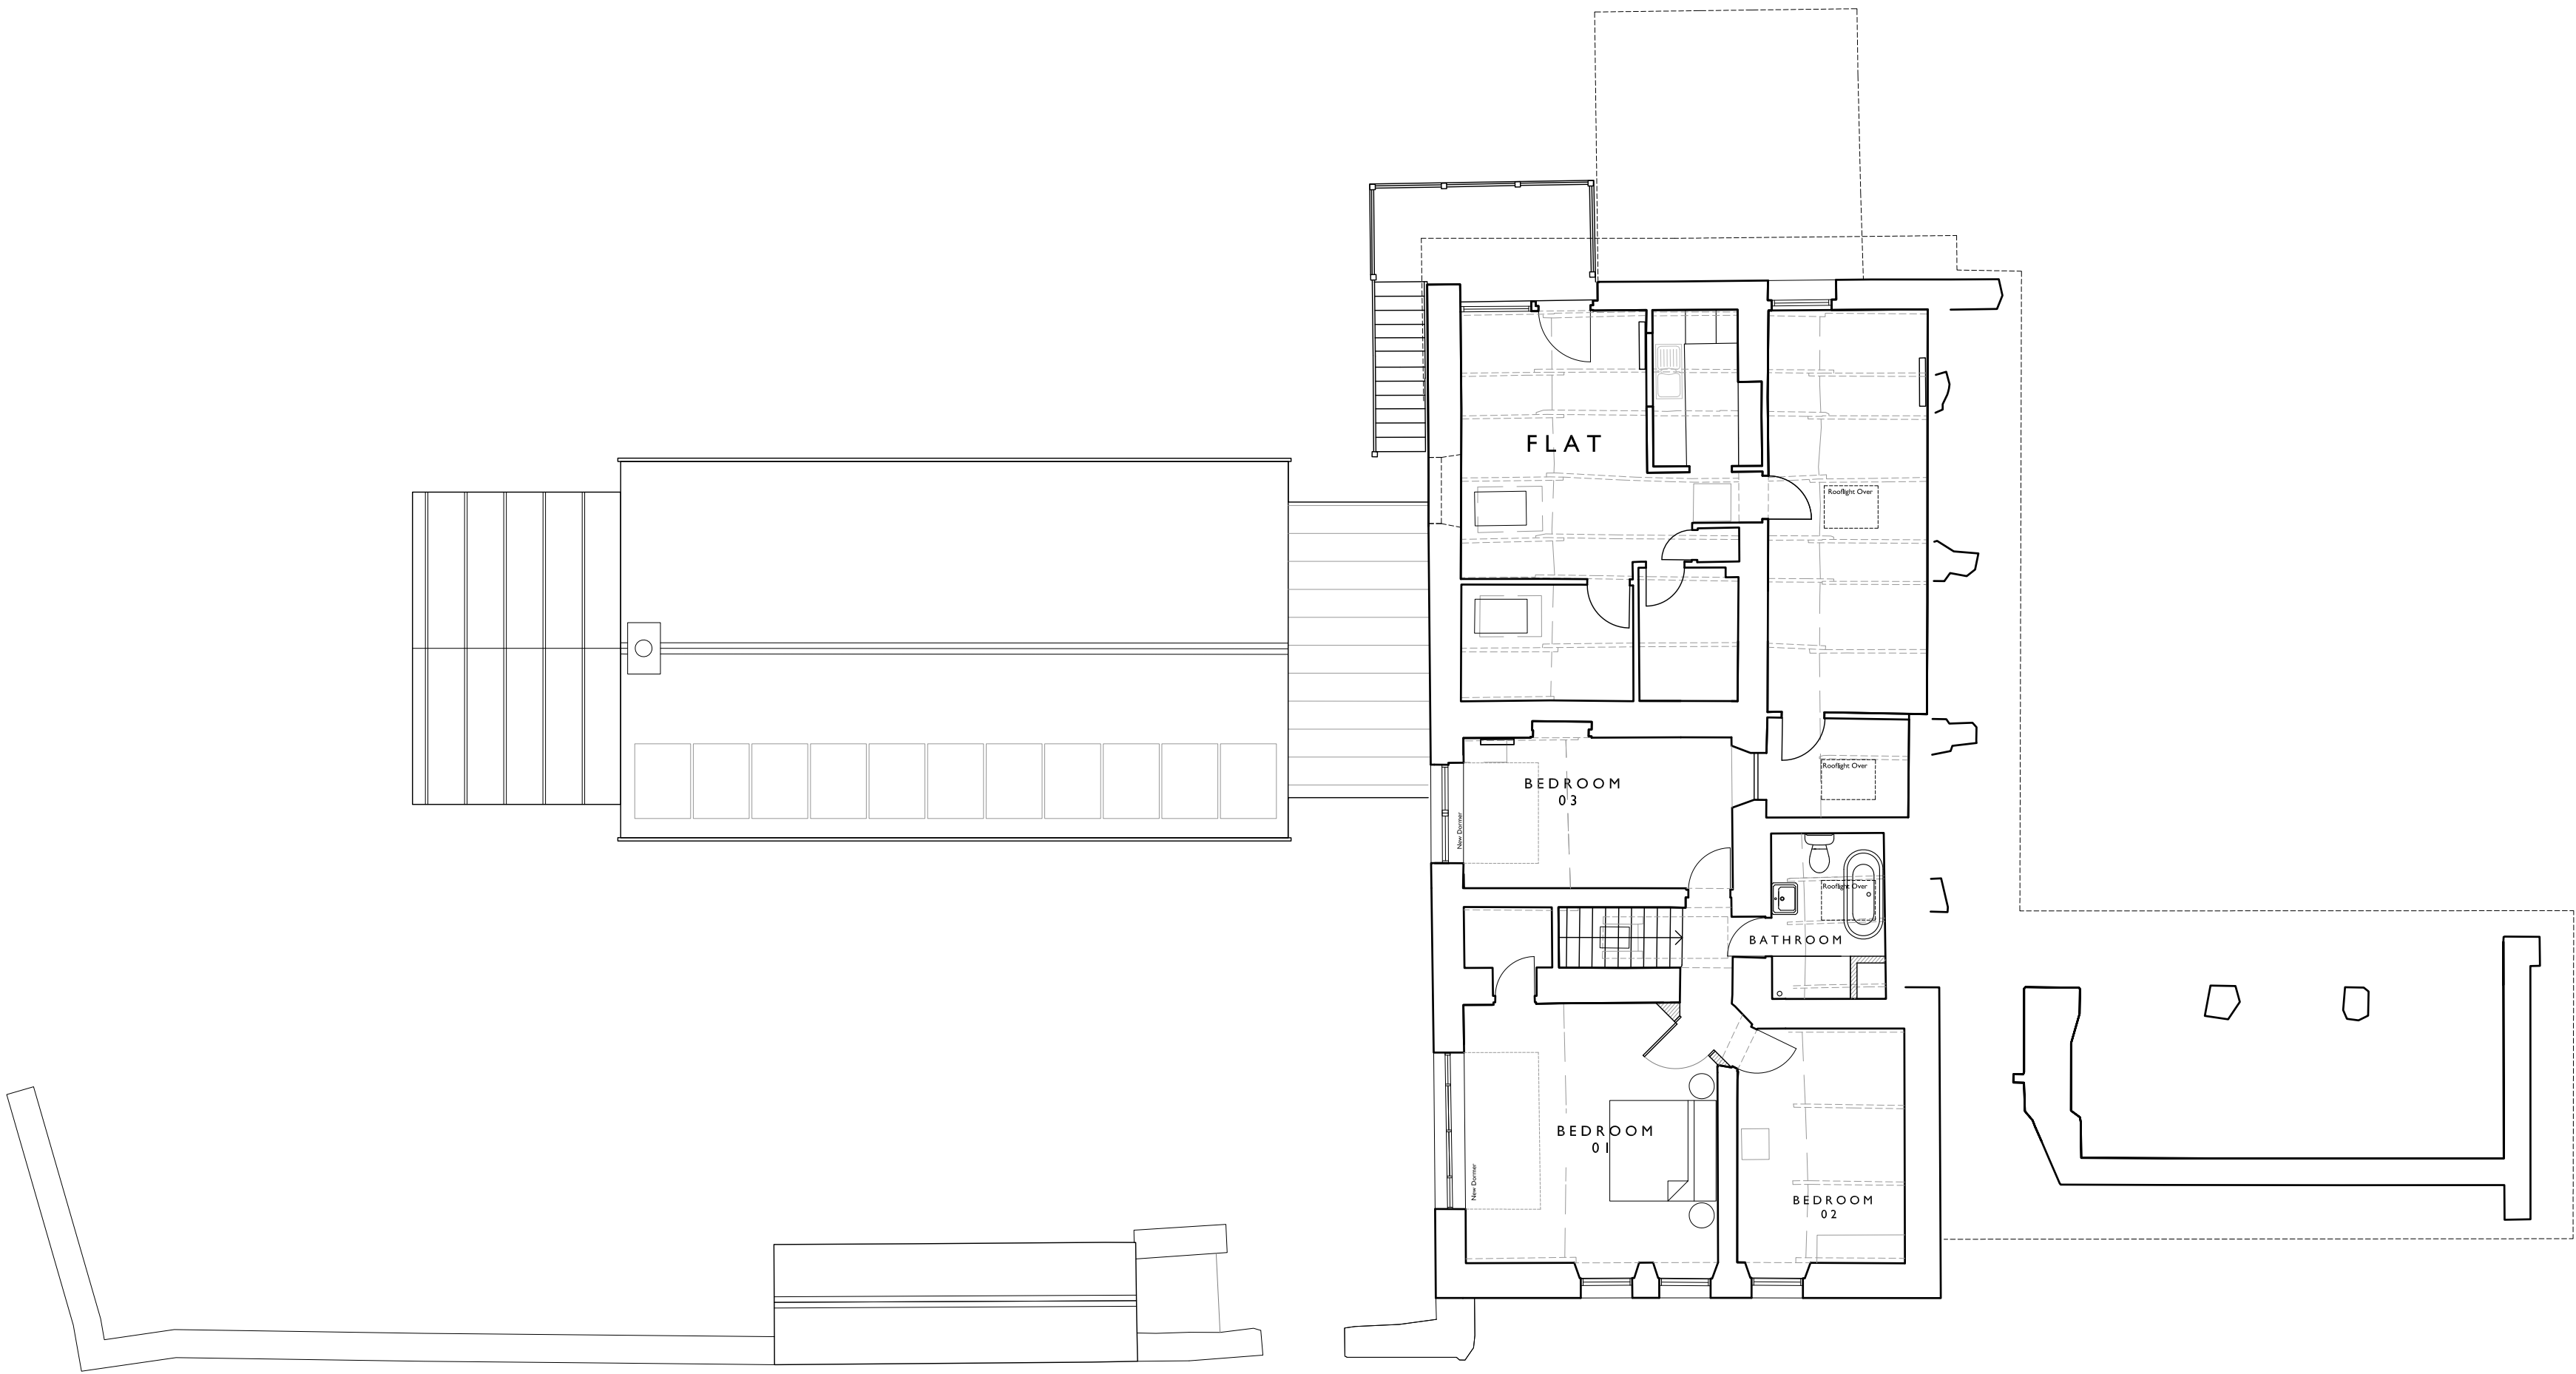
PROPOSED FIRST
FLOOR PLAN

PROPOSED GROUND
FLOOR PLAN

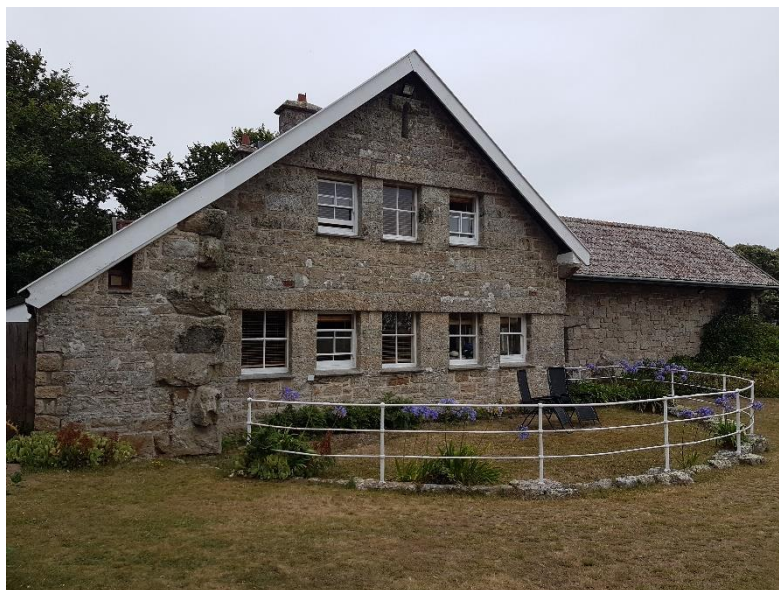
Figure 2: Southern elevation of Valhalla

Valhalla consists of a large two-storey L-shaped stone building, the eastern part of which contains the Valhalla Museum and the northern and western parts contain residential accommodation. The roof over the property is pitched with overhanging eaves on the northern and southern gable ends. The roof is covered with interlocking concrete and clay roof tiles with clay ridge tiles. On the western elevation the roof extends in a lean-to projection down to ground floor level, with a further concrete block single-storey lean-to projection in the centre at ground floor level. There is a single-storey attached outbuilding on the northern elevation, with a pitched slate roof and clay ridge tiles, and to the west of the property within the garden, is a detached single-storey outbuilding with a pitched roof covered with interlocking clay roof tiles (Figs 2 to 6).

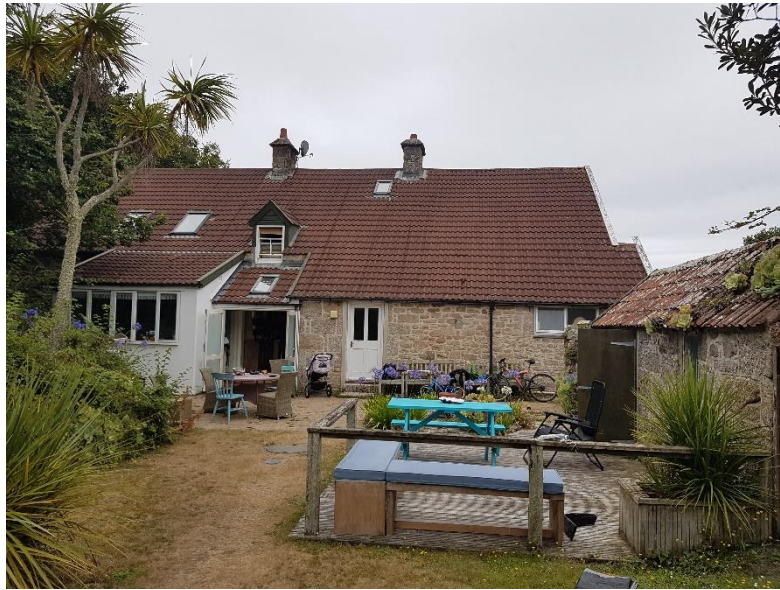
Figure 3: Western elevation of Valhalla and northern elevation of detached outbuilding

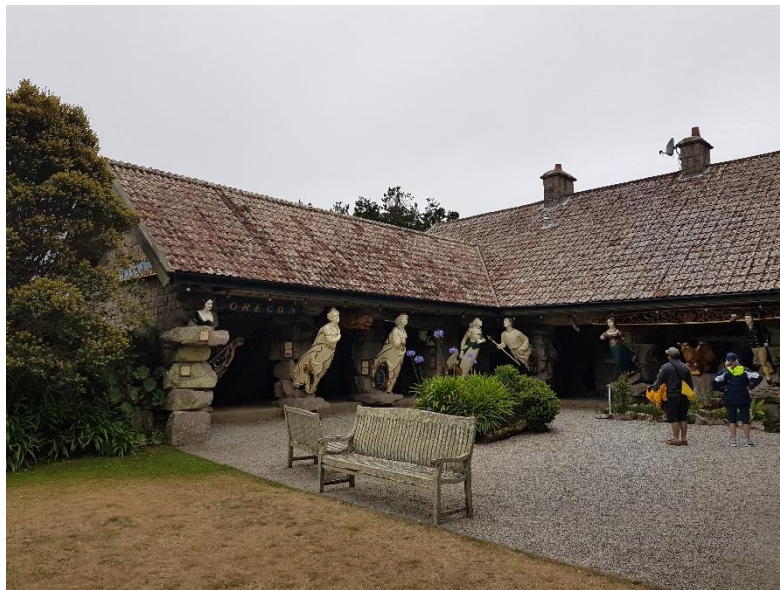
Figure 4: Northern and eastern elevations of Valhalla (showing Valhalla Museum)

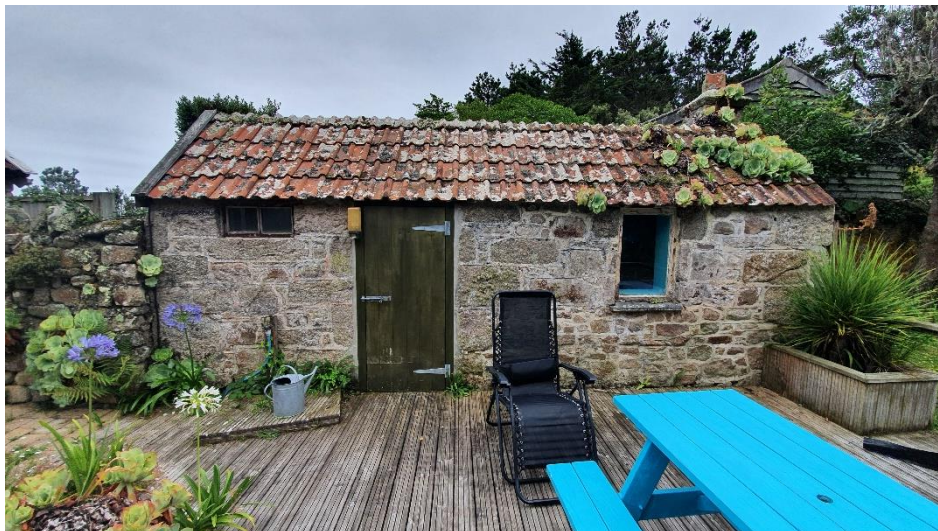
Figure 6: Northern elevation of detached outbuilding

The detached outbuilding has two small timber framed glazed windows and a timber door on the northern elevation. It features timber fascias and there is timber cladding on the eastern gable end. There are notable gaps underneath the fascia which provide potential roosting opportunities for bats and also provide potential access into the interior. The timber cladding is well-sealed (Fig 6).

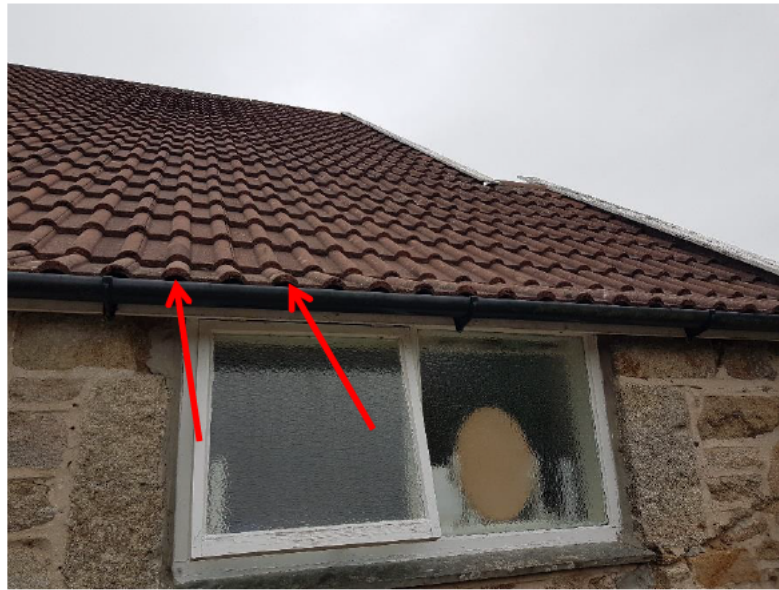
Figure 7: Gaps underneath the interlocking roof tiles on western elevation

The western section of the property consists of a two-storey residential house on the ground floor and part of the first floor, with a self-contained apartment on the first floor at the northern end accessed via an external timber staircase. There are roof lights and a dormer window with a pitched roof in the western elevation of the roof. The building features plastic guttering, timber fascias, timber barge boards on the northern and southern ends, timber framed glazed windows and timber doors, slate and timber windowsills and two stone chimneys on the main part of the roof. There are notable gaps at the wall tops under the overhanging eaves, behind the fascia boards and at the ends of the interlocking roof tiles which provide potential opportunities for roosting bats and potential access into the roof voids. On the southern gable end there is also a large gap under the eaves which provides potential access for bats to the underside of the roof and potentially also the roof void above (Figs 7 to 9).

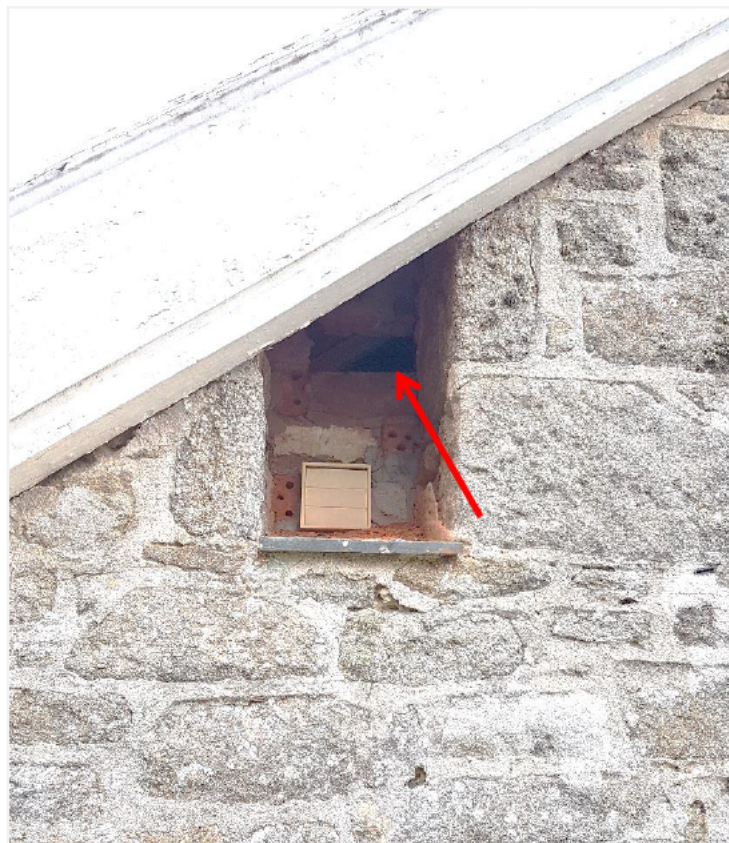
Figure 8: Gap under eaves on southern gable end

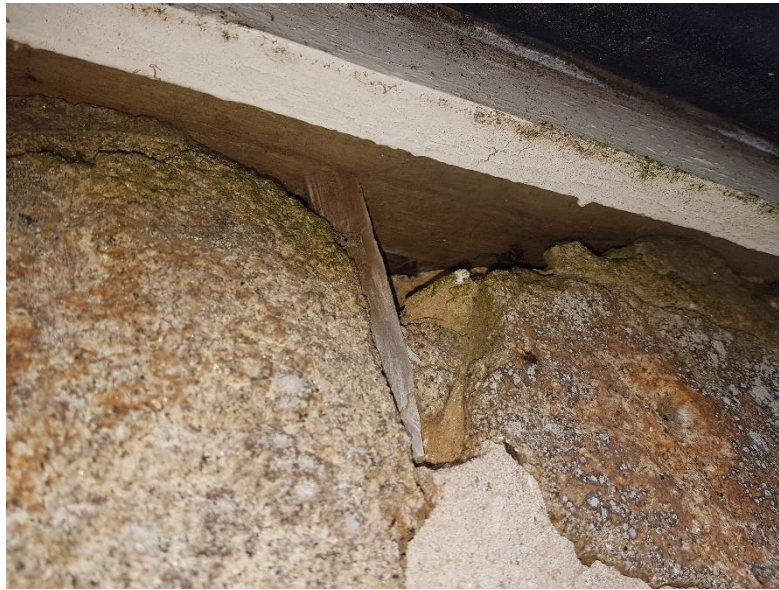
Figure 9: Gap on wall top behind fascia board on western elevation

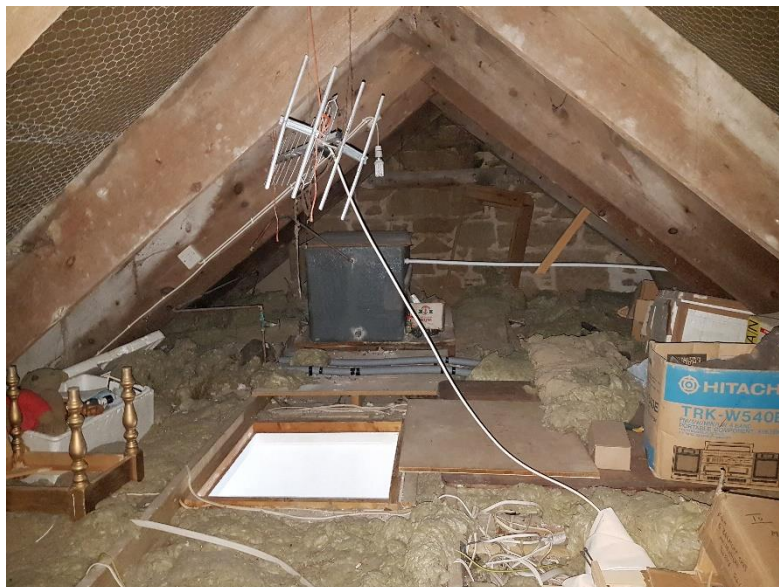
Figure 10: Interior of roof void over apartment (viewed towards the south)

Internally, the roof over the house is partially vaulted with two separate roof voids above the first floor. A third separate roof void is present over the apartment in the north of the property. The two voids over the house are separated by an internal stairwell with a roof light above. The three voids are of similar composition internally; open from the floors, which are covered with rolled insulation, to the underside of the roof, which is lined with a bitumen-based roofing felt covered with chicken wire. The internal walls are bare stone and there are no crossing timbers. The roof void over the apartment is larger than the other two roof voids as the ceiling in this part of the property is lower. This void contains a water tank and some stored materials (Fig 10).

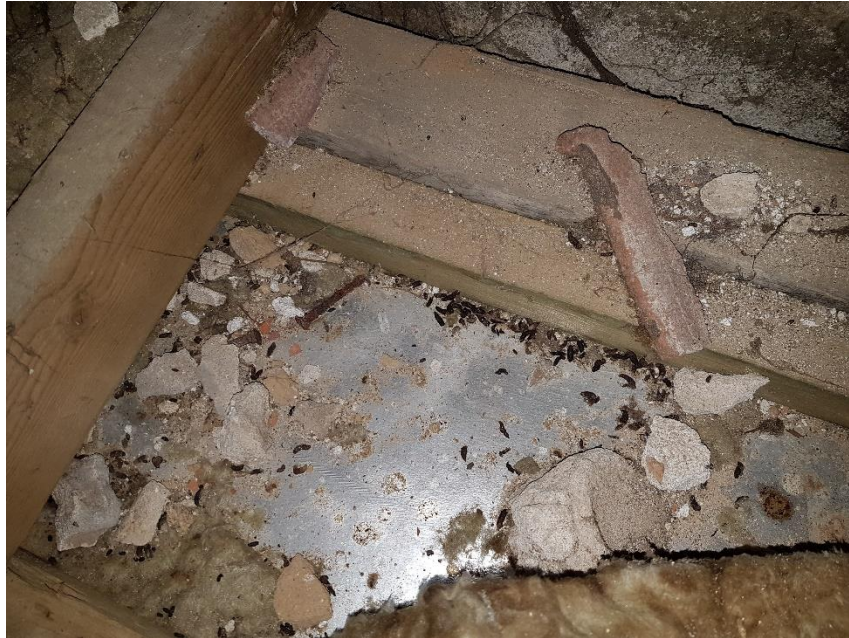
Figure 11: Accumulation of bat droppings at the northern gable end within roof void over the apartment.

noted, with a small accumulation of droppings noted under the ridge in the centre (approximately 10 – 20 droppings) and a larger accumulation at the northern gable end below the ridge (50+ droppings). The droppings were characteristic of a long-eared bat spp., likely to be brown long-eared bat as the site is outside the known range of grey long-eared bat (Fig 11).

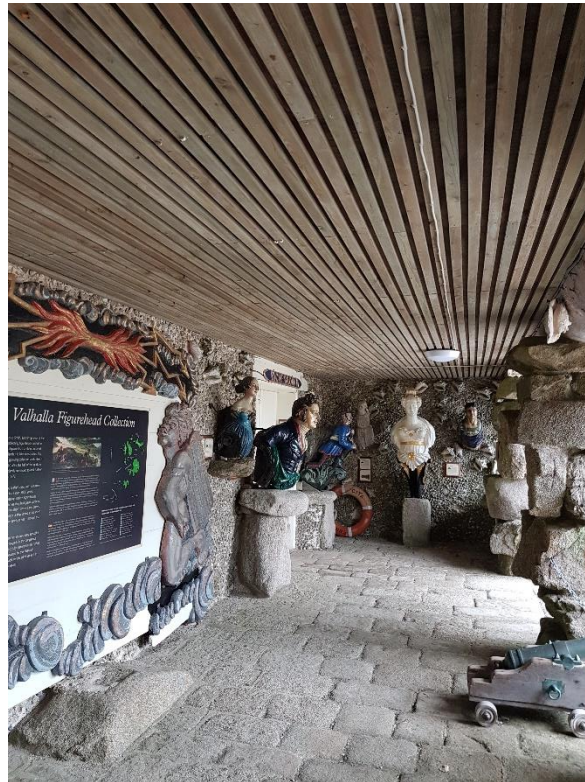
Figure 12: Interior of Valhalla Museum (viewed towards the west).

The Valhalla Museum is contained partly within a single storey extension, which projects eastwards from the main building creating an 'L-shape', and partly within the eastern side of the main building. This part of the building is open fronted along its northern and eastern sides, with stone pillars and ship figureheads present from the stone floor to the underside of the ceiling. The ceiling consists of timber battens over bitumen felt and the walls are either bare stone or they have been rendered and painted (Fig 12). The southern elevation of the eastern extension is a bare stone wall with a timber door leading through into the museum area. There is a loft hatch above this door, although it was not possible to inspect the roof void above due to the ceiling height being beyond the length of the ladder.

No evidence of use of this part of the building by roosting bats was noted. As it was not possible to inspect the interior of the roof void over the eastern extension the likely presence or absence of bats roosting within this area could not be determined. However, as far as we are aware, this section of the building will not be directly impacted by the proposed works.

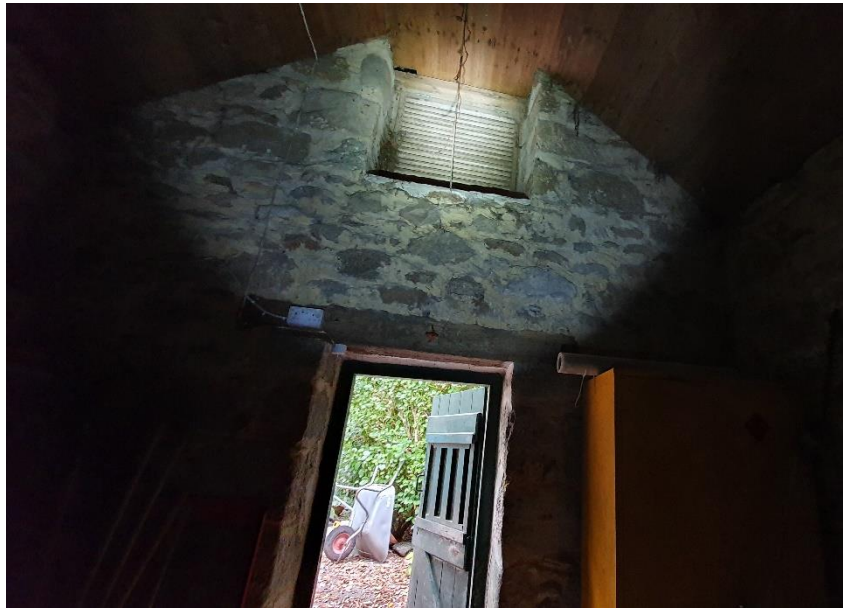
Figure 13: Interior of attached outbuilding (viewed towards the north).

The attached outbuilding has a timber door and a timber vent on the northern gable end. It also features a timber barge board on this end of the building, but there are no windows. There are notable gaps behind the barge board, in the timber door and vent which provide potential access for bats into the interior (Fig 5). Internally, the building consists of one room, which is very dark and is open from the stone floor to the underside of the roof, which has been partially vaulted and lined with timber sarking boards (Fig 13).

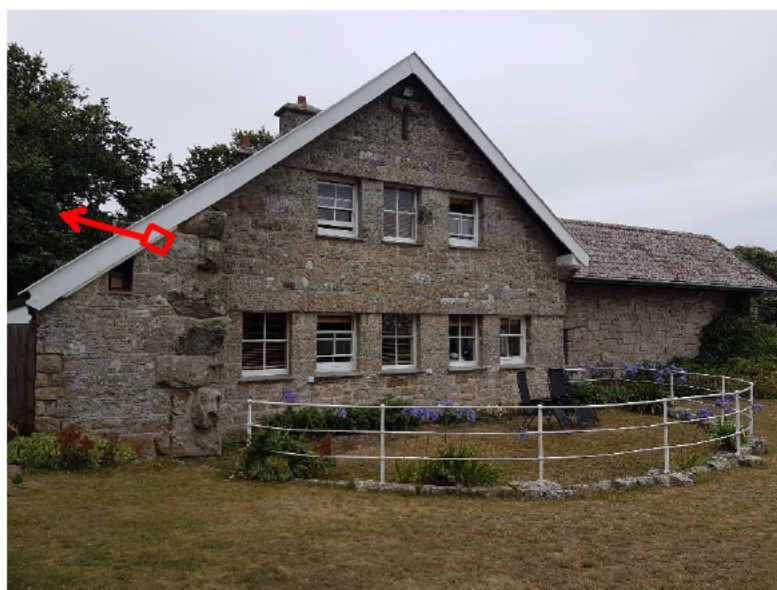
Figure 15: Location of three common pipistrelles seen to emerge during first emergence survey (red arrow) from under the fascia board on the southern elevation of Valhalla.

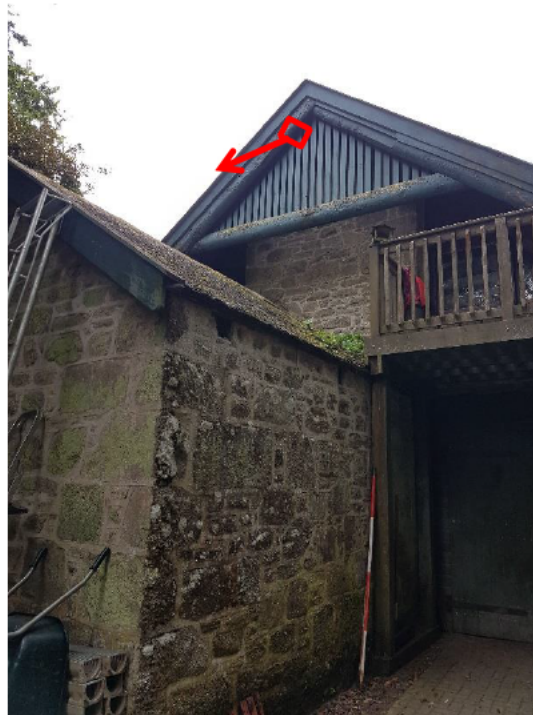
Figure 16: Location of a brown long-eared bat seen to emerge during the second emergence survey (red arrow) under wooden fascia near the apex on the northern elevation of Valhalla.

During the second emergence survey on 23rd September 2020, one brown long-eared bat was seen to emerge at 20:09 from under the wooden fascia board near the apex of the northern elevation of Valhalla (Fig 16). No bats were seen to emerge from the attached outbuilding or detached outbuilding during this survey.

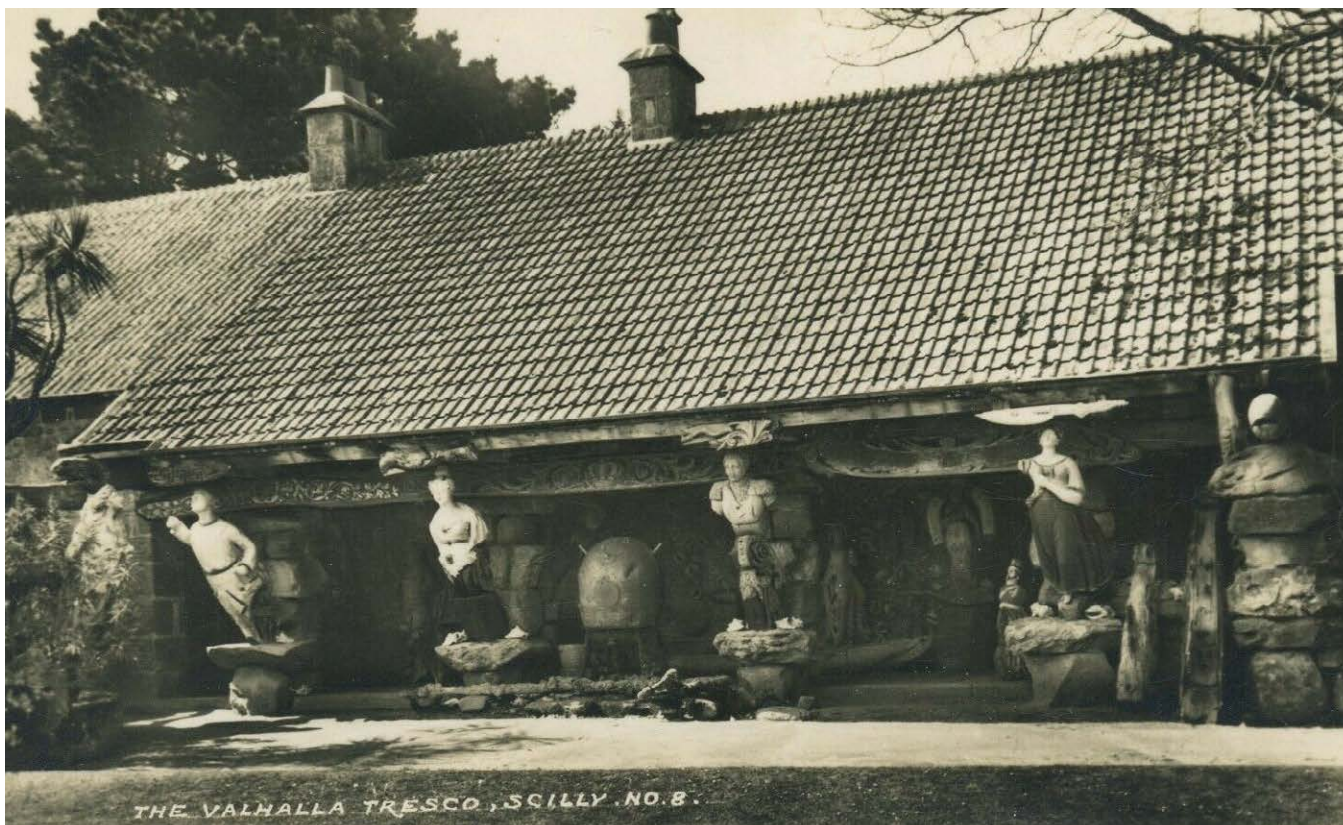
Fig 5 Post Card C.1960s prior to the addition of the loggia extension

The building remained in this form until the 1960s, when the eastern wing was added along the southern boundary in order to house the expanding figurehead collection, also creating a covered entrance way into the gardens. Two photographs from the period, show us the building shortly before and after these works were undertaken. [Fig 5 & 6]

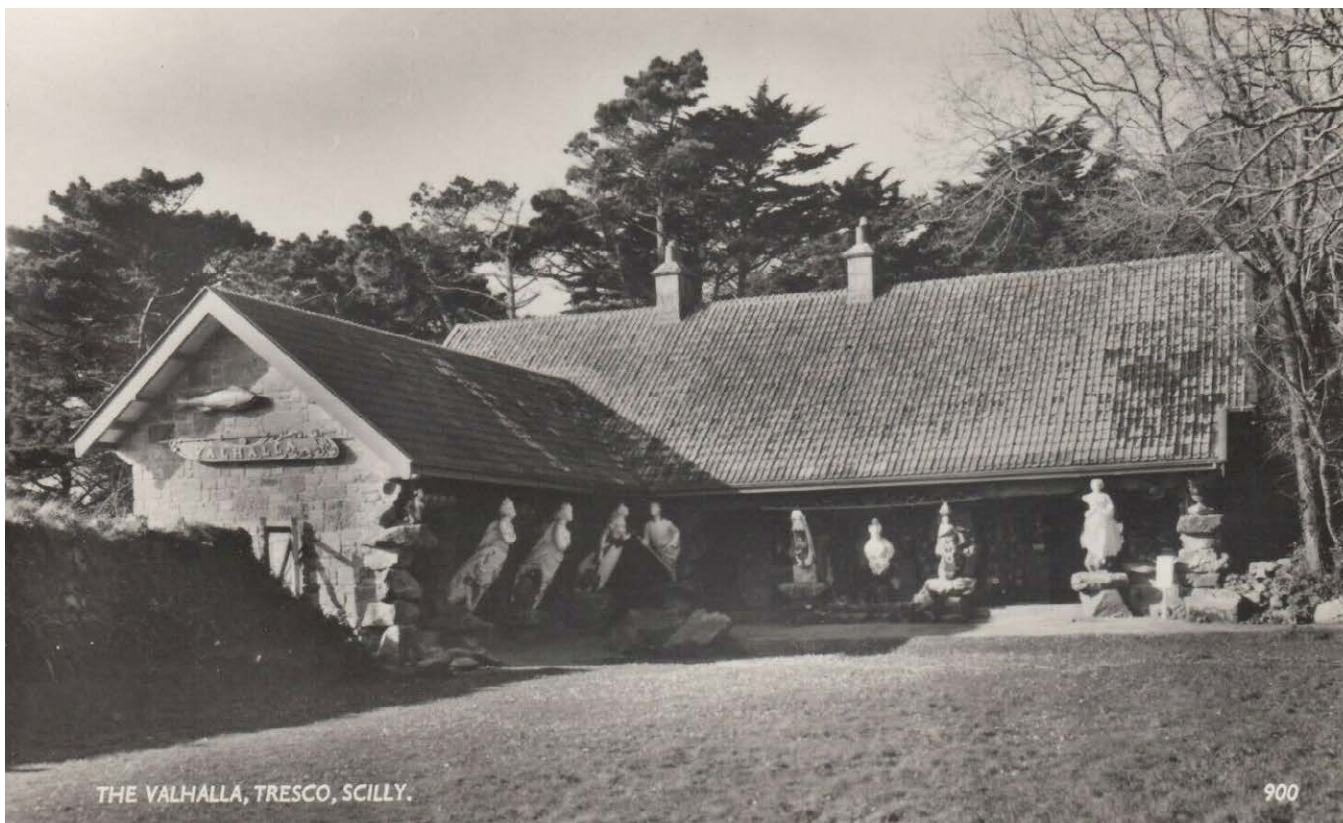
Fig 6. Postcard C.1960s following extension

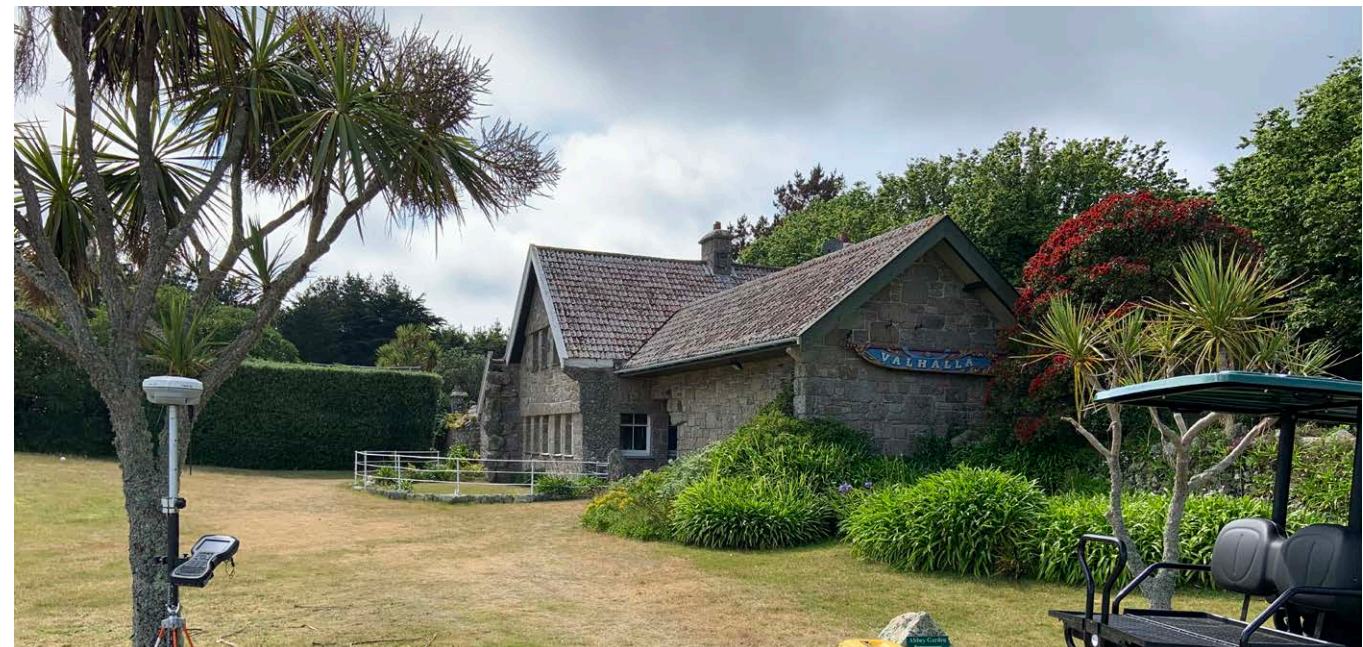
Figure 9 Looking across the South Elevation

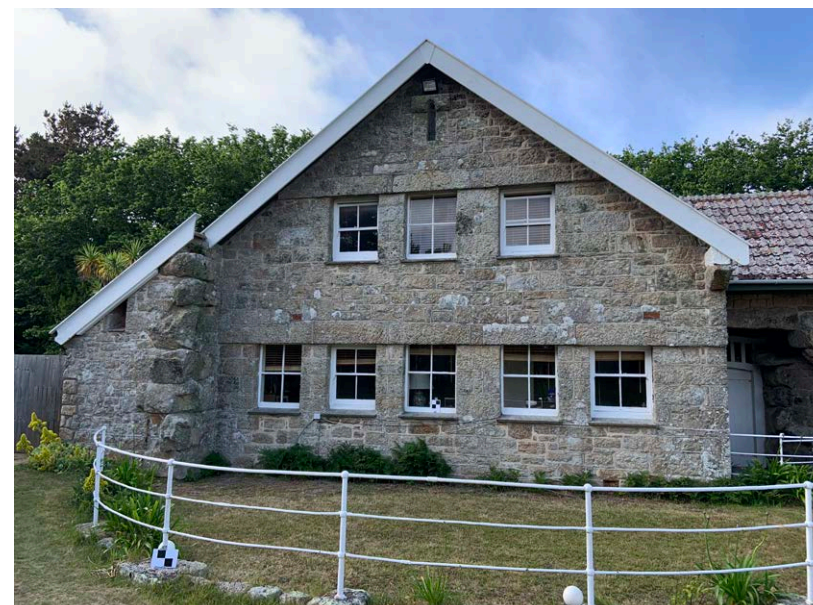
Figure 10 Gable Detail

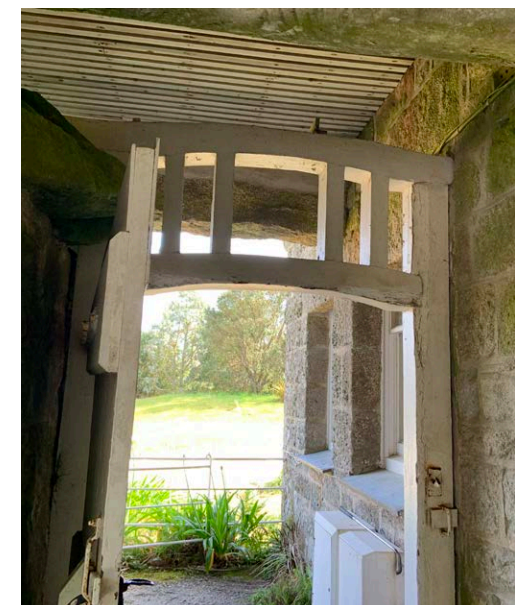
Figure 11 Gate Entrance

The eastern wing that houses the figurehead museum expansion was built over the former southern boundary granite wall in the 1960s. This presents a generally blank elevation to the south, with the exception of the opening formed with a rustic granite surround around the original entrance gateway tight to the original two storey cottage [Fig 11].

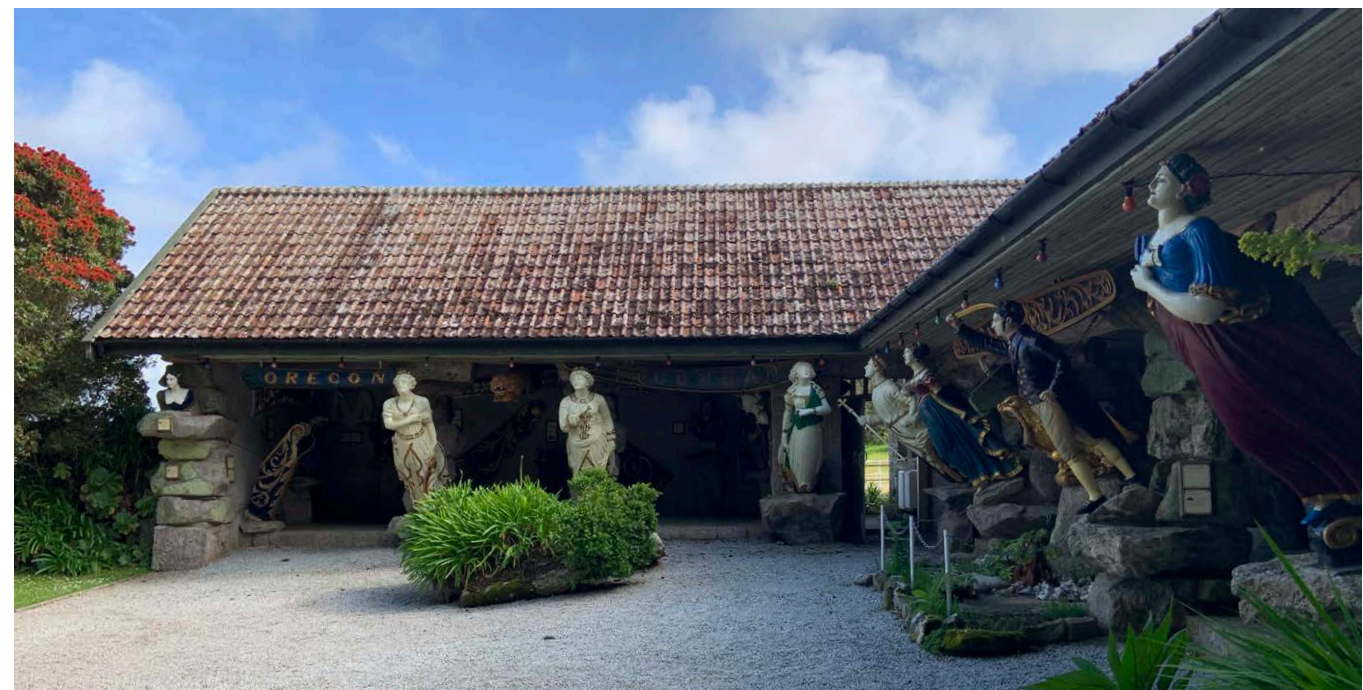
Figure 12 Figurehead Museum

The Figurehead Museum occupied the eastern side of the site. A loggia is formed of rustic granite piers which incorporate the display exhibits and support the expansive overhanging roof. Within the loggia original loggia walls are decorated with rustic gravel and seashell mosaic, soffits are now lined with narrow boarding, but were oginally decorated in the same manner [Fig. 27]. The eastern wing was added in the 1960s to expand exhibition capacity and effectively mimics the style of the existing original loggia, but with a plainer render lining in lieu of the more characterful mosaic work.

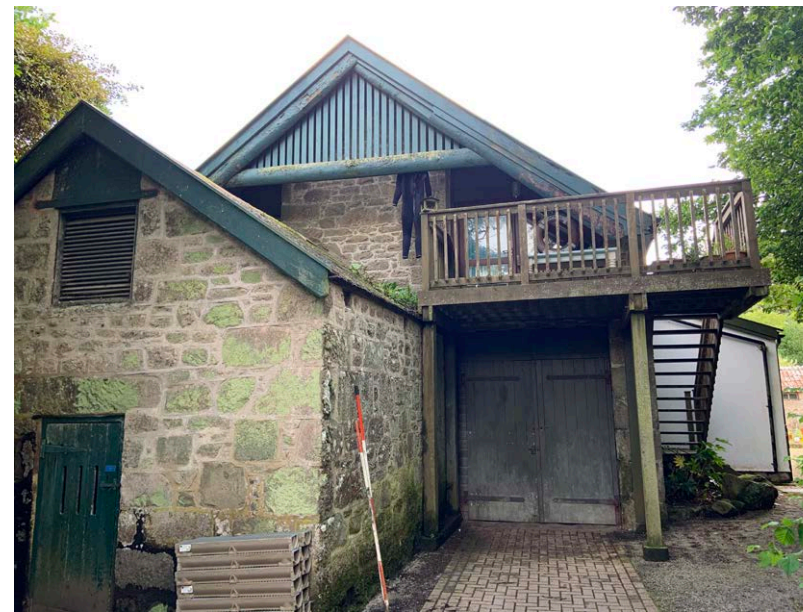
Figure 13. Rear North Elevation

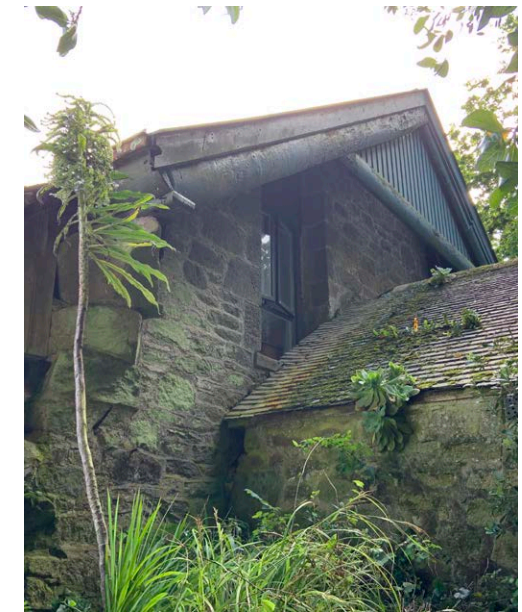
Figure 14. Scantle Roof Detail
