PERMISSION FOR DEVELOPMENT

Application No: P/23/022/ROV **Date Application Registered:** 4th April 2023

Site address: Valhalla Abbey Road Tresco Isles Of Scilly TR24 0QQ
Proposal: Variation of condition 2 (Approved Plans) of planning permission P/21/108/HH (Demolition of lean-to extension, construction of new single storey extension, installation of new dormer windows, construction of new swimming pool and other internal and external alterations. (Affecting setting of a listed building)) to make minor amendments to the approved scheme.

Bat Survey Report

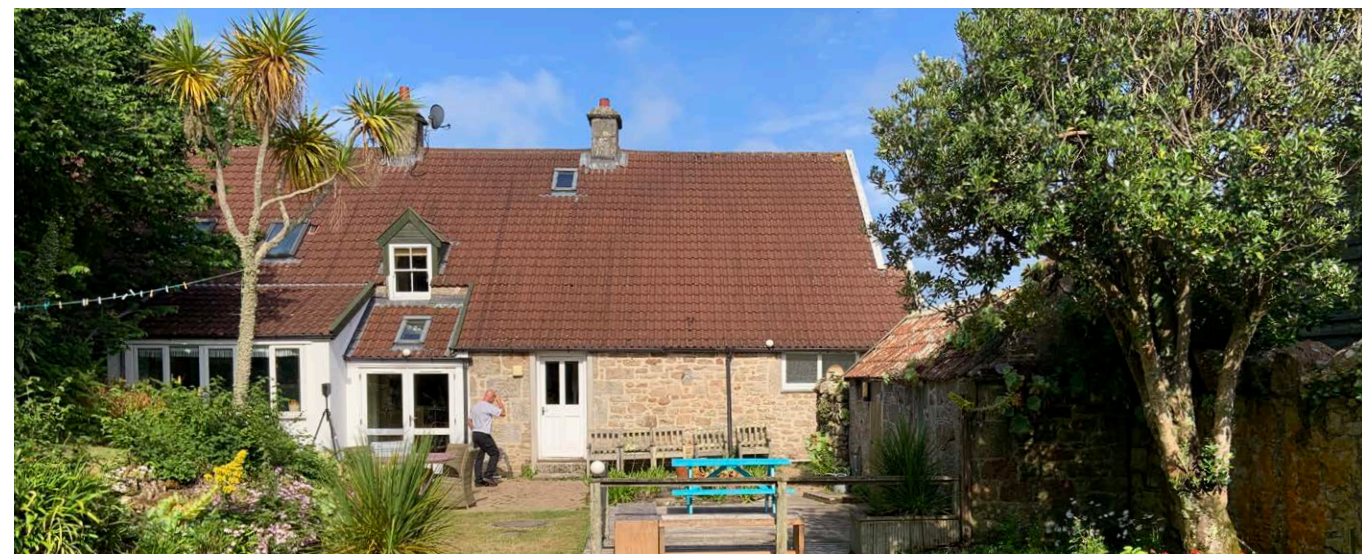
Figure 15. West Elevation

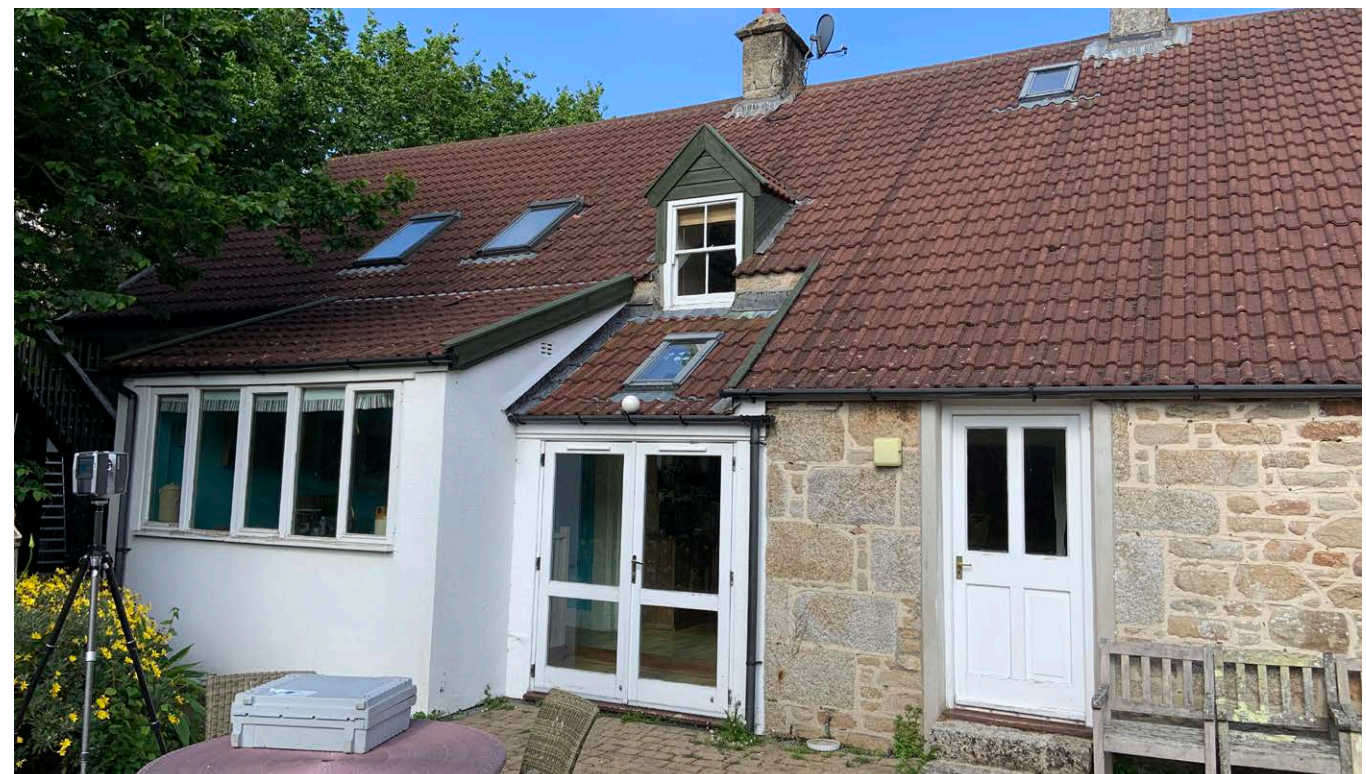
Figure 16. West Elevation Close-up

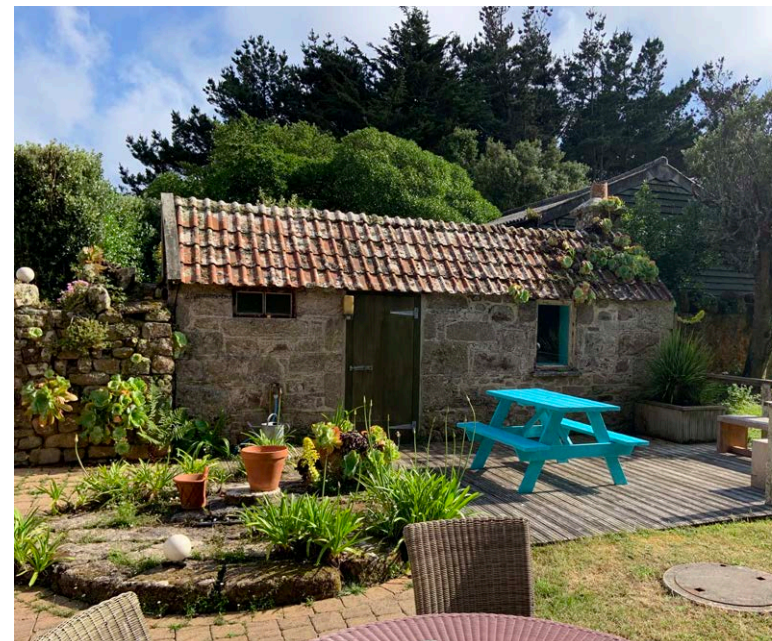
Figure 17. Outbuilding on southern boundary of private garden

A lean-to on the western elevation runs past the face of the primary gable. A wall and potting shed enclose the southern boundary to the west [Fig. 17].

A charming granite wall and small out building with granite chimney enclose the private garden along its southern edge. 4m tall hedges to the south, the visitors' centre complex to the West, and dense shelter-belt planting to the North provide further shelter, such that the garden area is not perceptible from outside the plot.

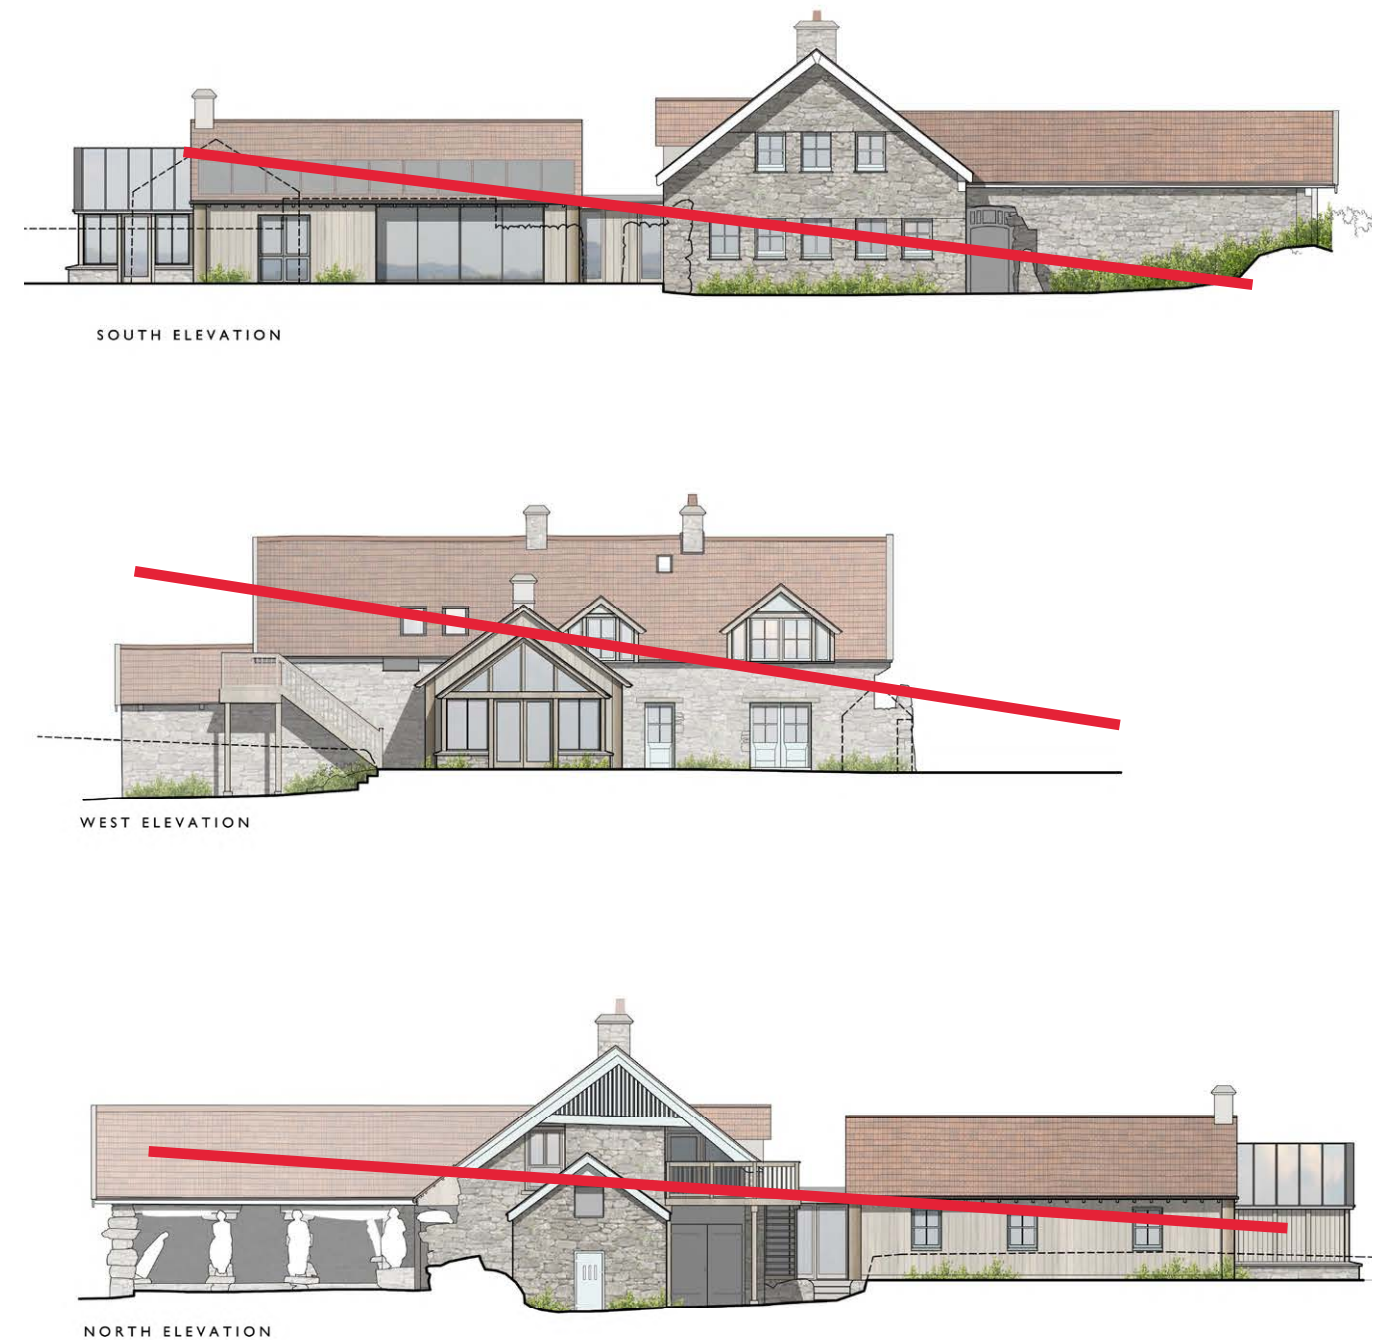
Figure 25. Proposed Elevations

The pitched roof wing would be of a scale and character to emulate the existing eastern wing, timber clad and with a double roman tiled roof, and would contain the kitchen dining room and drawing room. The dual pitched roof would allow for vaulted internal ceilings that would provide generous lofty living spaces. The kitchen and dining room would include a glazed screen, set back from the elevation, to provide natural light and views out into the garden.
