**Alterations to 25 Sallyport,
Hugh Town, St. Mary's
Isles of Scilly
TR21 0JE
for
Mike and Jen Bradbury**

DESIGN AND ACCESS STATEMENT

March 2023

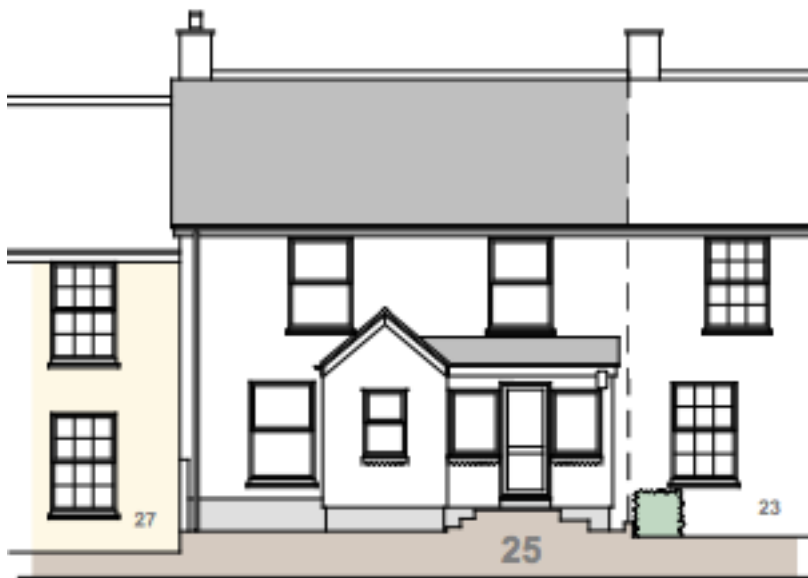
Existing front elevation

Each house in the terrace therefore has its own quality and identity. Number 25 differs from its neighbours as the original gabled roof entrance porch was reconstructed in 2000 and a lean-to sunroom was added at the same time. The latter has a natural slate roof. However, the glazing is rather disappointing with window heads out of alignment with the top of the door and the scalloped lead flashings below the sills are hardly a Scillonian feature (see below).

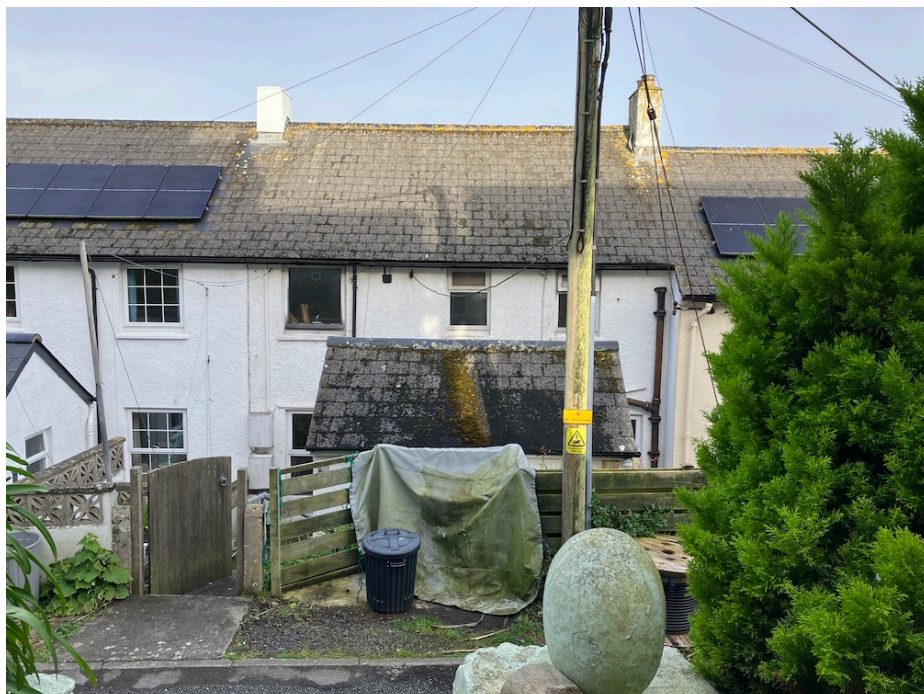
Above: Looking back to number 25 from the back lane. Note the unattractive landing and bathroom window proportions and the discoloured top kitchen window

All of the double glazed UPVC doors and windows at 25 Sallyport are in poor condition and in need of replacement. The surface of some windows has discoloured, opening windows are hard to open and close, hinges are failing and some of the windows leak. Security is also an issue at present.

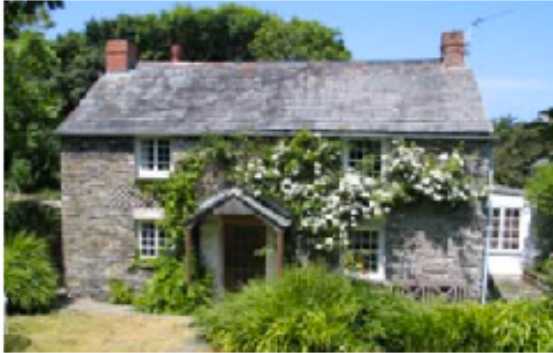
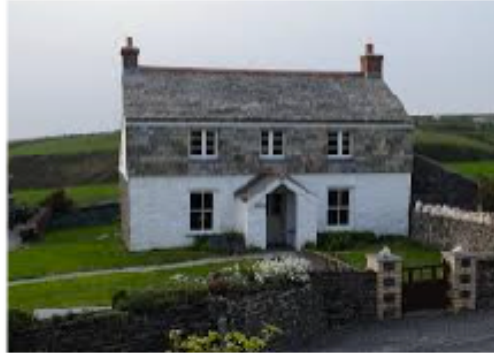
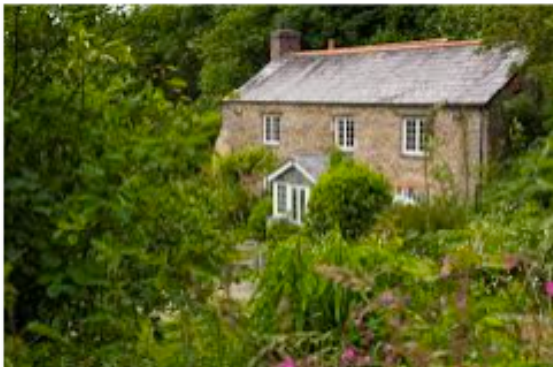
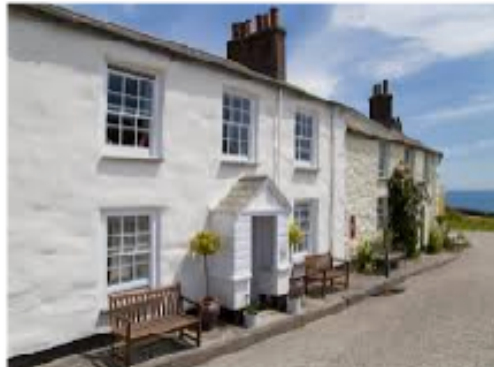
The images above are traditional Cornish cottages sharing the same gabled entrance porch feature. The front door in each case is very obviously in the centre of the cottage. The alterations at 25 Sallyport will also clearly define the front door and approach to the property. The decking in front of the doorway will be extended to provide a safe and easy entrance. In the adjacent lean-to, the uncomfortable arrangement of door and windows will be replaced by a simple sliding patio door. This will be a neater architectural solution and will also help to create a useful indoor sitting area taking advantage of the views over the beach and coastline.

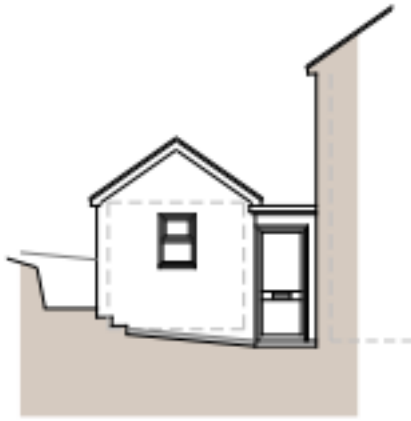
South Elevation

Extract from planning drawings showing back door

There are currently two back doors to the property serving each of the flats. These are situated in the flat-roofed link constructed in 2000 when the outbuilding was joined to the main dwelling. Only one of these is now needed so the plan is to replace one with a window and retain the door on the North side. The wall below the window will be constructed from timber stud-work, insulated and smooth rendered on the outside face. The wall will be painted pale blue to match the rest of the house.
