PROJECT
Isles of Scilly Cultural Centre and Museum
241601

TITLE
Planning - NW Elevation - Existing

DRAWING NUMBER
IOS-PUR-01-ZZ-DR-A-0113

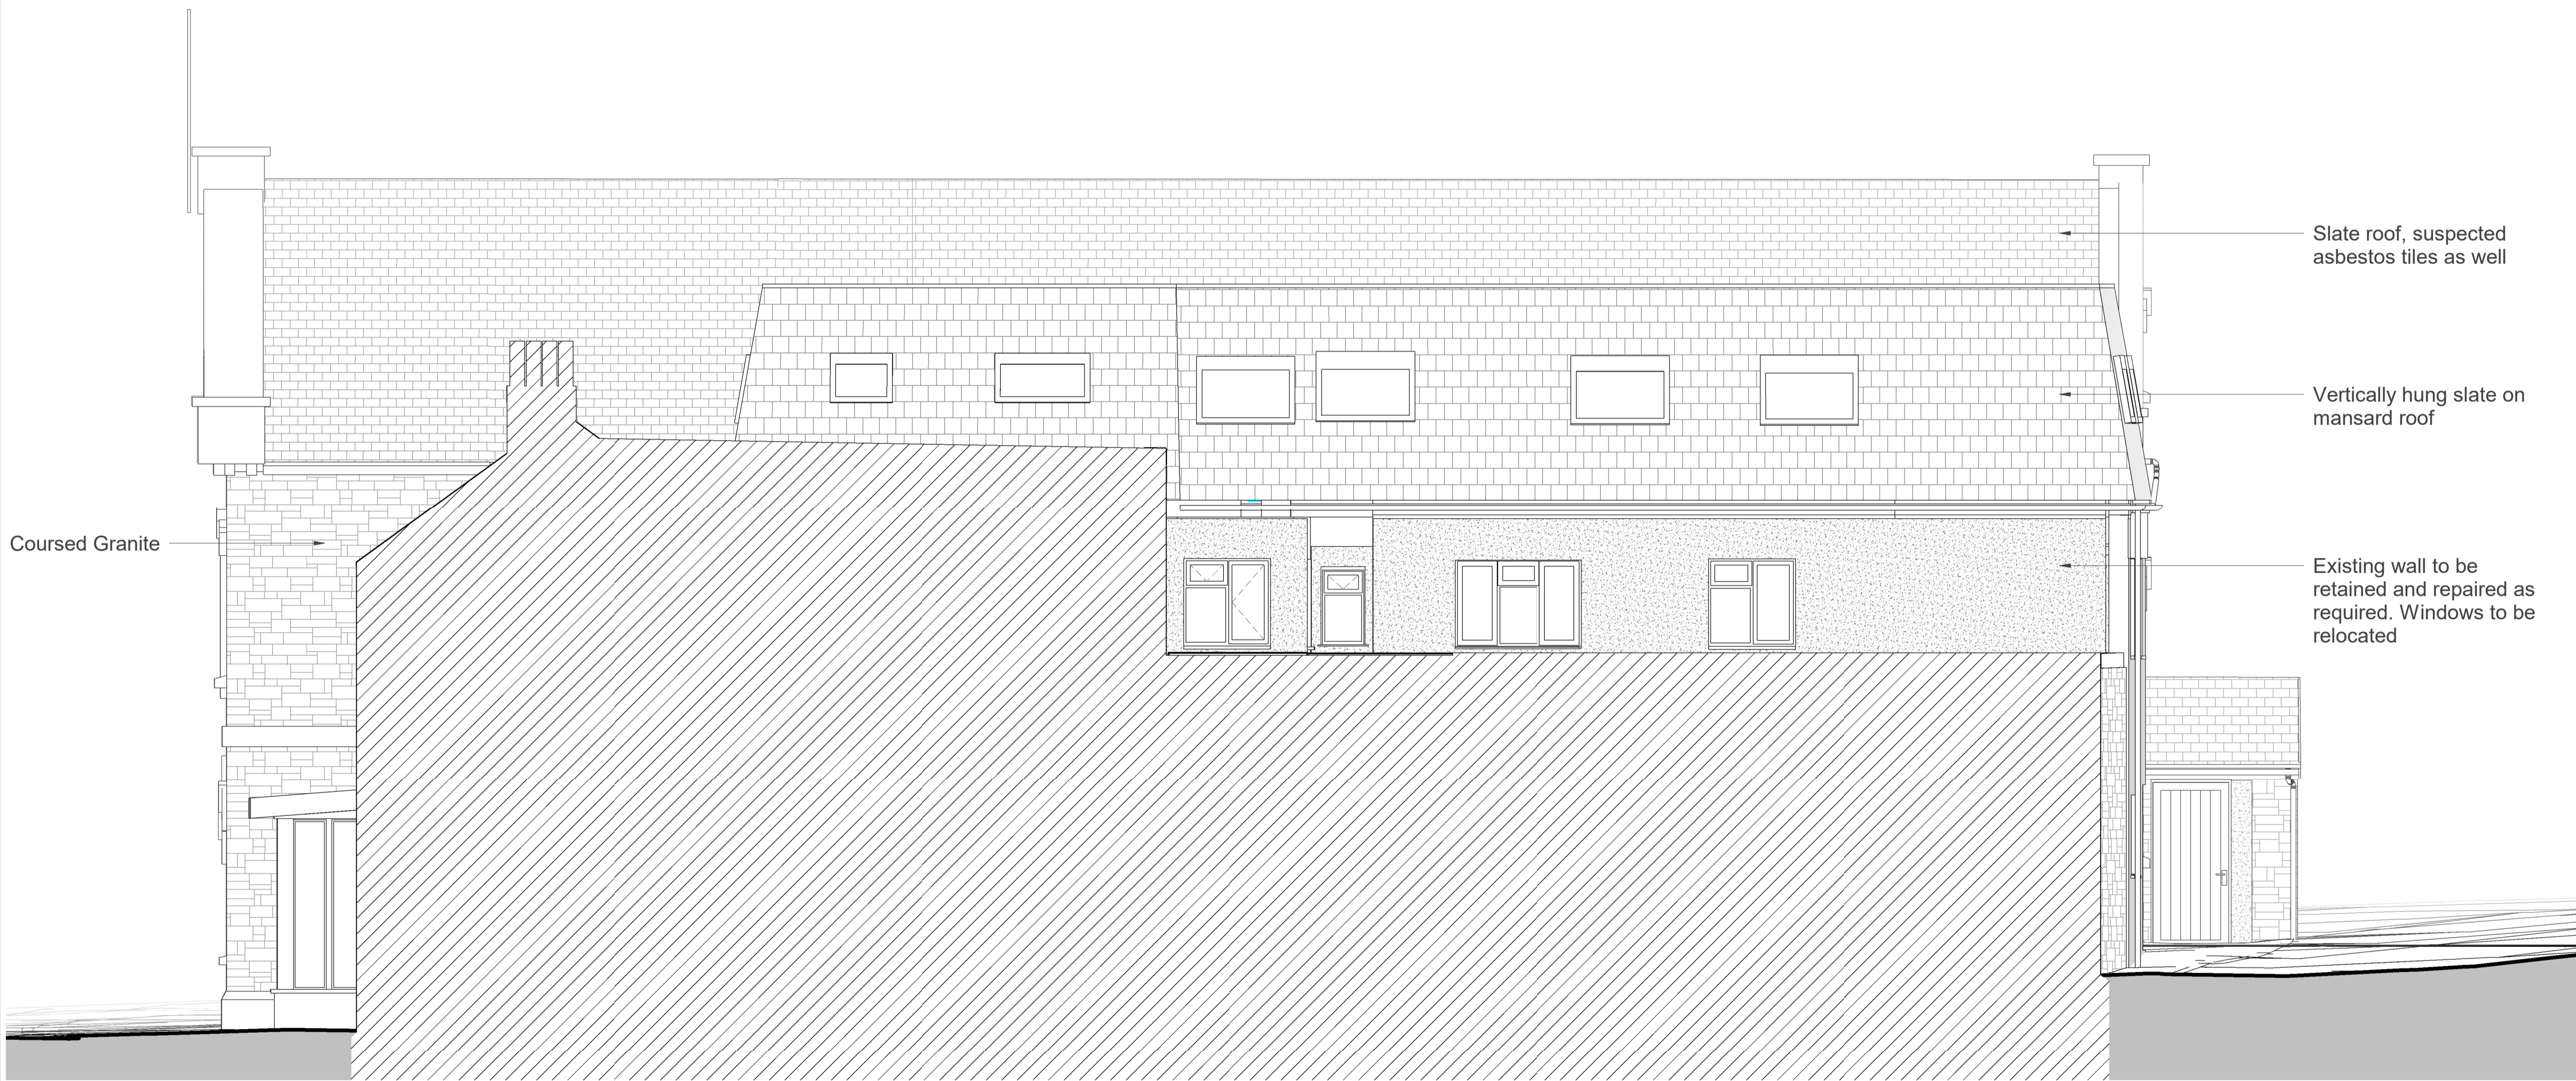
1 Planning North West Elevation - Existing
1 : 50

Slate roof, suspected asbestos tiles as well

Vertically hung slate on mansard roof

Existing wall to be retained and repaired as required. Windows to be relocated

Coursed Granite
