PERMISSION FOR DEVELOPMENT

Application No:	P/23/099/HH	Date Application Registered:	19th December 2023
Applicant:	Mrs Marilyn Sonnex Purdis Hall, Purdis Farm Lane, Foxhall, Suffolk, IP10 0AD	Agent:	Mr Clive Humphrey Rowenruth, Telegraph, St Mary's, Isles Of Scilly, TR21 0NS
Site address:	Grey Stones 1 Wellcross Hugh Town St Mary's Isles Of Scilly		
Proposal:	Replacement of existing concrete tiles with Spanish natural dry laid slate on front elevation of roof.

PRELIMINARY ROOST ASSESSMENT (PRA)

GREYSTONES, ST MARY'S, ISLES OF SCILLY

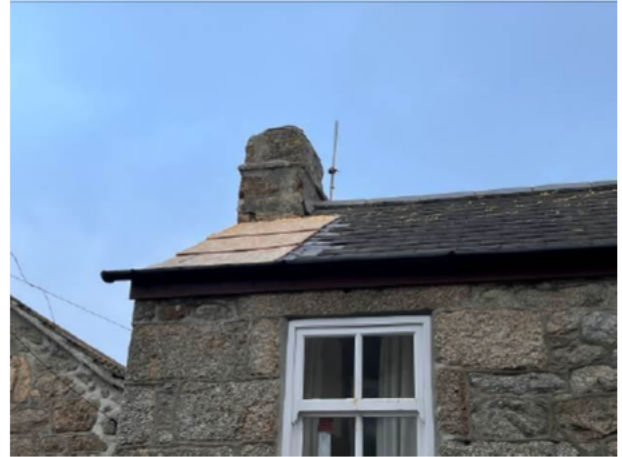
The roof of the property is dry-laid slate tile which is tightly fitted for the most part; however there is a missing section on the northern end which was damaged during a storm in late October 2023. Tiles are missing below the chimney on this aspect and a temporary repair has been made with chipboard and expanding foam. This is the only location where gaps are present beneath tiles but the recent nature of the incident would preclude all but opportunistic use of the feature by bats. The ridge tiles are tightly fitted with no gaps noted. The chimneys are well sealed at the junction with the roof tiles.

Photograph 2: Showing roof with the temporary repair to the damaged section below the northernmost chimney

The tiles immediately around the area of damage are lifted or accessible in places. In the highly unlikely event of bats finding roosting opportunities associated with this feature over the winter of 2023/4, care should be taken when removing the proximate tiles.

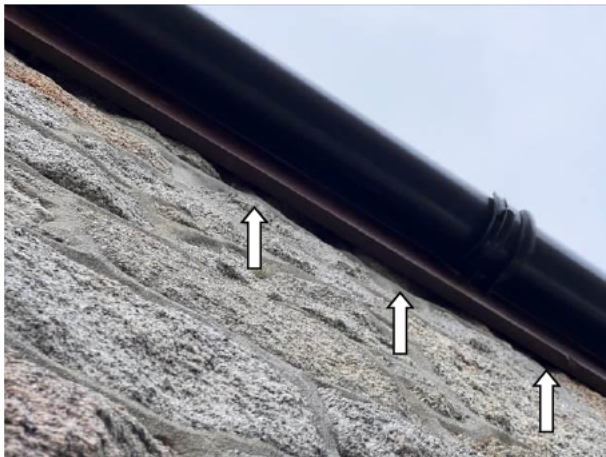
There is a fascia board running along the eaves with guttering attached – there are minor gaps behind this board where the straight plane of the wood is present alongside the irregular surface of the granite. The gaps were fully inspected with a torch and close-focussing binoculars and no bats were present at the time of survey.

Photograph 3: Showing the fascia board with intermittent gaps behind.

Care should be taken during works to ensure that these structures are not disturbed, obstructed, or damaged. This involves careful design of scaffolding installation and may include a contractor briefing to ensure that those working on the roof understand the requirement. Other measures such as a temporary sign, tape or physical barrier should be installed if deemed necessary.

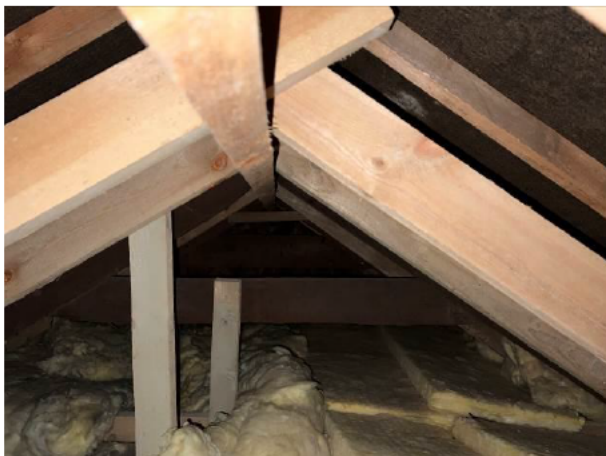
Internally, the loft space is situated above the cross-beam of the A-frame timbers which support the roof. A more modern ridge and rafter structure overlies original timbers but no gaps between loft timbers were noted. The underfelting is comprehensive and in good condition, aside from the damaged section on the northern end. Access for internal inspection was limited by the small dimensions of the space, intervening timbers and the use of the loft for routine storage. However inspection from the access hatch did not identify any droppings or other signs of bats.

Photograph 5: Showing the interior of the loft space
